Environmental Screening Follow-up Report

FRASER RIVER FLOOD CONTROL PROJECT No.19

**Nicomen Island Bank Protection
Quaamitch Slough**

September , 1985

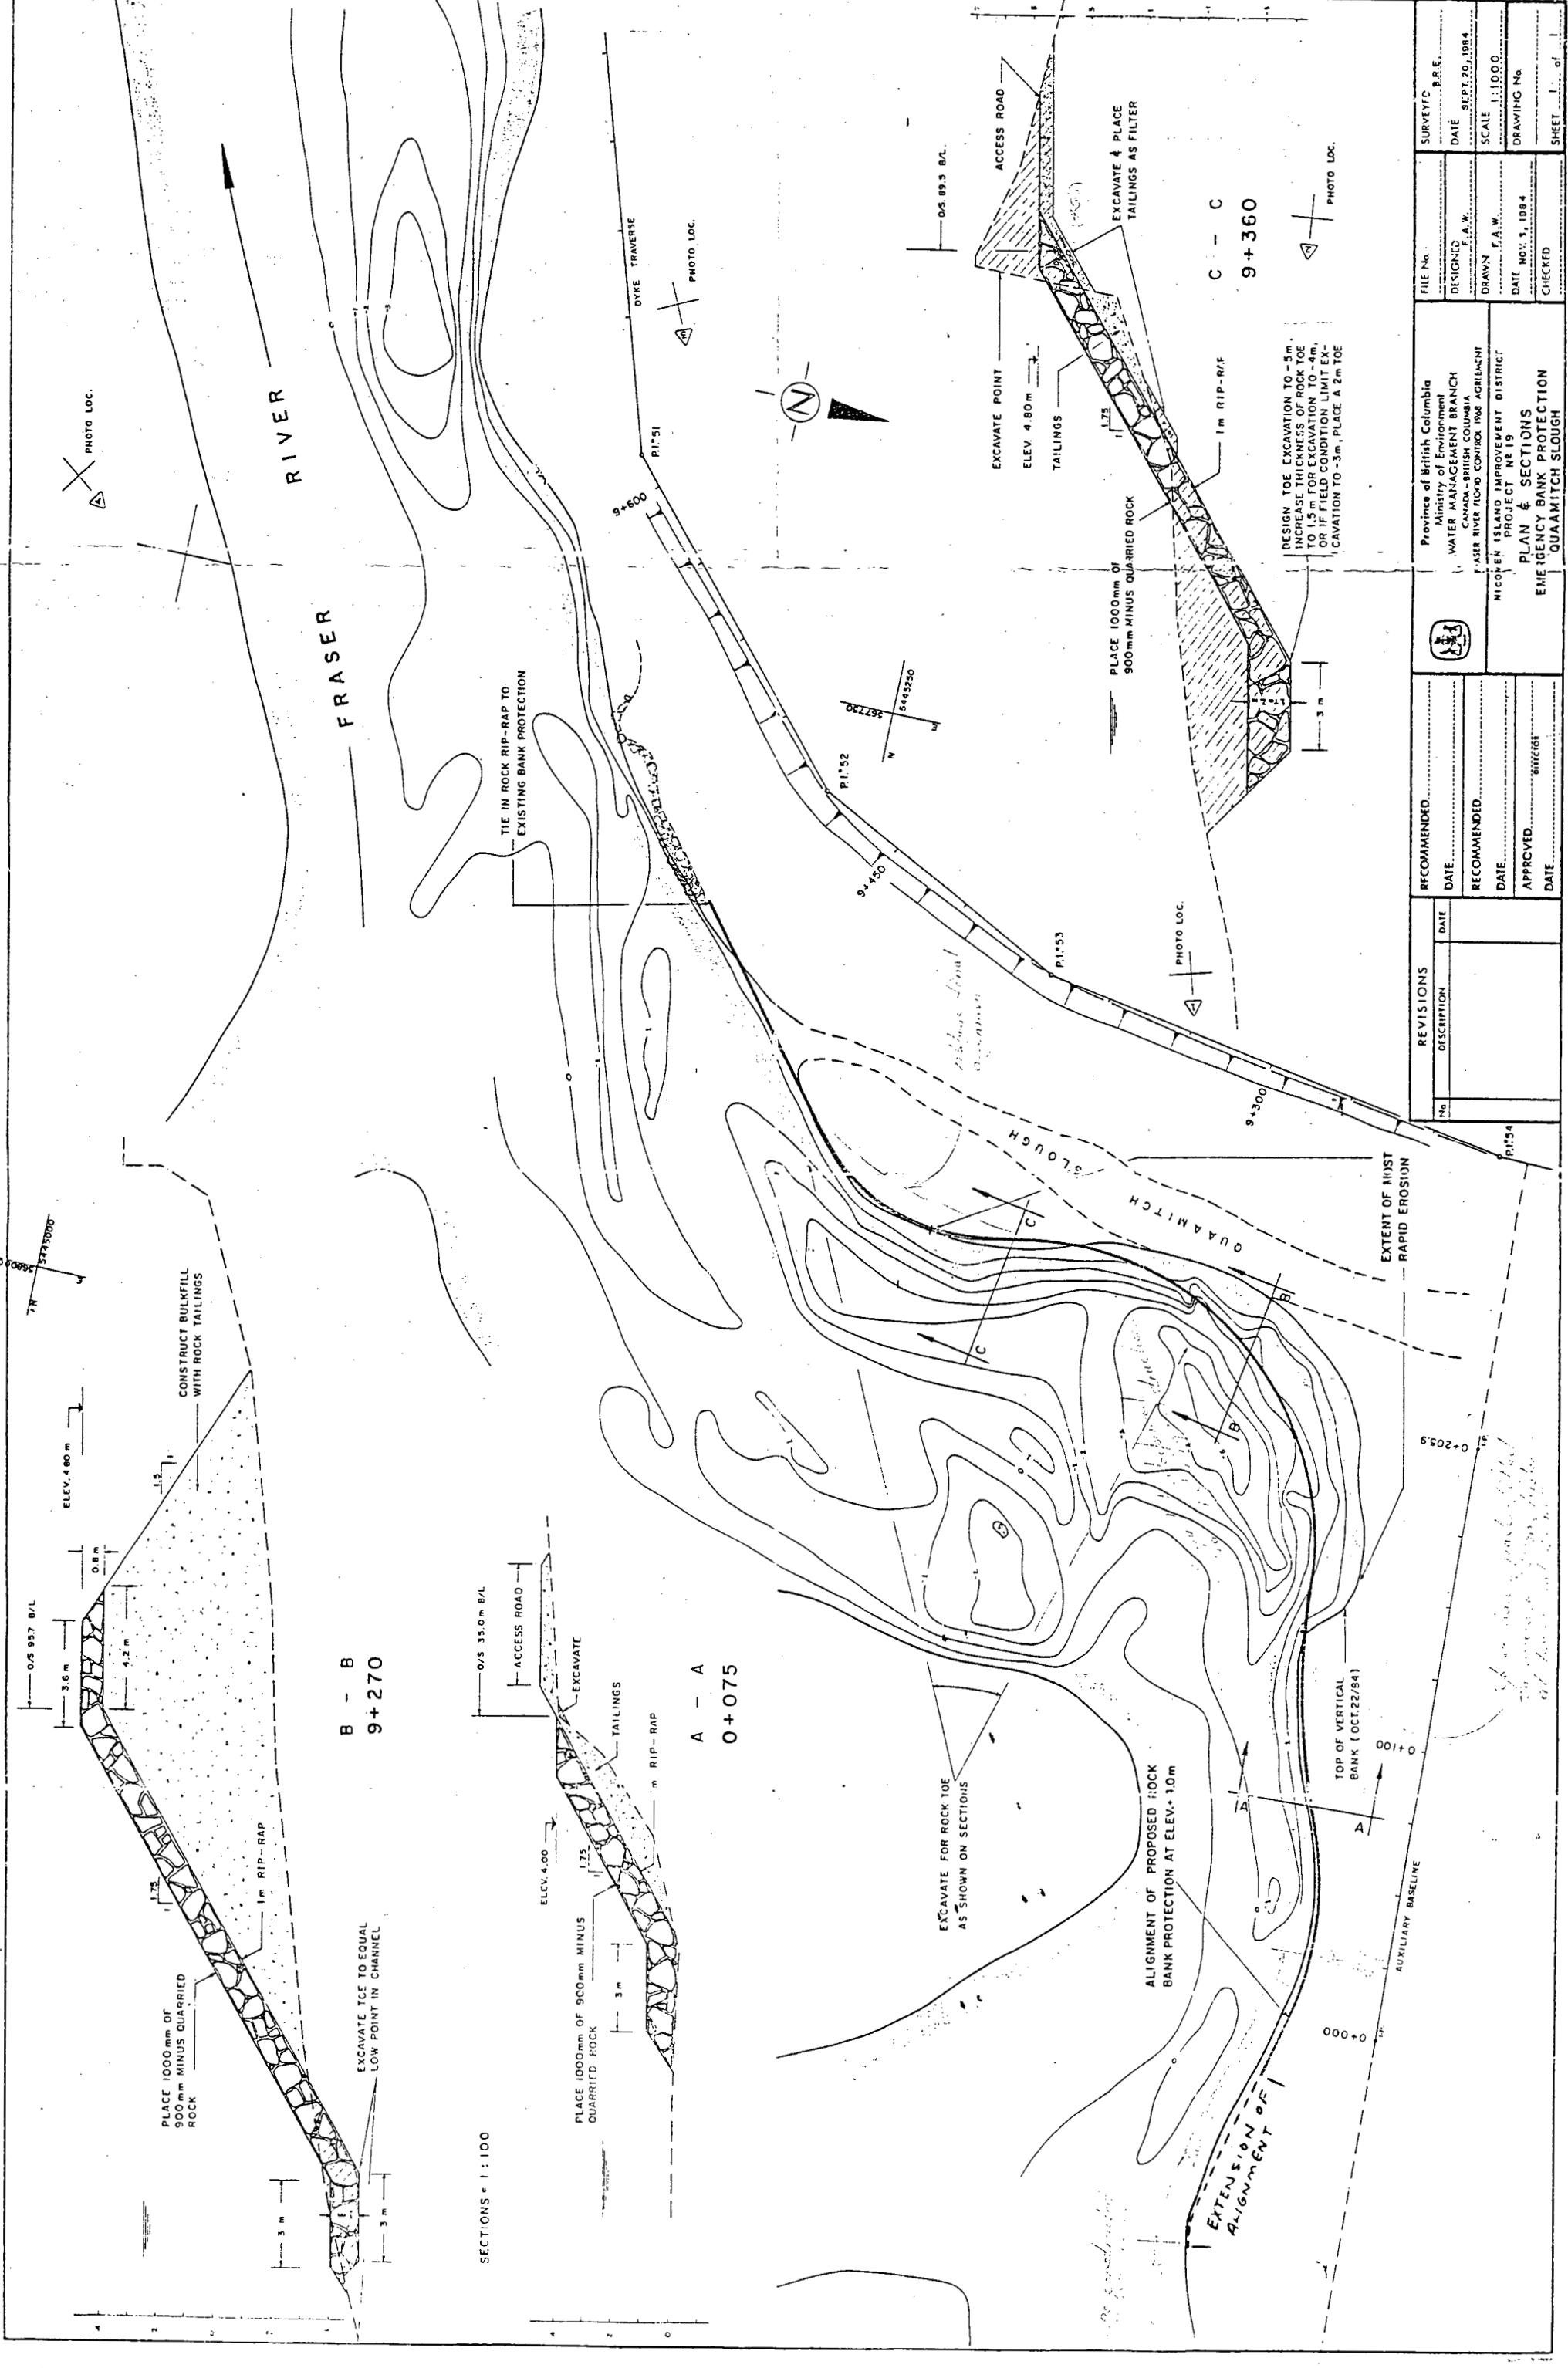
Quaamitch Slough Bank Protection Plan and Sections

1. The bank protection alignment on the eastern end of the project was extended further upstream of that which is shown on the design plan of Attachment 2 (ie. the extension is shown by a broken line on the plan). It was extended to an area slightly above the convergence of the two side channels of the river (Plate 14). This decision was made during construction as overbank erosion in that area became evident (Plate 15). However, this additional construction did not raise any additional environmental concerns.
