**TILBURY SLOUGH
DYKE RECONSTRUCTION PROJECT**

*Construction and Post Construction
Environmental Impact Assessment*

R.N. NEUMEYER & V.G. BARTNIK

MARCH, 1981

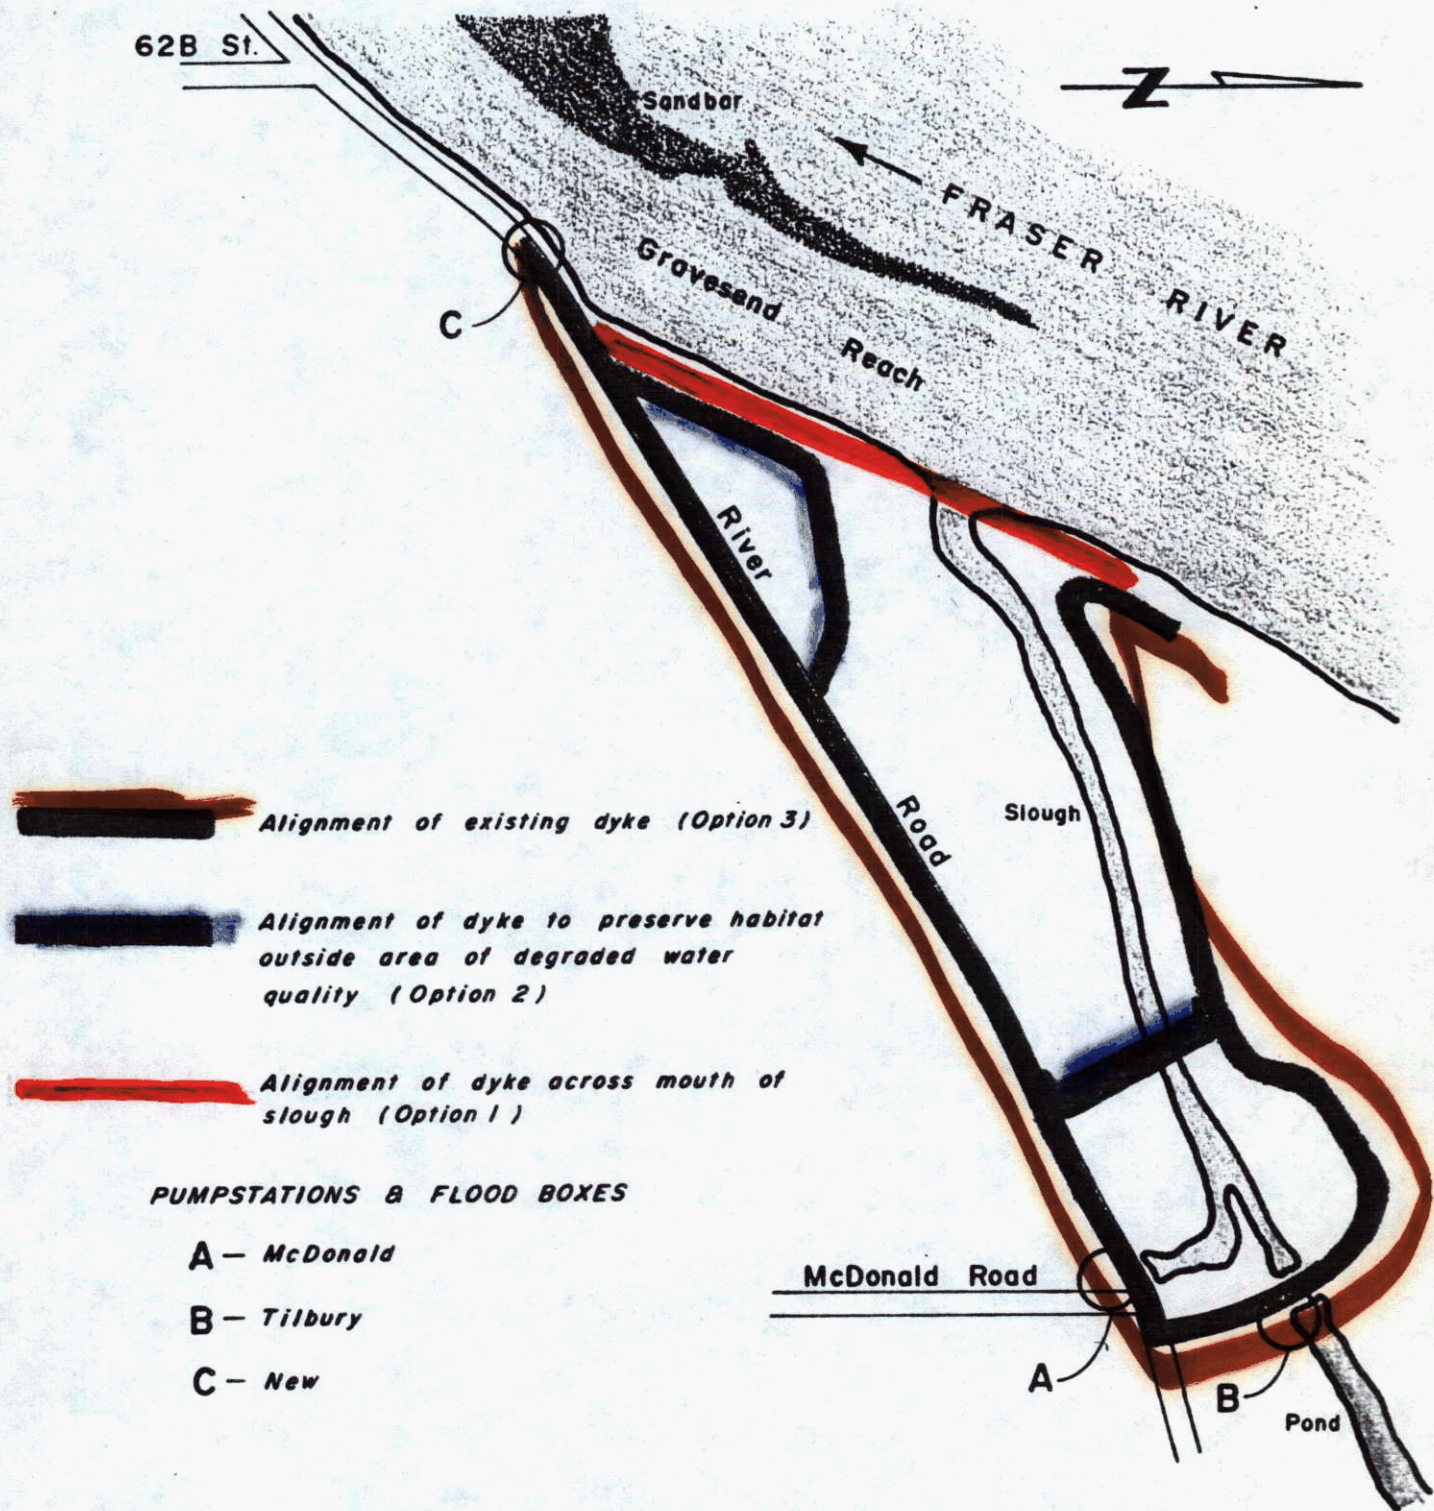
Figure 2. Dyke alignment options and associated drainage control structures.

As a result of the Project, the McDonald pump station and floodbox are now inactive and no longer release high organic content agricultural drainage to the upper reaches of Tilbury Slough, (see figure 2 and print 13). Instead this water has been re-routed to the new combined pump station and floodbox facility downstream of the slough near the foot of 62B Street (see prints 14 and 15). In the IEE report, prepared by the Interagency Task Force, water quality degradation in the slough was identified and linked to drainage from the McDonald discharge structures. With the redirecting of this discharge into the south arm of the Fraser River, a gradual improvement in the water quality of the slough should become evident. [If such improvement [benefits the slough's indigenous biological community, then it will constitute a positive impact of the Project on Tilbury Slough.

The riparian habitat of Tilbury Slough was protected by designing and constructing the new dyke so that its centre line was shifted inland relative to the existing dyke. In this manner, the toe of the new dyke did not encroach upon the slough (see figure 2). Furthermore, both the quality and aesthetics of the riparian habitat have been improved,

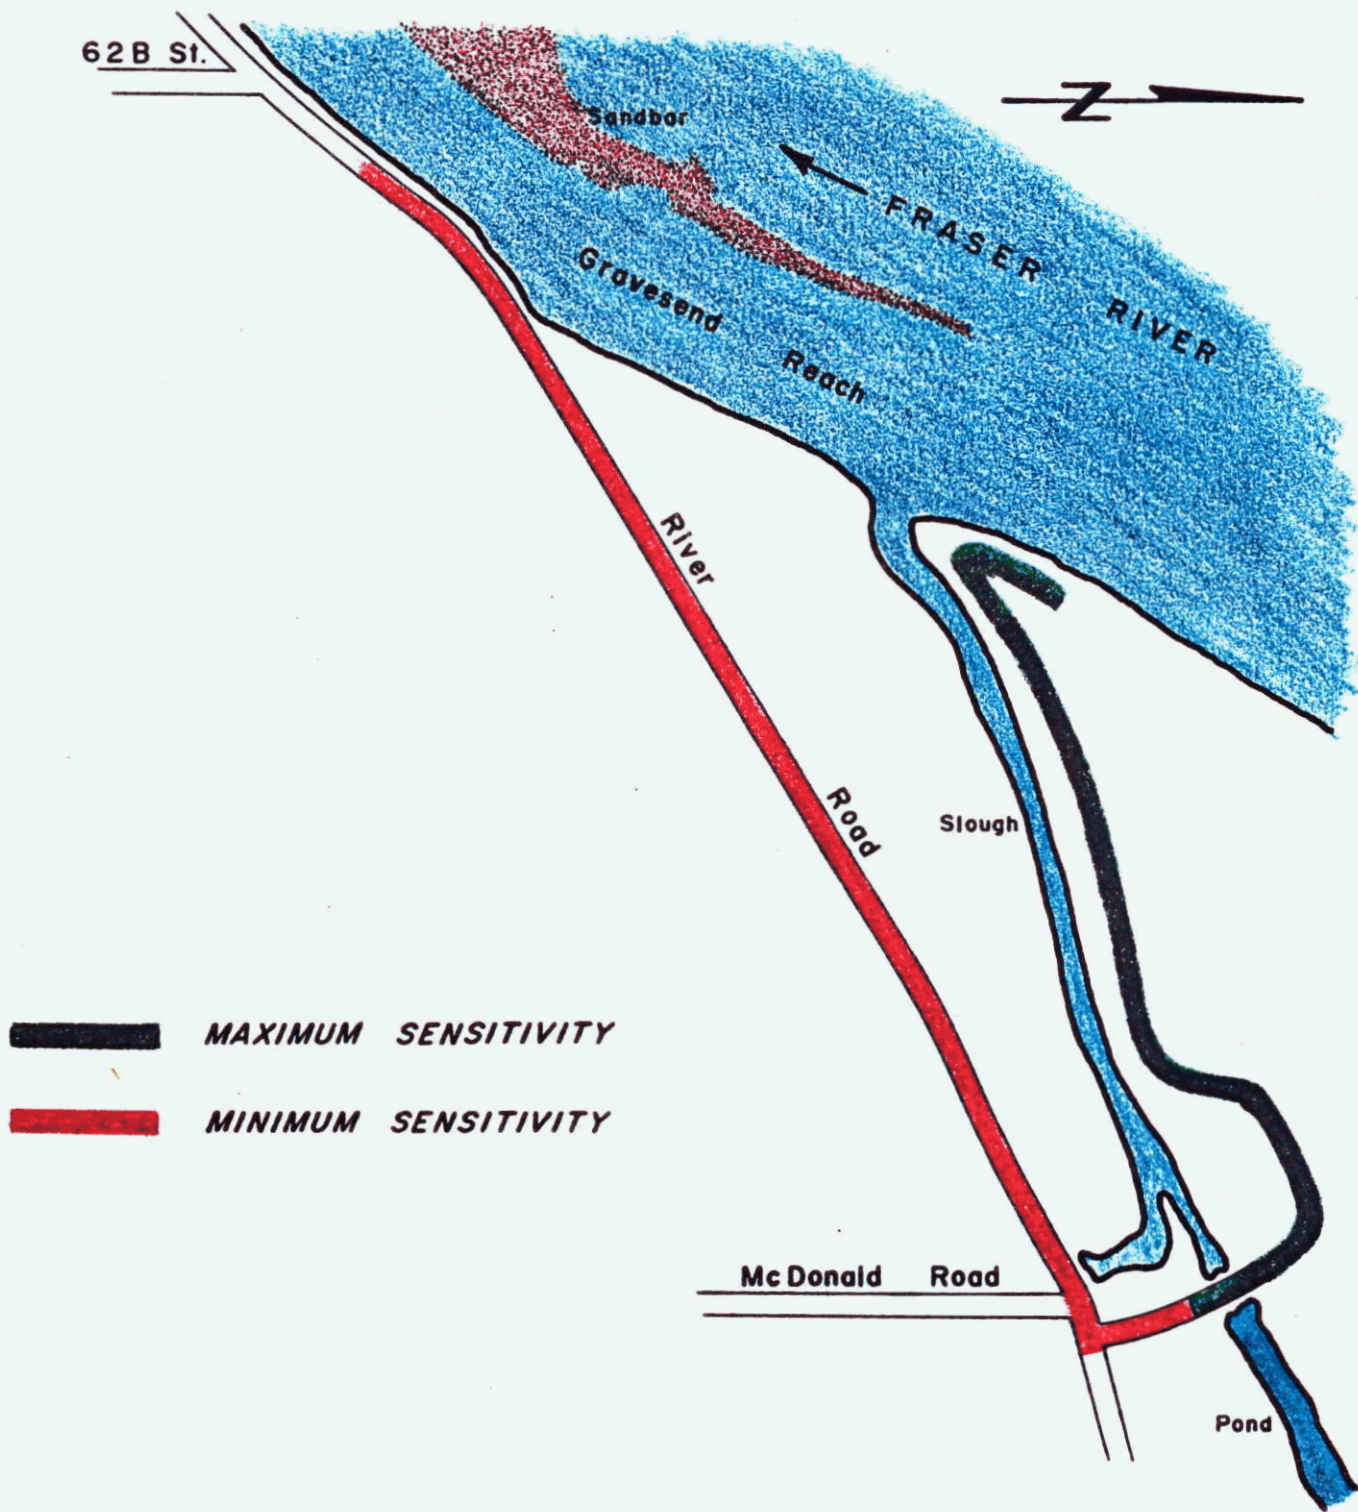
Figure 4. Environmental sensitivity along the alignment

remaining portion of the alignment since its proximity to the slough constituted a higher degree of environmental sensitivity (see figure 4). This section was walked during each visit and 35 mm photographs were taken from various locations (see figure 5).

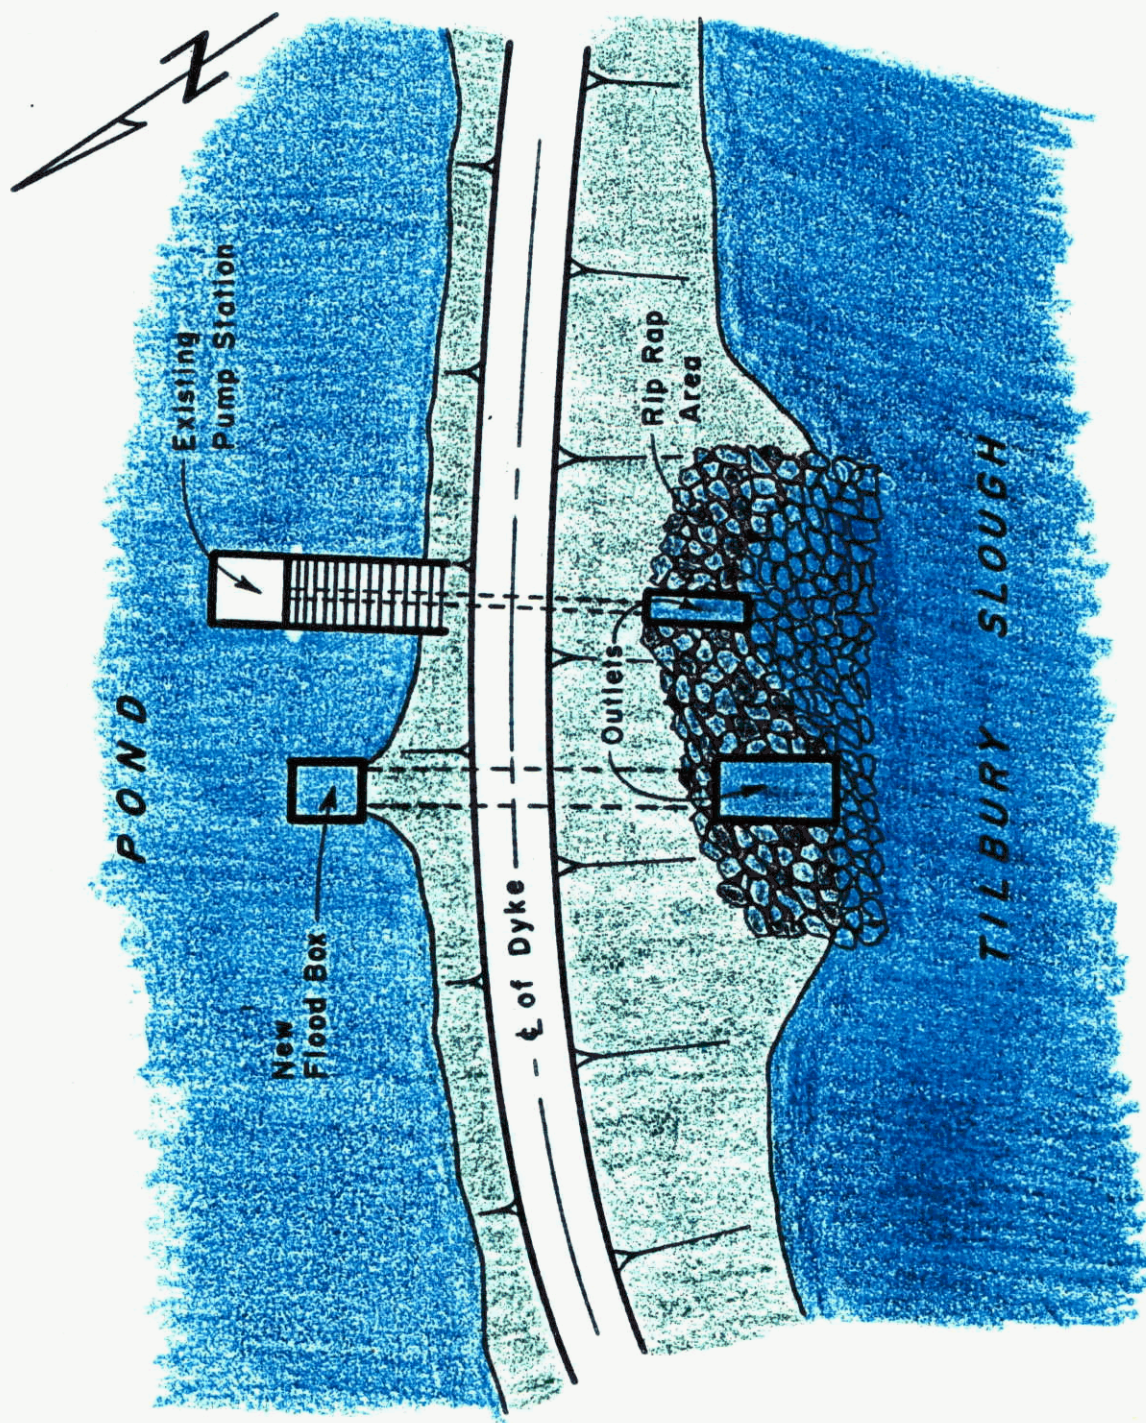
Figure 6. Site plan for the Tilbury pump station and flood box.

Some inland drainage, however, does continue to enter the slough through the remaining Tilbury pump station and floodbox, located at the apex of the slough (see figures 2 and 6, prints 12 and 16). These structures release water from a portion of the slough that has been isolated from tidal influences by previous dyking and fill, becoming, in essence, a large freshwater pond (see print 17). Neither the pond's water chemistry nor the structure of its aquatic community has been investigated. Therefore, it is not known what effect this remaining discharge has on the slough's ecology. Consequently, any possible future salmonid enhancement activity at Tilbury Slough by the Department of Fisheries and Oceans should include a detailed examination of the role that this pond plays in the productivity and quality of the slough's aquatic habitat.
