TSAWWASSEN INDIAN RESERVE FLOOD CONTROL WORKS

post-project environmental analysis

D.J. BERNARD and V.G. BARTNIK
MARCH, 1987

Inland Waters and Lands
Pacific and Yukon Region
Vancouver, B.C.

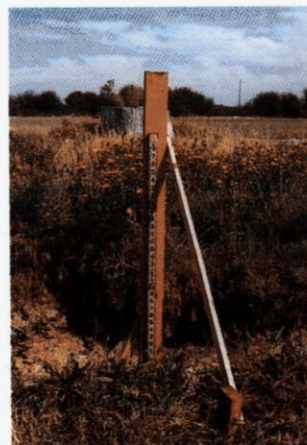
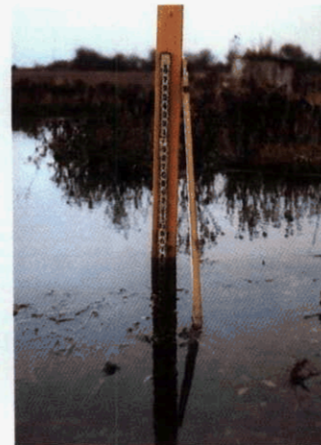
PLATE 20

A water level gauge, set at geodetic datum, used to monitor salt marsh tidal inundation. See section on Inundation Monitoring.

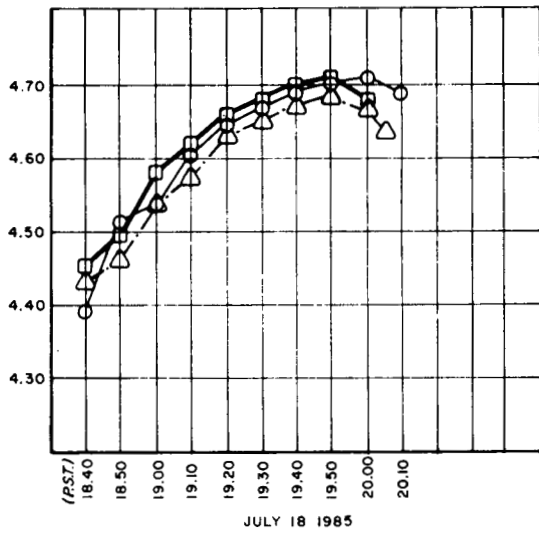
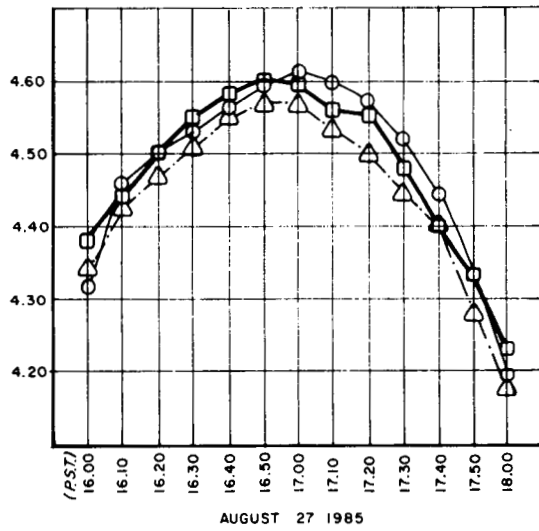
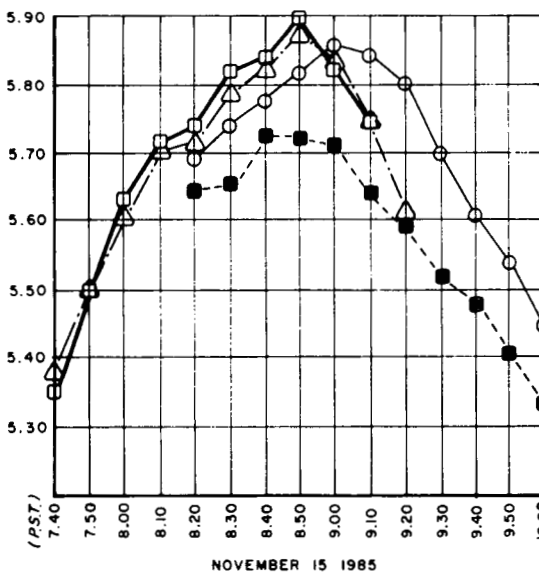
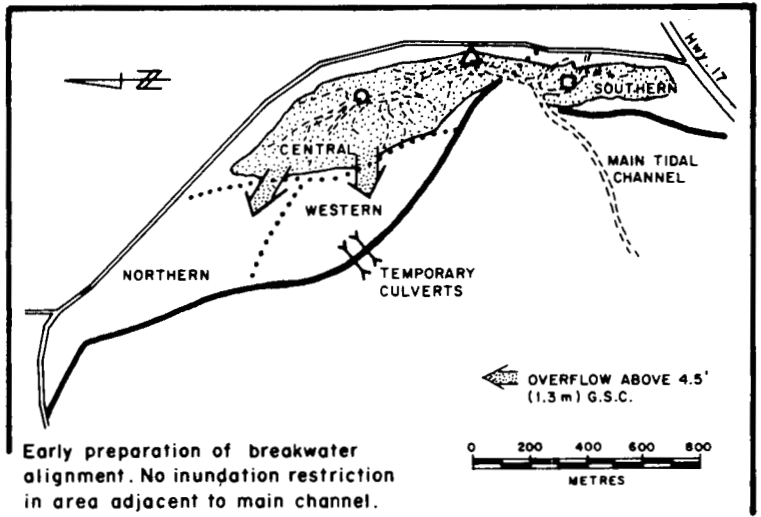
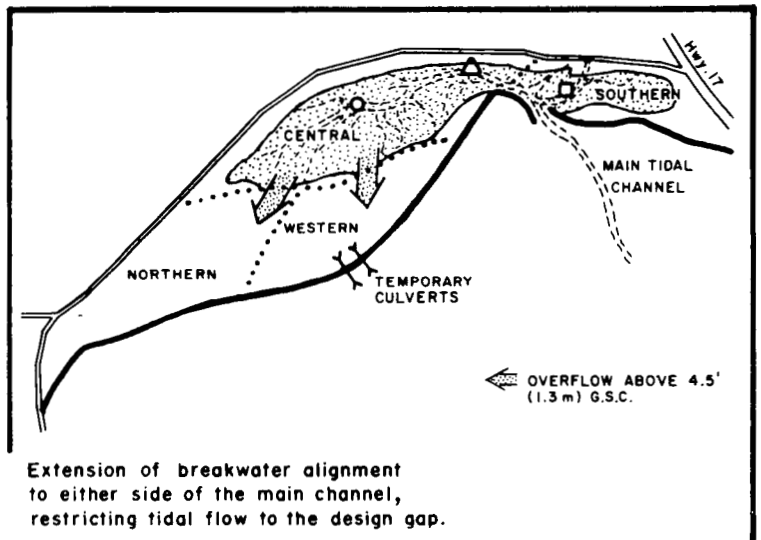
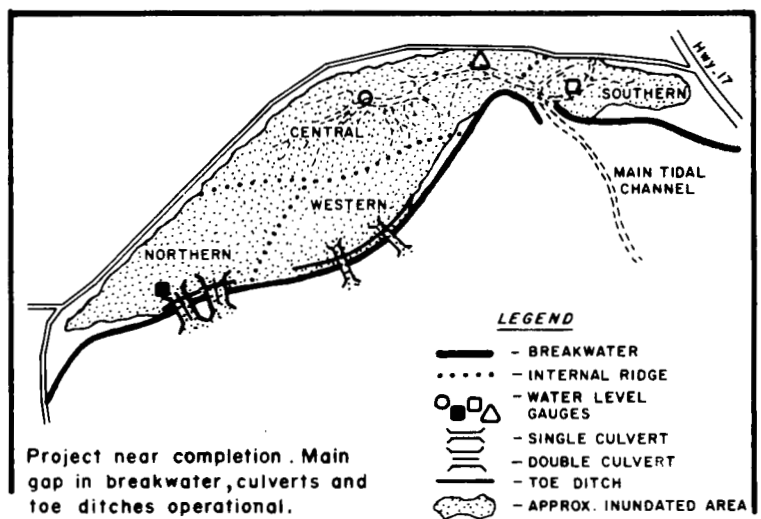
FIGURE 4 HIGH TIDAL CYCLE WATER LEVEL READINGS FROM MONITORED GAUGES (on the left) AND THE CORRESPONDING INUNDATION OCCURRING (on the right) AT THREE DIFFERENT STAGES OF PROJECT CONSTRUCTION (adapted from Associated Engineering Ltd. 1984 and 1986).

At all three different stages of construction negligible differences in water levels were recorded in the southern and central areas of the marsh. In particular, no discernible differences in water levels occurred after tidal flows in the area of the main channel were restricted to the design gap (compare July 18 and August 27 water levels in Figure 4). On all three monitoring dates the observed tidal peaks in the marsh agreed closely with the recorded tidal gauge station readings at Point Atkinson.

After the culvert/toe ditch system was completed direct tidal access was restored to the northern area but water levels were about 0.1 ft. (3.05 cm) lower than those recorded at other gauges for most of the high tidal cycle (see Figure 4). The difference was almost 0.2 ft. (6.10 cm) lower during the 20-minute peak flooding period. This difference in water level was likely due in part to retardation of the spill-over across the internal ridge by marsh vegetation. In addition, the inverts of the double culverts providing flows to the northern area were at a slightly higher elevation because they had been placed to suit existing marsh tidal channel inverts. Until the culvert/toe ditch drainage system became operational, inundation of the northern area was dependent on overflow across the internal ridge from the central area [at tidal elevation 4.5 ft. (1.37 m) GSC or greater]. The western area similarly depended on overflow from the central area but had some direct tidal access to the foreshore through two small temporary culverts installed during construction. The completion of the culvert/toe ditch system greatly improved the inundation of both of these areas, as shown by the approximate inundation pattern of November 15 (see Figure 4). On that date the high tide was estimated to cover between 66.8 to 70.8 ha of the 81 ha marsh (AEL 1986).

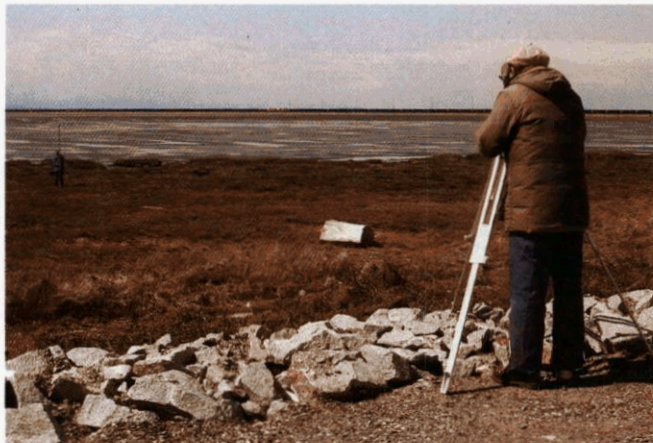
PLATE 25

Illustration of the erosion survey techniques used to map the leading edge of the Tsawwassen salt marsh on the seaside of the breakwater (photo April 23, 1986).

To confirm these observations of progressive erosion, baseline surveys were conducted using a survey instrument (Kern K1-RA Theolodite) set on bench marks established on top of the breakwater (see Plate 25). The configuration and location of the leading edge of the marsh was mapped at four selected areas, such that future detailed resurvey could provide quantification of erosion (see Figure 5). The surveys were carried out between April 15 and May 30, 1986.

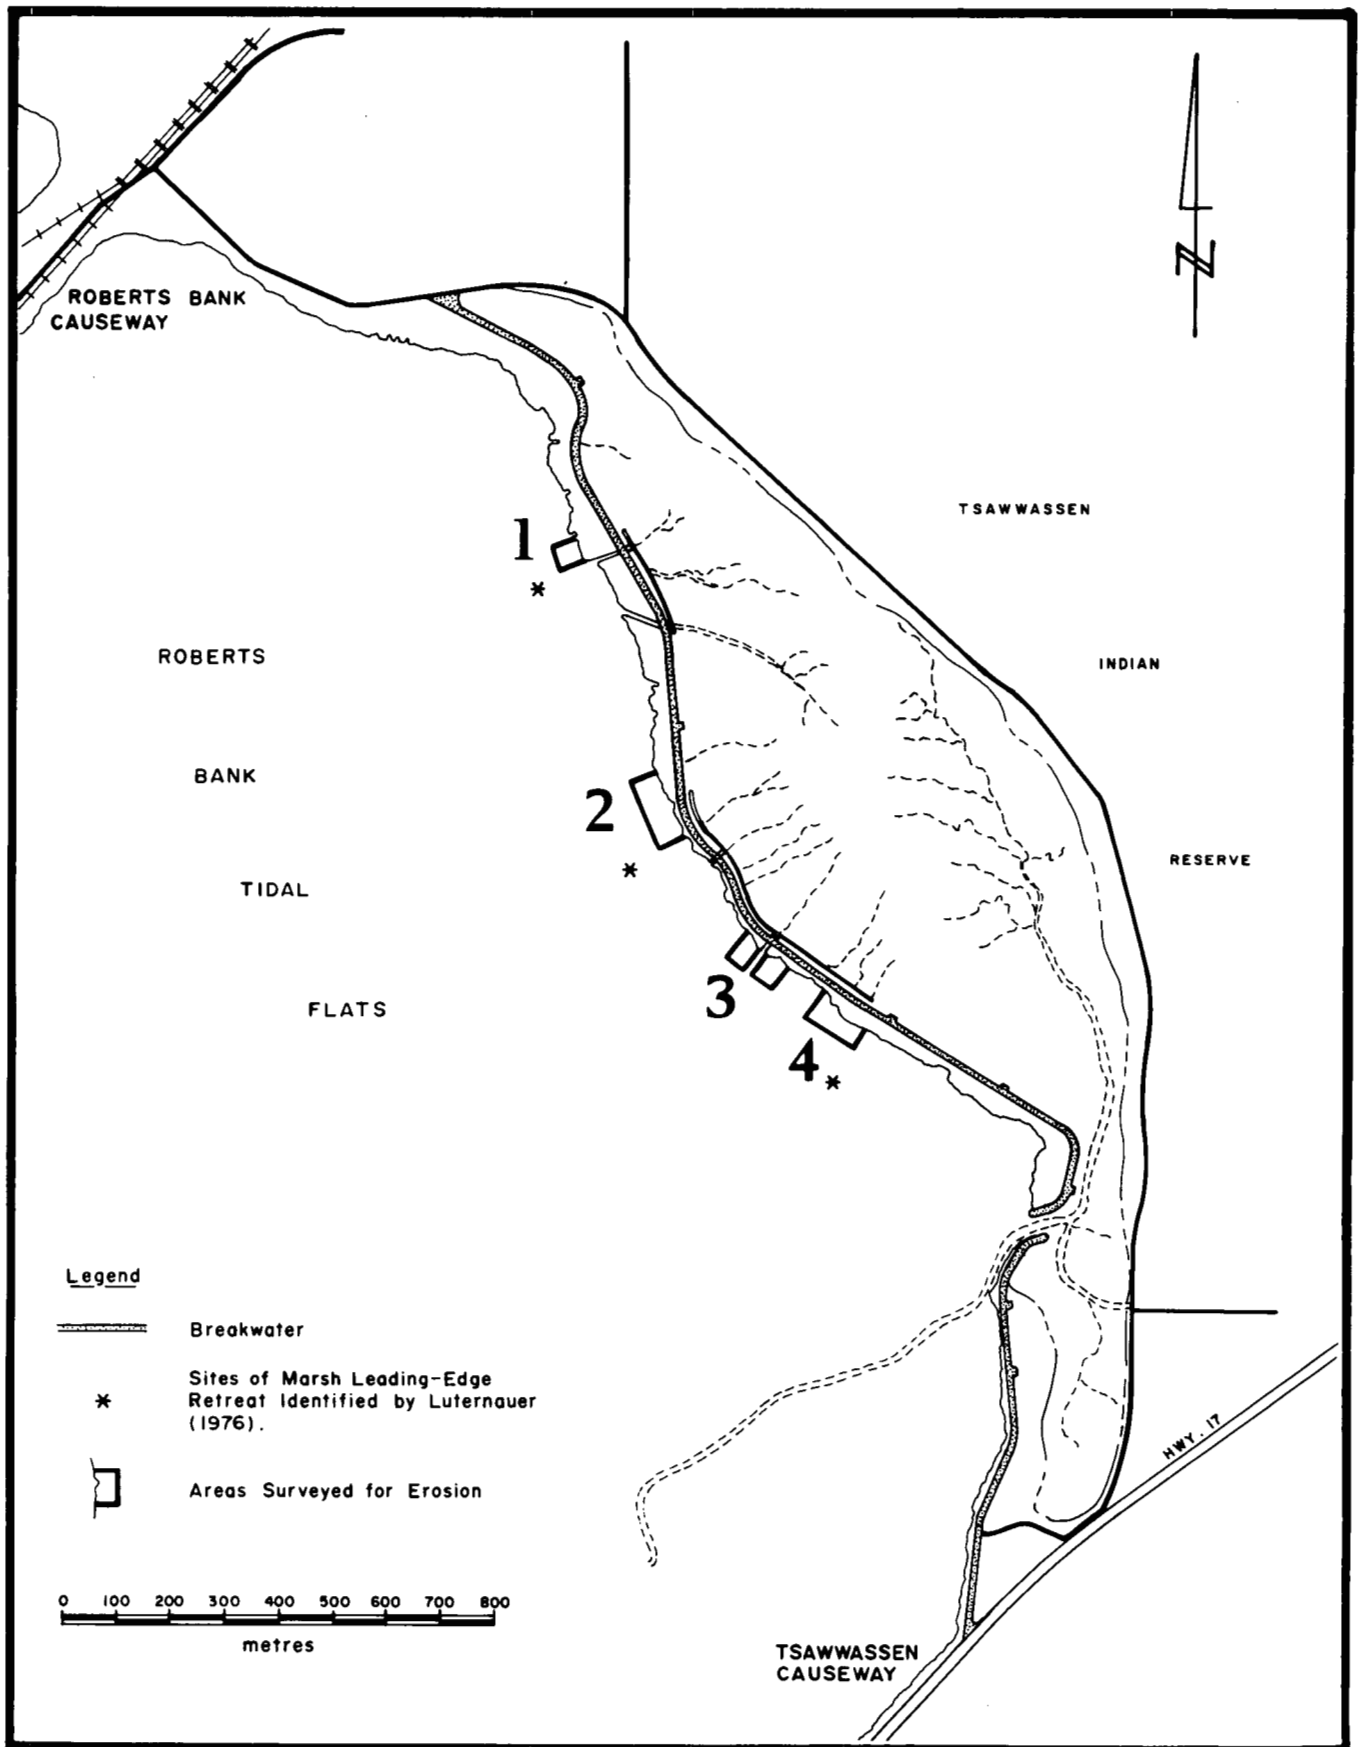
FIGURE 5 AREAS SURVEYED FOR EROSION ALONG THE LEADING-EDGE OF THE MARSH.

During the baseline surveys a total of seven steel rods were also installed and surveyed in as reference pins to demarcate the leading edge of local promontories. The reference pins were located 23 to 75.5 m from the top of the breakwater. After approximately eight months, inspection of the reference pins indicated measurable erosion had already occurred at promontories in the four areas. The erosion measured at area one was 2 and 12.5 cm, at area two, 30.5 and 35.7 cm, at area three 10.7 cm and at area four 3.7 and 26.9 cm. A comparison of photographs taken of the same reference pin at area two shows how the leading edge of the promontory had eroded back by 35.7 cm (compare Plate 23 and Plate 24).

The initial observations indicate that the erosion of marsh promontories is progressing, probably due to the focusing of wave energy. If the heterogeneity of marsh material is preventing a stable marsh front from being established then it is likely this erosion will continue until arrested by the newly-constructed flood control breakwater. The breakwater will then serve to secure the areal extent of the marsh now protected by it.
