WASTE DISPOSAL AT COQUALEETZA

P. W. SOPER

Federal Activities Abatement Group  
Environmental Protection Service  
Environment Canada

September 1975

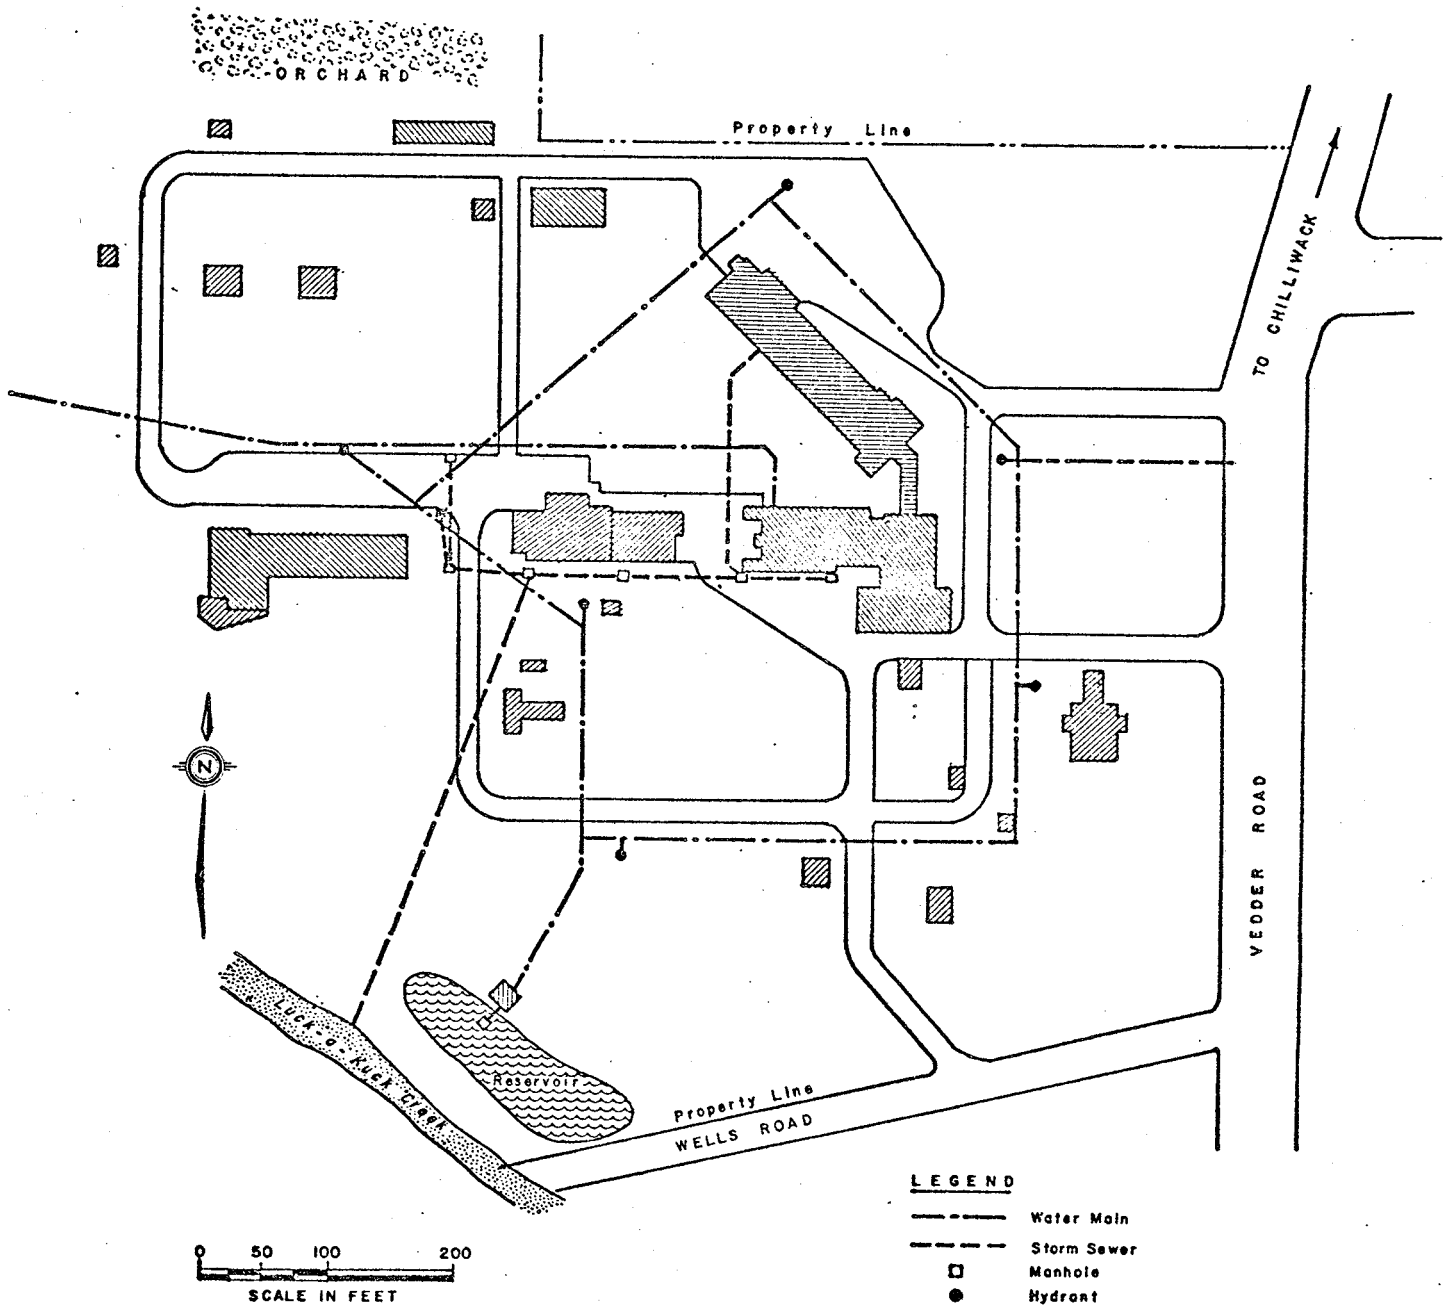
FIGURE 4 WATER SUPPLY AND STORM SEWER LAYOUT

The domestic sewerage works are shown in Figure 3, and the water and storm sewer layout in Figure 4.

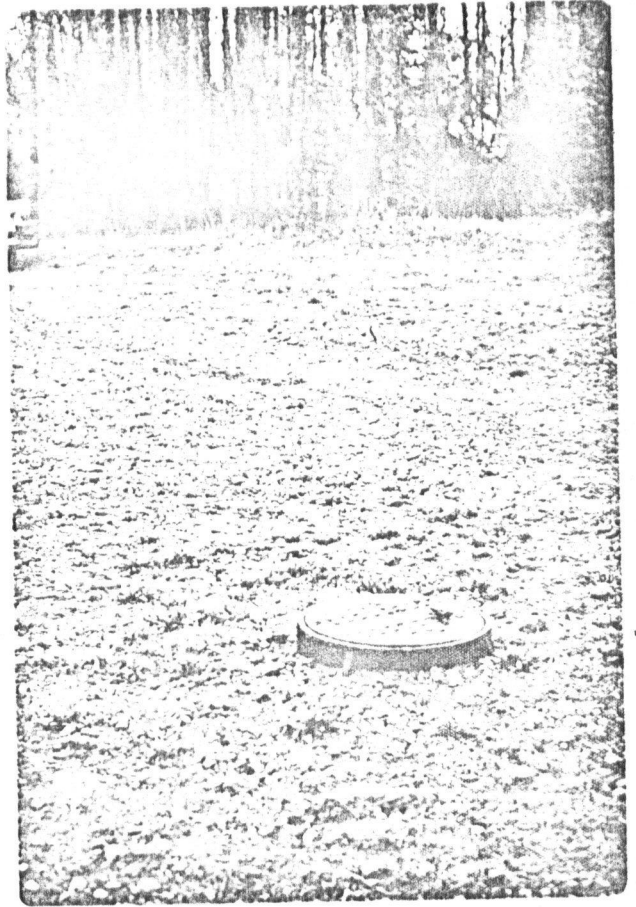
Plate 9: New Sewer Manhole

A recently constructed gravity sewer line discharging to the Chilliwack inter-municipal treatment plant, crosses by right-of-way adjacent to and within the west boundary of the Coqualeetza property, and it is recommended that a connection to this system be sought. This line was constructed by and services Fraser Valley Milk Producers, Fraser Valley Frosted Foods and Sardis Land Developments. The sewer is operated by the Municipality in the right of the three companies who own the sewer line and consequently, whose permission for connection is required for a period of five years. A manhole for this system is located approximately 100 feet from the treatment compound (Plate 9) with an invert elevation estimated to be 8 feet lower than the Imhoff tank inlet. The Coqualeetza property was included in the original project capital costing. However, in the same time period, the turnover from Health and Welfare to DPW was underway and a connection agreement apparently was never consummated. The consultant's estimate of the Coqualeetza population was 200, or 3%, and the proportionate cost of connection was estimated at approximately \$50,000, or 4.5%, of the total net capital cost.

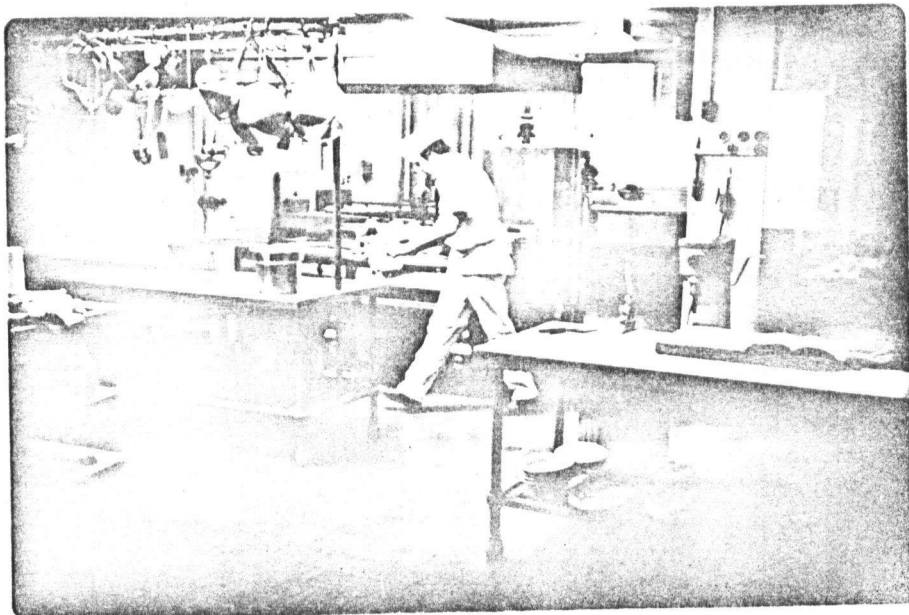
Plate 10:  
Kitchen

Kitchen waste made up of scraps, peelings, cans, etc. is deposited in plastic lined garbage cans, several of which are located within the kitchen facilities (Plate 10). The full cans are taken to a small building on the property where the full garbage bags are stored for removal. The garbage cans are cleaned in a steam washing facility (Plate 11) and stored.
