AIR TRANSPORTATION SAFETY INVESTIGATION REPORT A17C0146

LOSS OF CONTROL AND COLLISION WITH TERRAIN

Avions de Transport Régional ATR 42-320, C-GWEA

Fond-du-Lac, Saskatchewan

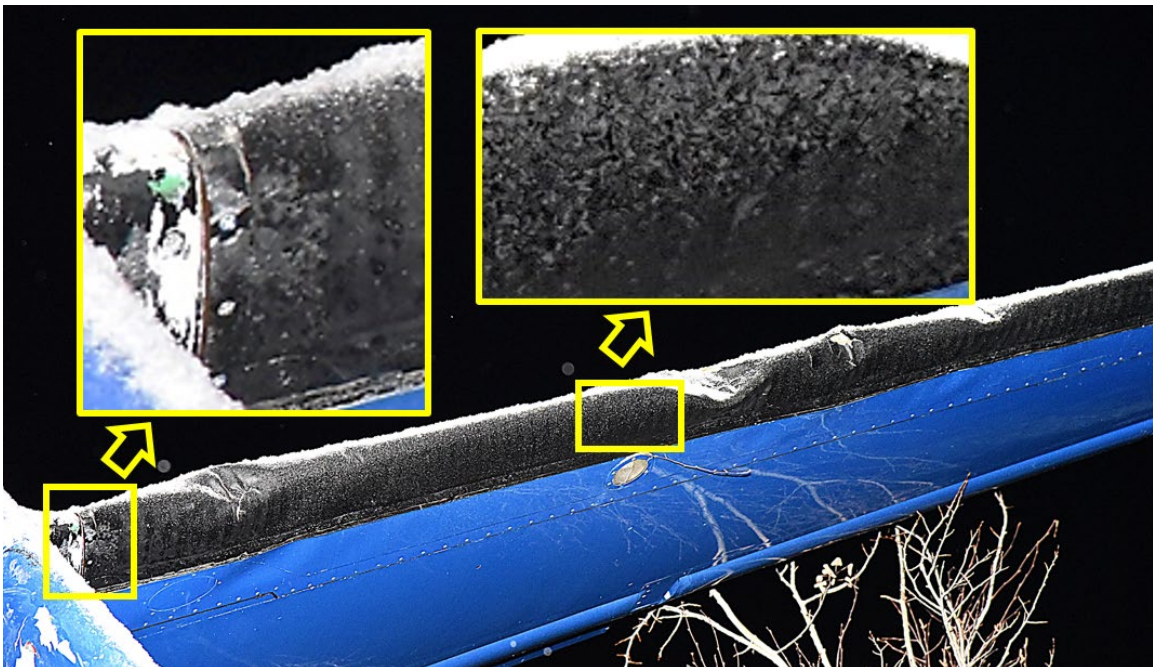
Examination of photographs taken by the Royal Canadian Mounted Police (RCMP) about 8 hours after the accident revealed the presence of ice contamination on the aircraft (figures 16, 17, and 18). Although ground icing conditions persisted following the crash, these figures provide some indication of the contamination present on the aircraft during the occurrence flight.

Figure 16. Photo of left horizontal stabilizer, with 2 inset images showing ice contamination on leading edge (Source: Royal Canadian Mounted Police, with TSB annotations)

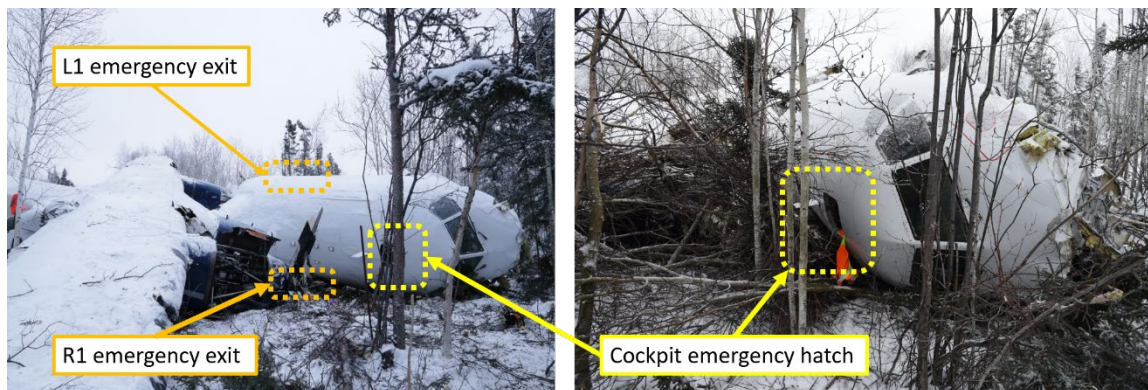
The forward part of the aircraft, including the cockpit, rolled 90° to the right and came to rest lying on its right side. Emergency exit R1 was squashed at the bottom of the fuselage, and emergency exit L1 was vertically at the top. The 90° orientation also placed the cockpit emergency hatch on the side of the aircraft, where it was partially blocked by trees (Figure 28).

Figure 28. Orientation and access to emergency exits L1 and R1 (left image) and the cockpit emergency hatch (right and left images) (Source: Royal Canadian Mounted Police, with TSB annotations)

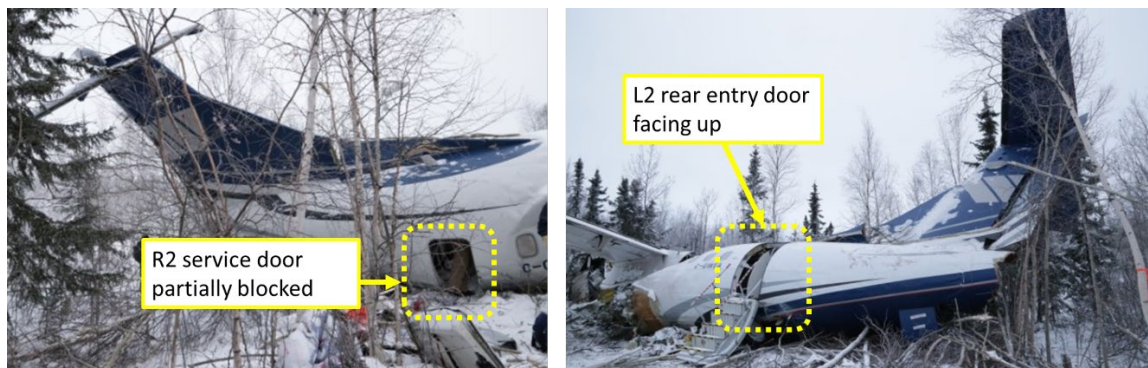
Because the main passenger cabin had rolled approximately 40° to the right, the service door (R2) was partially blocked by external terrain. The main exit point, the rear entry door (L2), was facing up, making it difficult to be opened (Figure 29).

Figure 29. Orientation of the service door (R2) (left image) and the rear entry door (L2) (right image) (Source: TSB)

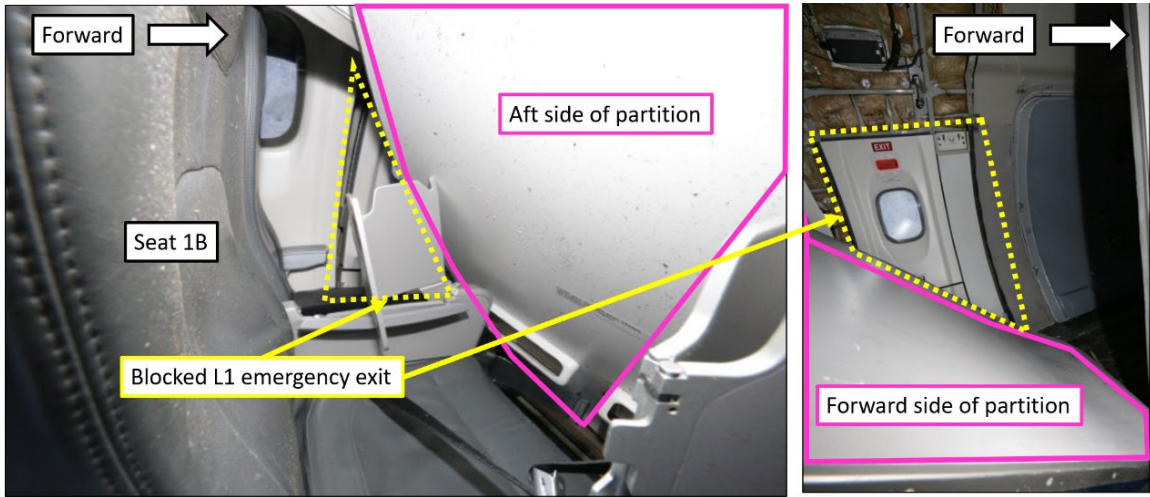
During the accident sequence, many of the partitions became dislodged. The partition that separated the forward cargo area from the passenger cabin had dislodged and fallen into seats 1A and 1B, blocking access and identification of the L1 emergency exit (Figure 30).

Figure 30. Photos of the L1 emergency exit (dashed line) blocked by displaced partition (solid line) (Source: TSB)

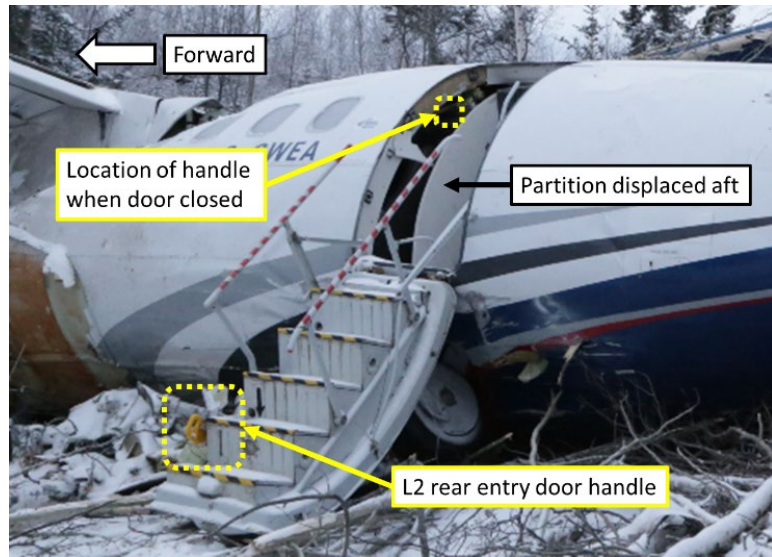
The partition that separated the passenger cabin from the rear entry door (L2) was also dislodged and fell across the door, blocking access to the door handle, which was on the other side of the partition (Figure 31).

Figure 31. Partition displaced toward the aft, blocking access to the L2 rear entry door handle (Source: TSB)

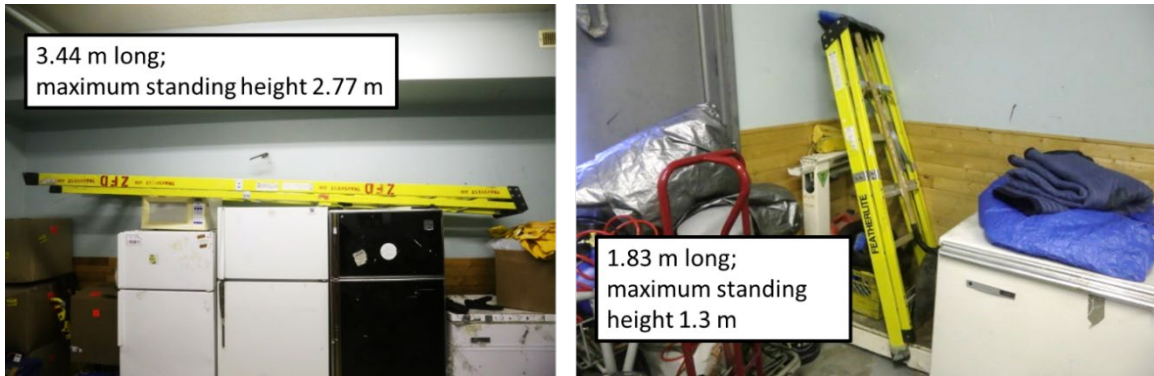
Figure 37. Photos showing ladders available at the Fond-du-Lac Airport terminal (Source: TSB)

At CZFD, there was no equipment available that would enable someone to visually inspect the top portion of an ATR 42’s critical surfaces, given their height, nor to reach them to apply de-icing fluid. The only equipment available were 2 ladders, 1 approximately 3.44 m and the other 1.83 m (Figure 37). The 3.44 m ladder had a maximum standing height of 2.77 m.

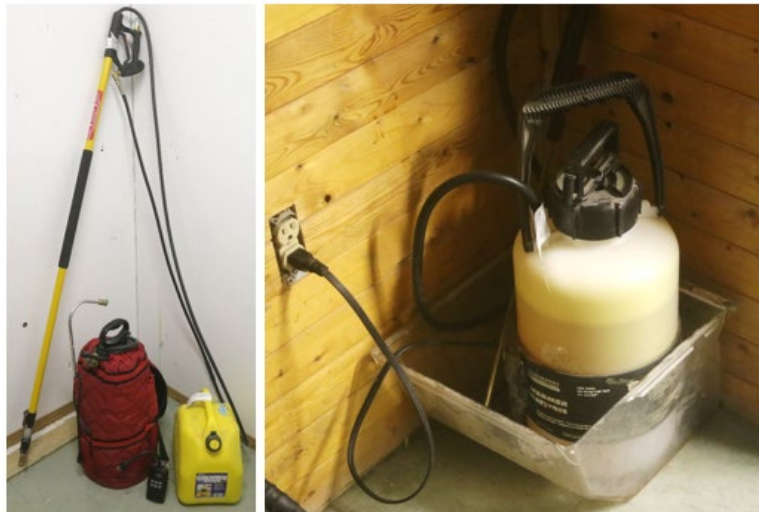
Figure 38. De-icing equipment available at Fond-du-Lac Airport: West Wind's equipment on left, another operator's equipment on right (Source: TSB)

West Wind's de-icing spray equipment at CZFD consisted of a hand-held spray system with a small-capacity heated fluid reservoir and 20 L container of additional type I fluid.²⁶⁹ Another air operator also had a small (20 L), heated hand-held spray system in the terminal building that was available to West Wind personnel on request (Figure 38).

Published de-icing standards recommend that the fluid quantity required to de-ice an aircraft is 1 L/m² of aircraft surface. In the case of an ATR 42 aircraft, more than 66 L would be required.²⁷⁰
