Transportation
Safety Board
of Canada

AIR TRANSPORTATION SAFETY INVESTIGATION REPORT A20Q0015

CONTROLLED FLIGHT INTO TERRAIN

Service aérien gouvernemental of Quebec
Bell 206L-4 (helicopter), C-GSQA
Lac Saint-Jean, Quebec
22 January 2020

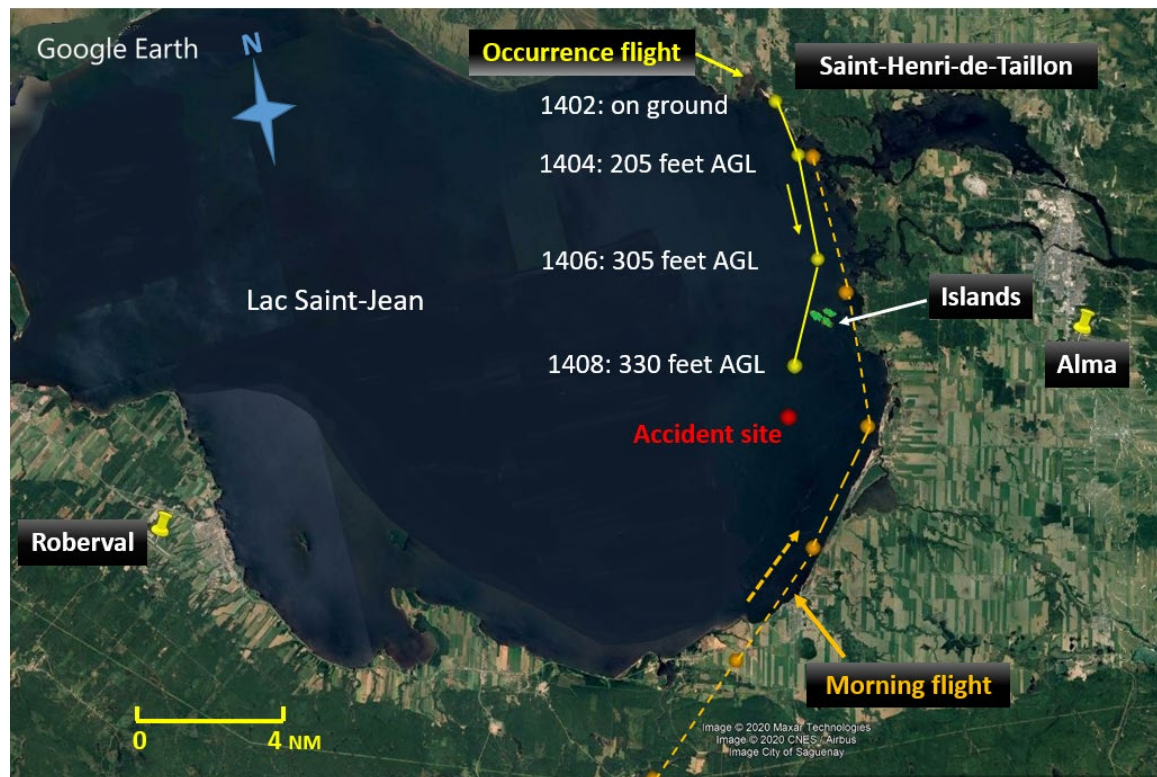
Figure 5. Representation of the morning flight (dashed line) and occurrence flight (solid line) (Source: Google Earth, with TSB annotations based on data from the flight tracking system)

However, the aircraft was equipped with a satellite flight tracking system, and data were retrieved from the SAG's aircraft tracking and management website. This system recorded the aircraft's GPS position, altitude, and ground speed every 2 minutes (Figure 5).

For the flight out in the morning, the pilots of the 2 helicopters, including the occurrence one, decided to fly along the eastern shore of Lac Saint-Jean as they headed to Saint-Henri-de-Taillon because of the low contrast over the lake.

For the return flight in the afternoon, the occurrence pilot had planned to fly at a low altitude (approximately 500 feet AGL) because there was a headwind. The aircraft took off from Saint-Henri-de-Taillon at 1402 and flew a track that was almost parallel to the eastern shore of the lake. At 1406, at an altitude of 305 feet AGL and 1 NM laterally from the shore, the aircraft was approaching a group of islands 1.3 NM ahead. The pilot veered right, flying west of the islands. At 1408, the aircraft was 2.4 NM laterally from the shore at an altitude of 330 feet AGL. The aircraft struck the surface of the lake about 1 minute later, approximately 1.34 NM further. The angle between the height of the last recorded position at 1408 and the point of impact was approximately 2.3°.
