RAIL TRANSPORTATION SAFETY INVESTIGATION REPORT R21M0002

MAIN-TRACK TRAIN DERAILMENT

Canadian National Railway Company
Freight train M30631-25
Mile 8.04, Pelletier Subdivision
Albertine Station, New Brunswick
26 January 2021

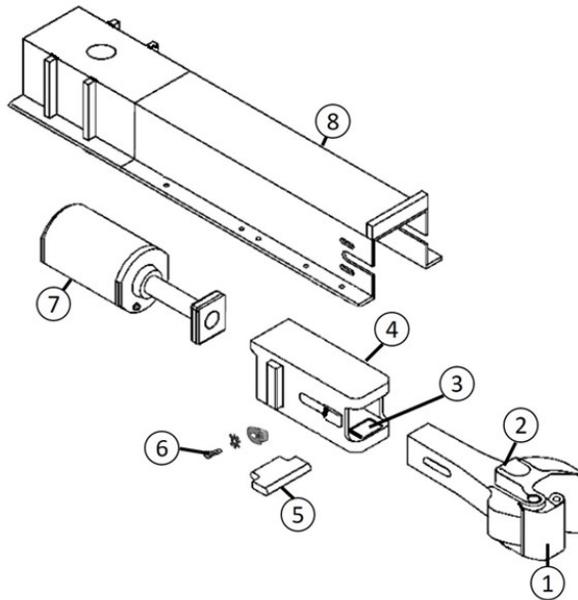
Figure 4. Schematic of an EOCCD draft assembly (Source: TSB)

Within the draft assembly, the coupler carrier wear plate helps ensure that the coupler remains level and at the proper height. This steel or polymer wear plate is fitted to the yoke or striker, and the shank of the coupler rests upon it. Normal coupler movements can wear the plate, causing the coupler to sit lower and at an angle, which puts additional stresses on the cross key. In this occurrence, the coupler carrier wear plate on the A-end of IC 21013 was in place and did not show signs of excessive wear.

Cross keys in EOCCDs are a solid piece of forged metal and are designed to retain the coupler in the yoke as part of the draft assembly. They generally remain in service for many years, and are only replaced when they are worn beyond set limits (see Section 1.10) or develop a condemnable defect.
