RAIL TRANSPORTATION SAFETY INVESTIGATION REPORT R21V0118

MAIN-TRACK TRAIN DERAILMENT

Canadian National Railway Company
Freight train A47251-02
Mile 547.7, Chetwynd Subdivision
Hodda Station, British Columbia
03 June 2021

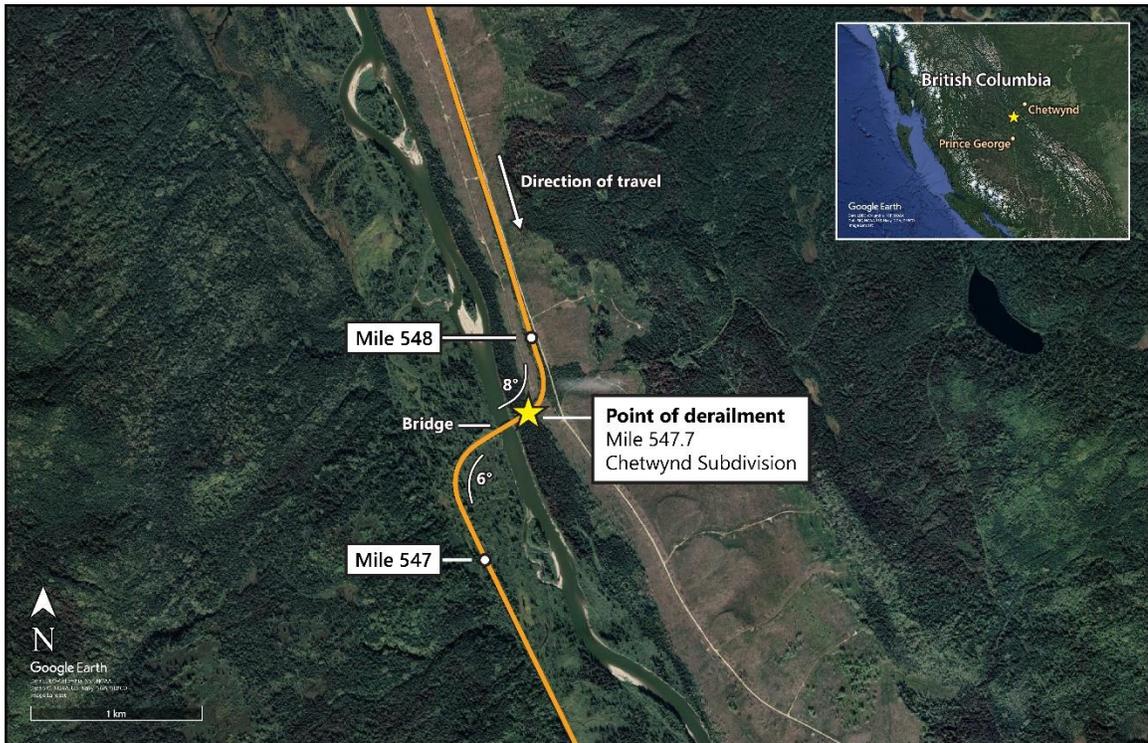
Figure 1. Map showing the occurrence location (Source: Google Earth, with TSB annotations)

The derailment took place at Mile 547.7 in a remote area about 85 miles north of Prince George. Near the point of derailment in the direction of travel, there is an 8° right-hand curve. The track then crosses a bridge over Parsnip River, after which there is a 6° left-hand curve (Figure 1).
