A Survey of Problem Homes of the Environmentally Hypersensitive

Prepared for: Research Division
Canada Mortgage and Housing Corporation
700 Montreal Road
Ottawa, Ontario
K1A 0P7
CMHC Project Manager: Virginia Salares

Prepared by: Drerup Armstrong Ltd
P.O. Box 130
Carp, Ontario
K0A 1L0
Drerup Armstrong Project Manager: Oliver Drerup

May 1996

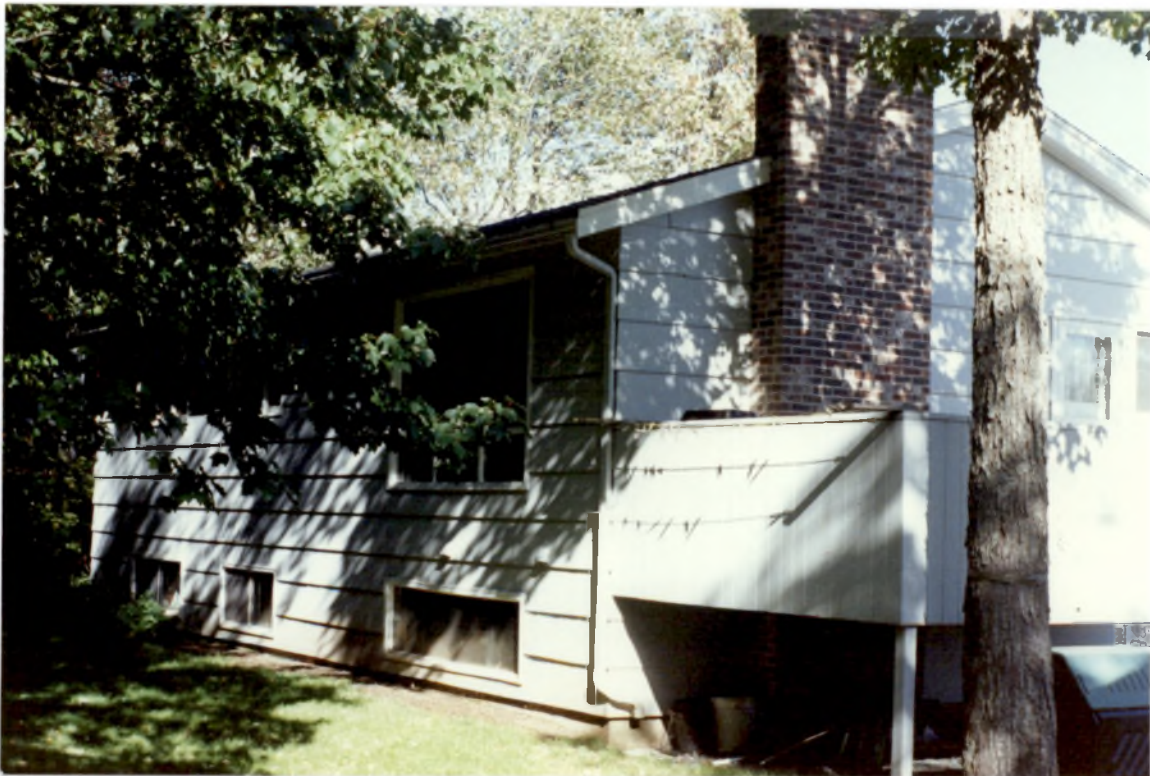
PHOTOGRAPH:

- BASEMENT:** - floor drain—hole drilled in floor, slight crack, dry
- insulation—floor SM, wall partial
- KITCHEN:** - cabinet doors made of veneer plywood, cabinets made of softwood plywood, hardwood plywood, softwood, painted but not all edges sealed

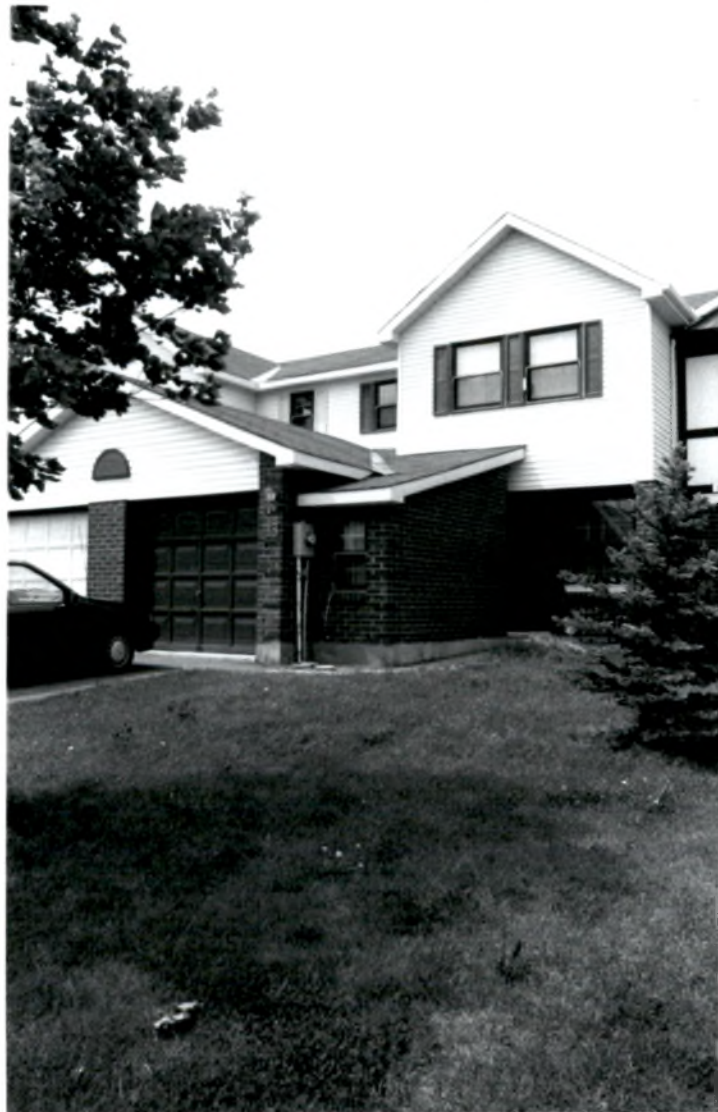
PHOTOGRAPH:

- 9 rooms/areas were surveyed in total - living, dining, front, kitchen, powder, bed-master, bed 1&2, baths-upper floor.
- closest neighbor—attached at both sides
- building not well constructed
- ductwork installation—poor workmanship
- central vacuum exhausts dust particles into ducts
- airtightness poor at sill plates
- substantial amount of formaldehyde-based glue and materials in building
- building filled with particle board material—this impression is heightened by removal of carpets and exposed OSB covered with a coat of white paint
- significant amount of sawdust composite-board furniture
- carpets still in place on stairs
- unusual layout with garage building into front hall
- recent repainting of main and upper floor walls and ceiling with low VOC paints
- windows installed in 1988, includes swiggle-strip thermal break
