ISSUE 1/2022

AVIATION SAFETY LETTER

TP 185E

TSB Final Report A20C0016—Runway Excursion

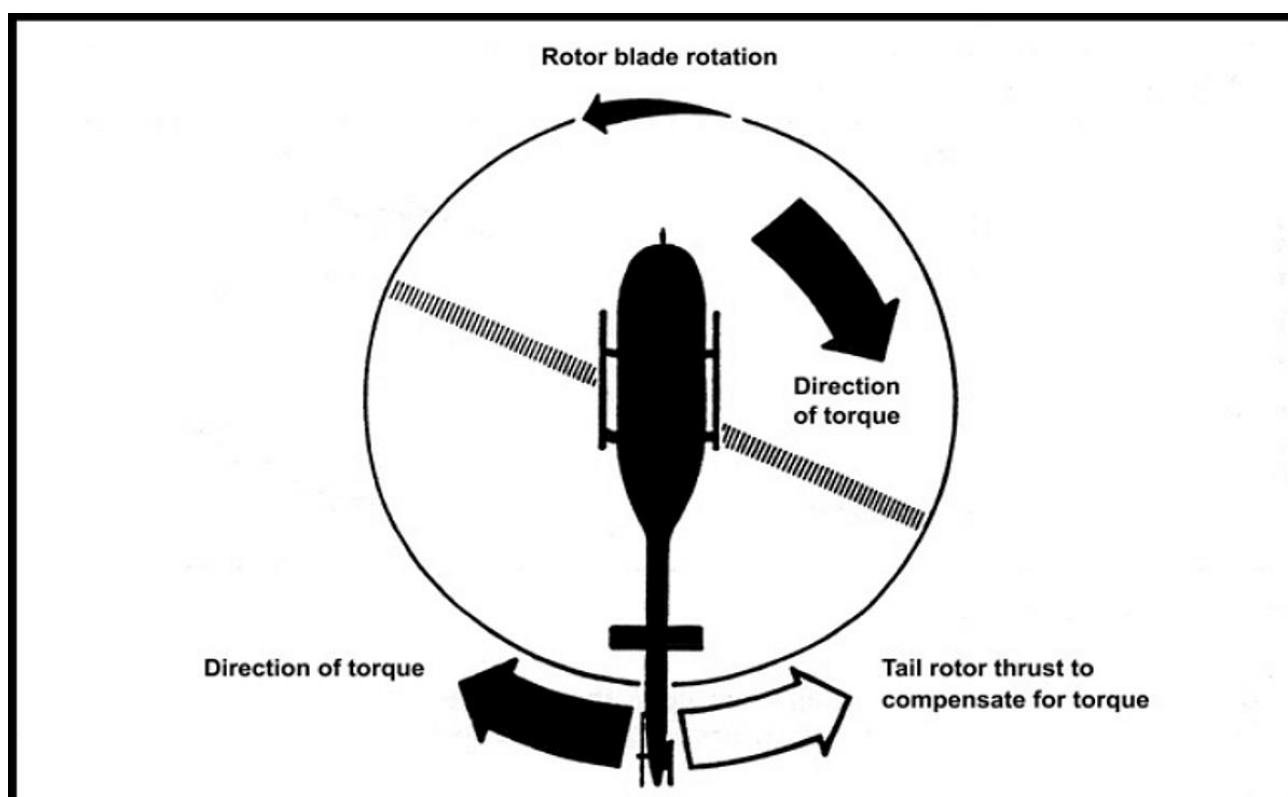
When seen from above, the main rotor blades of the Robinson R44 turn counterclockwise. Due to this rotation, the helicopter experiences a torque reaction in the opposite direction, which results in the helicopter yawing to the right (Figure 2).

Figure 2. Torque effect (Source: Transport Canada, TP 9982, Helicopter Flight Training Manual, Second Edition [June 2006], Figure 3-3)

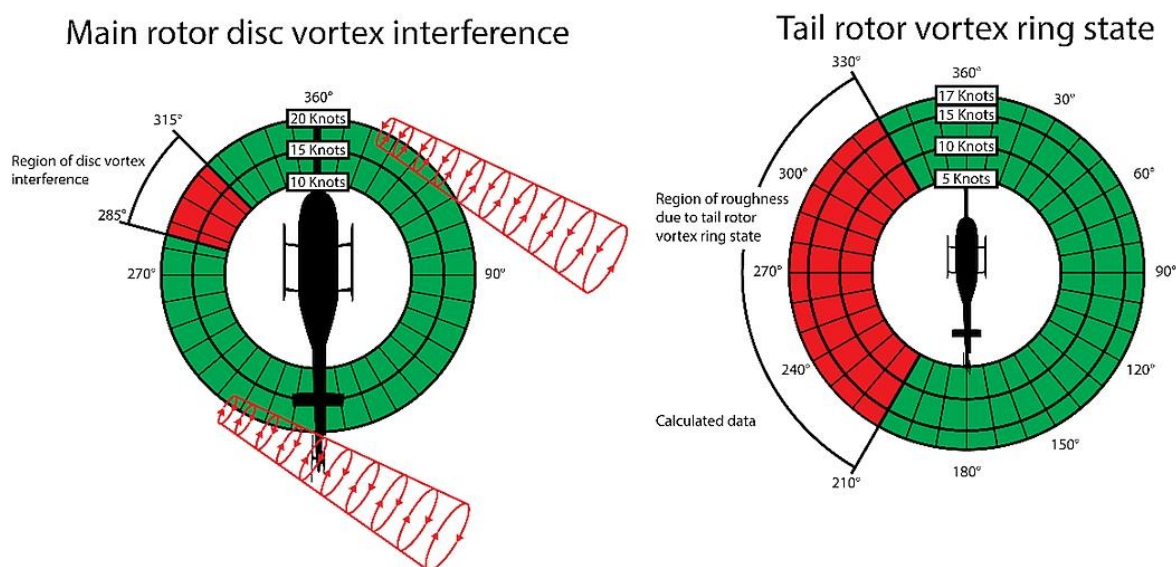
In addition, four relative wind azimuth regions can produce an environment that is conducive to LTE (Figure 3):

- main rotor disc vortex wind (winds from 285° to 315° relative to the helicopter);
- weathercock stability (winds from 120° to 240°);
- tail rotor vortex ring (winds from 210° to 330°); or
- loss of translational lift (winds from all directions).

Figure 3. Main rotor disc vortex interference and tail rotor vortex ring state angle
(Source: TSB, based on figures included in Federal Aviation Administration, Advisory Circular 90-95:
Unanticipated Right Yaw in Helicopters [1995])

At the time of the occurrence, the helicopter was approximately 130 lb below the maximum gross weight and in an out-of-ground-effect hover. Winds were estimated to be gusting up to 20 kt, turbulent, and approaching the helicopter from the left. Given these conditions, the helicopter was operating in a high-power regime within the critical wind azimuth regions of the main rotor disc vortex wind and tail rotor vortex ring that could induce an unanticipated yaw.
