Transport
Canada

ISSUE 2/2022

AVIATION **S**AFETY **L**ETTER

TP 185E

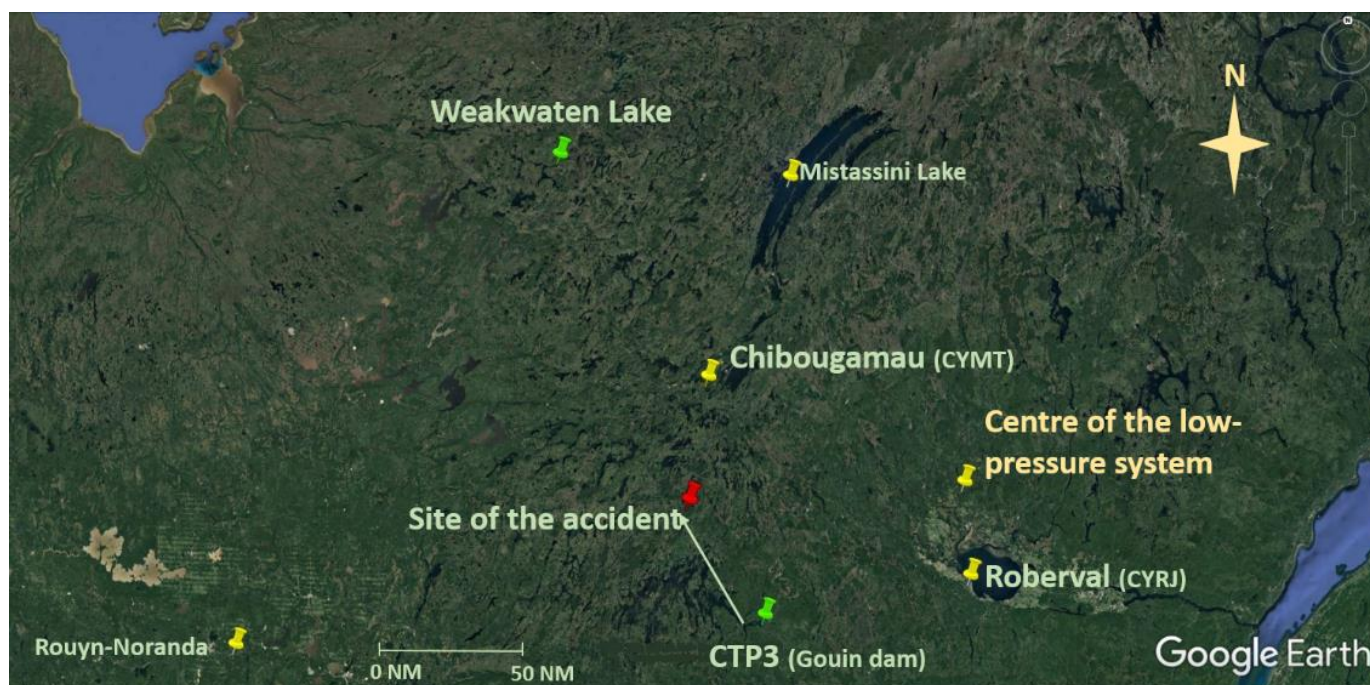
At 1300, the centre of a quasi-stationary low-pressure system was located approximately 37 statute miles (SM) north of the Roberval Airport (CYRJ), Quebec (Figure 1). Areas to the west and northwest of the low-pressure system were influenced by a cloudy return flow strengthened by high humidity, which was 87% at CTP3 and 100% near the site of the accident. Localized areas of mist, drizzle or intermittent rain were also possible in these areas, which could lead to a reduction in visibility and in the height of the cloud ceiling. Between 1300 and 1700, the Chibougamau/Chapais Airport (CYMT), Quebec, located approximately 43 nautical miles (NM) north of the scene of the accident, reported visibility varying between 2½ SM and 9 SM, with a ceiling at 400 ft above ground level (AGL) and intermittent low precipitation.

Figure 1. Centre of the low-pressure system in relation to the points of interest in the occurrence (Source: Google Earth, with TSB annotations; map data: Image Landsat/Copernicus, Data SIO, NOAA, U.S. Navy, NGA, GEBCO)

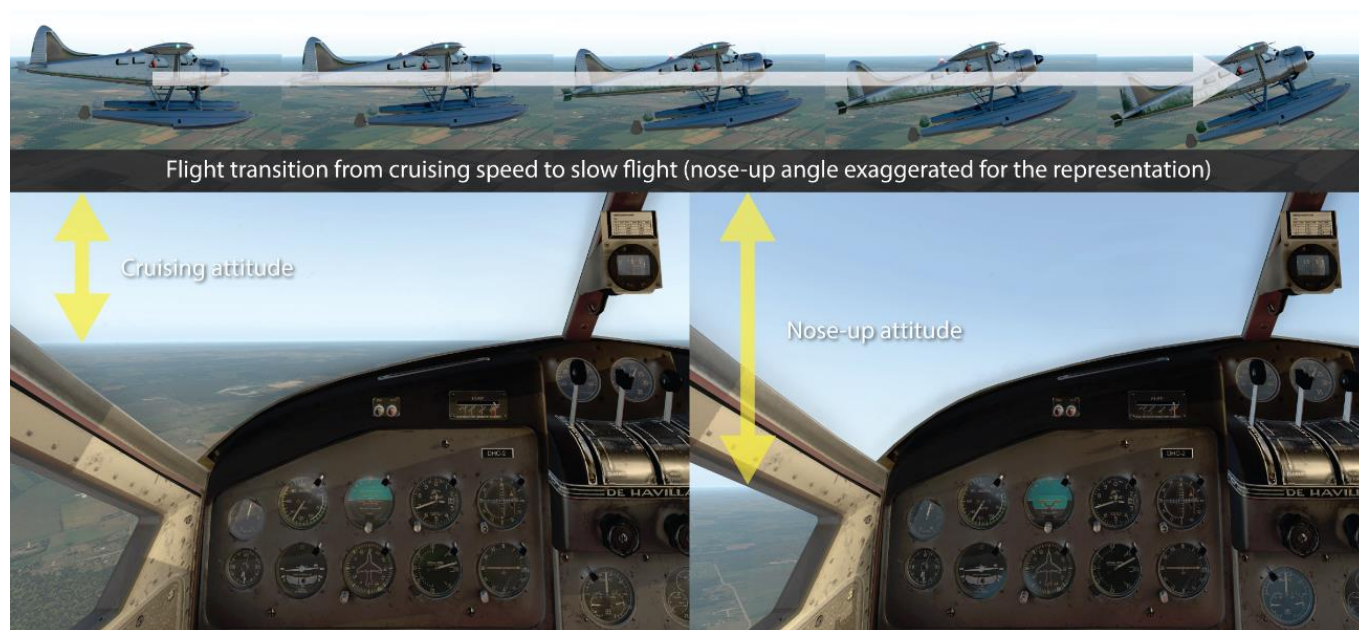
Figure 3. Visual references of the attitude from the cockpit (Source: TSB)

In slow flight, the aircraft is more nose-up than it is at cruising speed. The nose-up position changes the position of the horizon visible from the cockpit as well as the earth's surface that is visible (Figure 3). The horizon and the earth's surface are therefore the main visual cues used by a pilot to determine the aircraft's attitude. If a pilot sees the horizon move to the lower part of the windshield and the earth's surface that is visible diminish above the instrument panel, the pilot can recognize the aircraft's nose-up position.

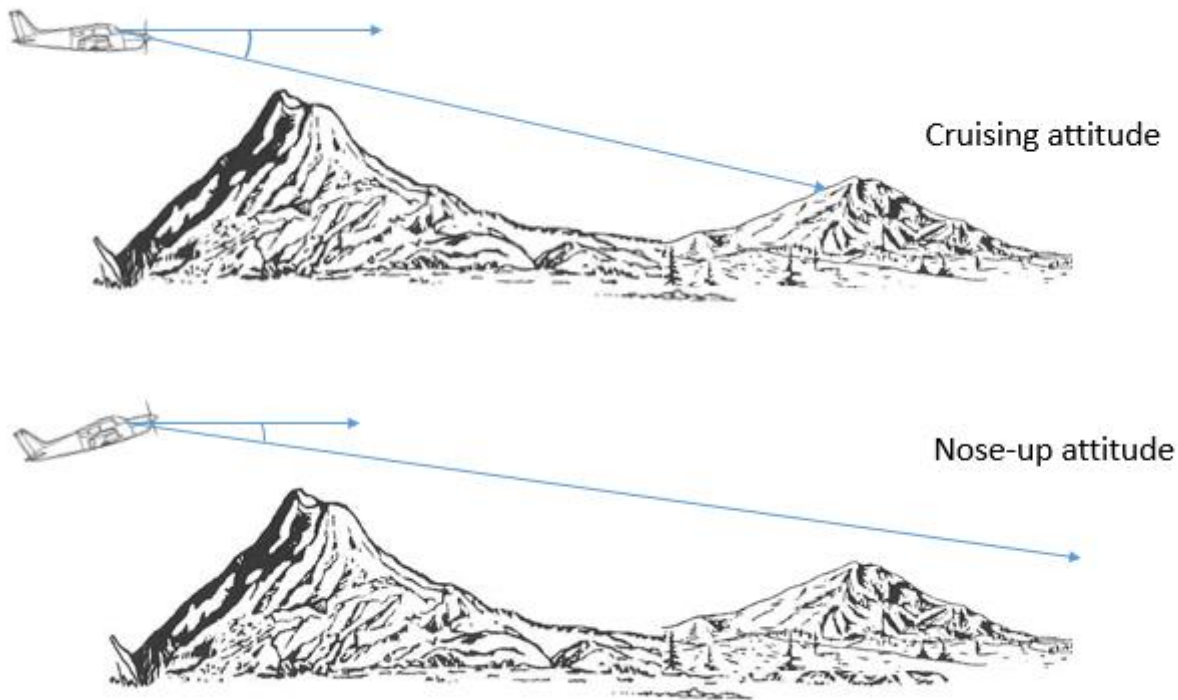
In slow flight, the pilot's front viewing angle is reduced (Figure 4). Also, when the aircraft has a high instrument panel, as is the case in the DHC-2, the reference line for the actual horizon and the terrain may be completely hidden by the instrument panel. Hence, the visual cues needed to detect obstacles straight ahead are greatly reduced, which hinders the pilot's ability to maintain a safe altitude when flying at low altitude, and even more so when visibility is reduced.

In this occurrence, the fact that there was a sudden increase in power a few seconds before the collision with the trees, while the aircraft was possibly descending toward a rising terrain, suggests that the pilot saw the trees too late. The reduced speed, excess weight and proximity of the trees prevented the aircraft from regaining sufficient altitude to avoid the impact.

Figure 4. Pilot's viewing angle depending on the flight attitude (Source: TSB, using figures in Transport Canada's Air Command Weather Manual [TP 9352E] and Flight Training Manual [TP 1102E])

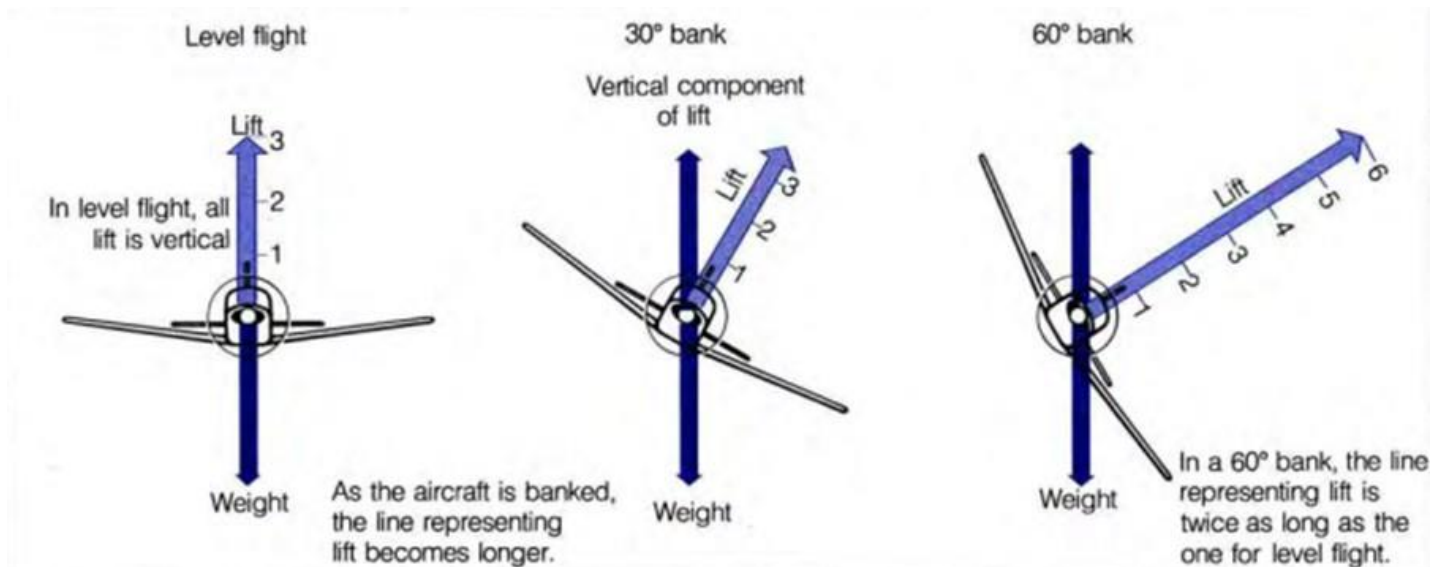
During straight and level flight, lift and weight are equal, and the load factor is 1. To maintain level flight when an aircraft is banked, the vertical component of lift must be increased to equal the weight of the aircraft; this is accomplished by increasing the angle of attack of the wing by pulling on the elevator control to maintain altitude (Figure 4).

Figure 4. Relationship between lift and angle of bank (Source: Transport Canada, TP 1102E, Flight Training Manual Aeroplane, 4th edition [Revised], p. 63)

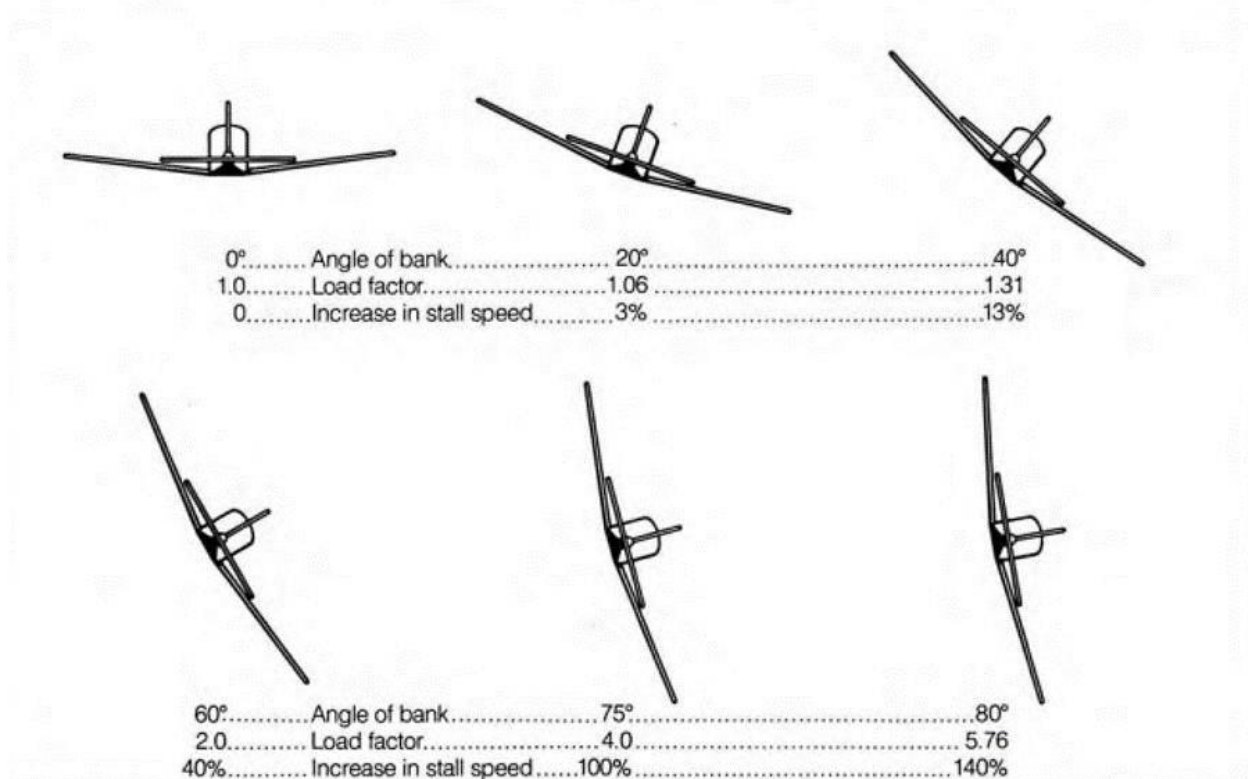
Increasing the angle of bank increases the load factor and the aircraft's stalling speed because it causes the aircraft to perform as if it is heavier. At a 60° angle of bank, the load factor is 2, meaning that the aircraft performs as if it is twice as heavy as it would be in level flight. The stall speed is increased by 40% at a 60° angle of bank (Figure 5).

Figure 5. Relationship between angle of bank, load factor, and basic stall speed (Source: Transport Canada, TP 1102E, Flight Training Manual Aeroplane, 4th edition [Revised], p. 63)

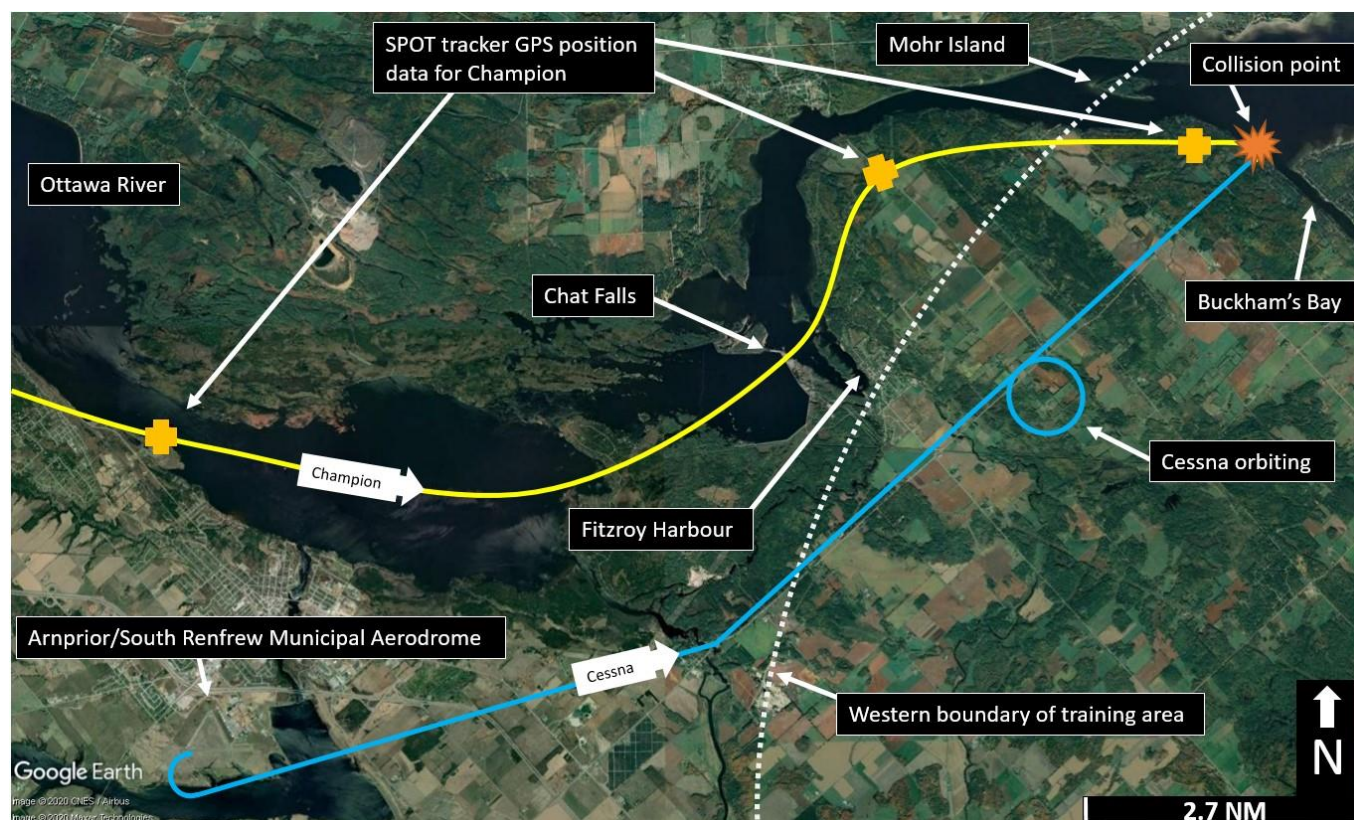
Figure 1. Estimated flight paths of the Champion and the Cessna (Source: Google Earth, with TSB annotations)

At approximately 1446, the two aircraft collided while flying over the Ottawa River near Buckham's Bay, approximately 12 NM east-northeast of CNP3 (Figure 1).
