AIR TRANSPORTATION SAFETY INVESTIGATION REPORT A17C0146

LOSS OF CONTROL AND COLLISION WITH TERRAIN

West Wind Aviation L.P.
Avions de Transport Régional ATR 42-320, C-GWEA
Fond-du-Lac, Saskatchewan
13 December 2017

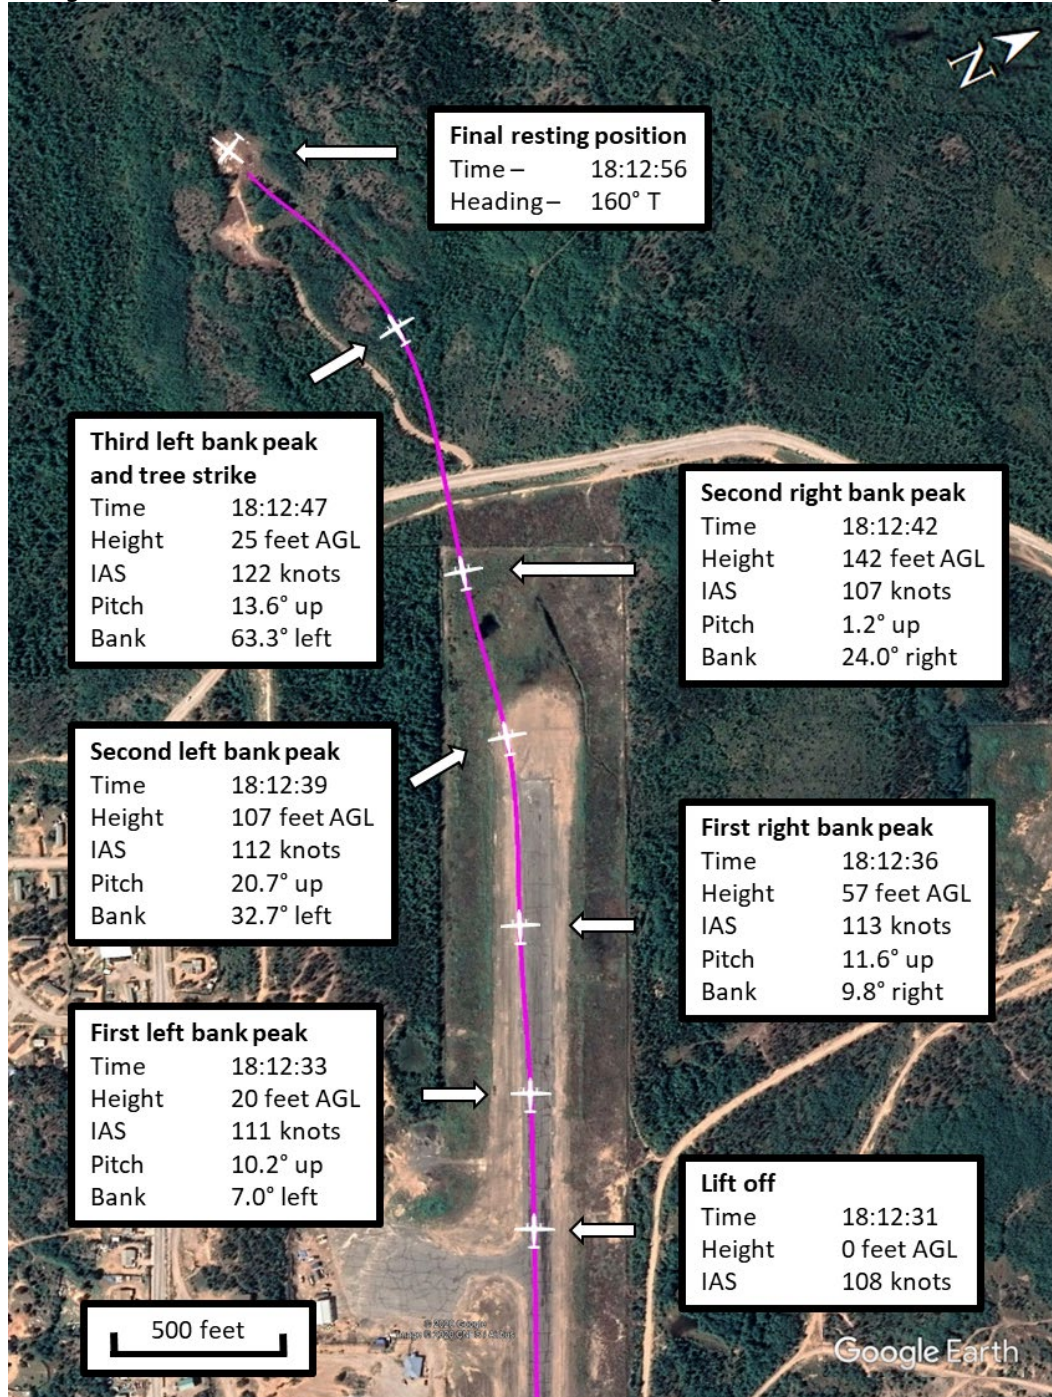
At 1812:48 the aircraft collided with the ground in a 32.0° left bank with approximately 4° of nose-up pitch. The aircraft slid along the ground for about 9 seconds and came to a rest at 1812:57 (Figure 2).

Figure 2. Aircraft height above ground level (AGL), indicated airspeed (IAS), pitch, and bank, during the occurrence takeoff and ground collision (Source: Google Earth, with TSB annotations)

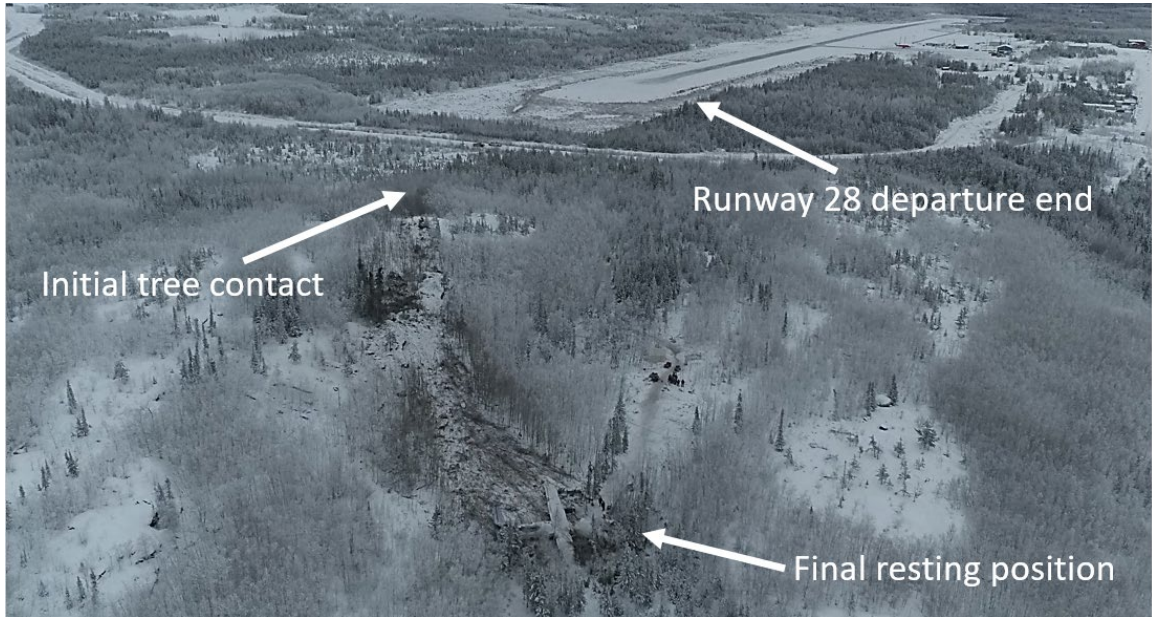
The terrain in the wooded area rises slightly, and the aircraft struck treetops in this area before contacting the ground near the top of the hill. As it made initial contact with the ground and then a secondary ridge, the aircraft left a debris trail before coming to rest. In relation to the departure end of the runway, the aircraft's final resting position was 600 m away, on a bearing of 270°T (Figure 6).

Figure 6. Aerial view of occurrence site (Source: Royal Canadian Mounted Police, with TSB annotations)

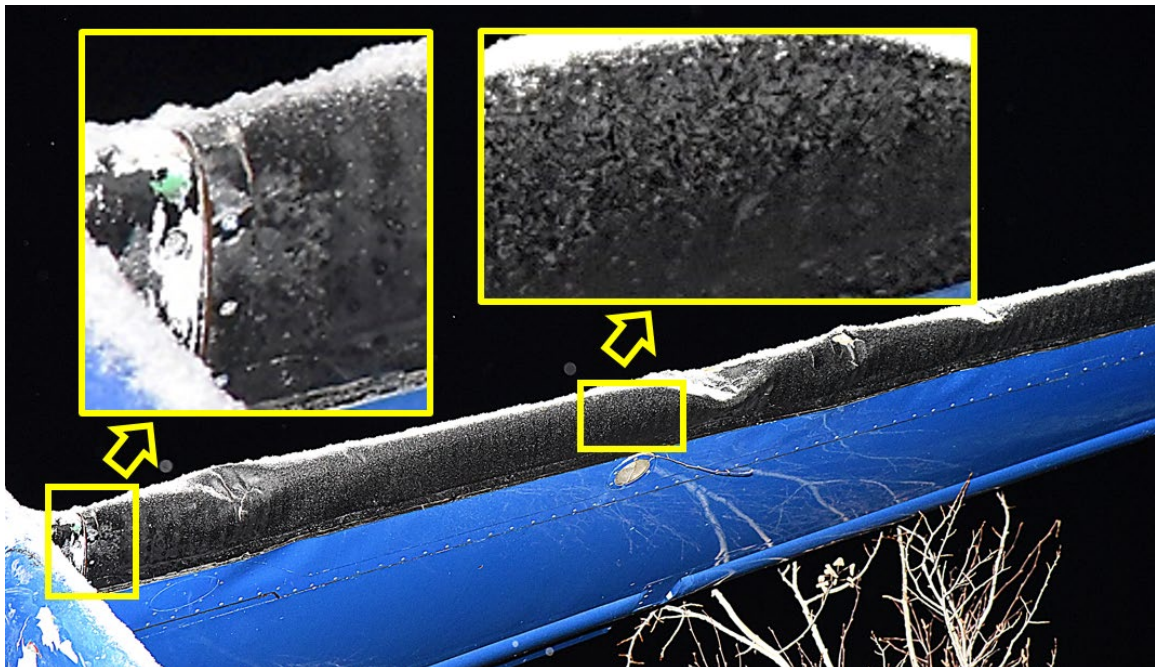
Examination of photographs taken by the Royal Canadian Mounted Police (RCMP) about 8 hours after the accident revealed the presence of ice contamination on the aircraft (figures 16, 17, and 18). Although ground icing conditions persisted following the crash, these figures provide some indication of the contamination present on the aircraft during the occurrence flight.

Figure 16. Photo of left horizontal stabilizer, with 2 inset images showing ice contamination on leading edge (Source: Royal Canadian Mounted Police, with TSB annotations)

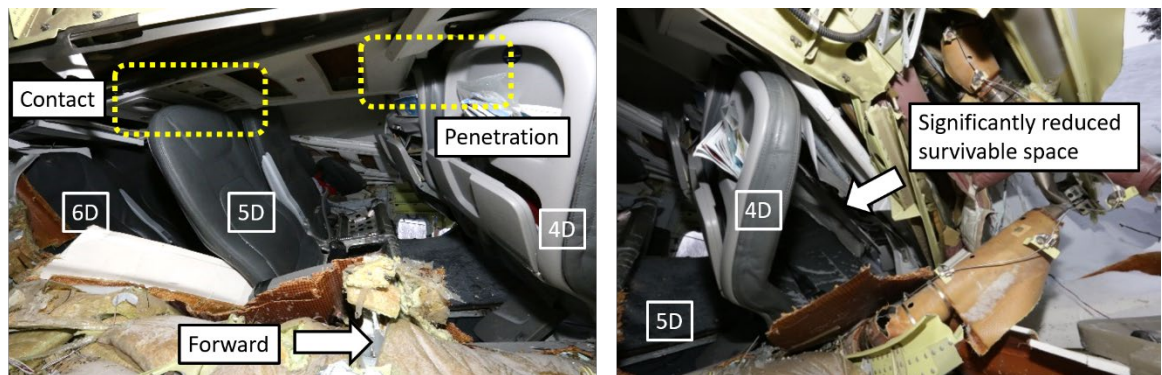
The tops of the seatbacks of the seats in rows 4 and 5 on the right side of the aisle had contacted or penetrated the overhead luggage compartment. The survivable space for each seat in rows 4 to 6 had been reduced to 1 to 2 feet, and the head space had been reduced in many other nearby rows (Figure 22).

Figure 22. Photos showing the reduced survivable space in rows 4 to 6, with seatbacks contacting or penetrating overhead luggage compartment (Source: TSB)

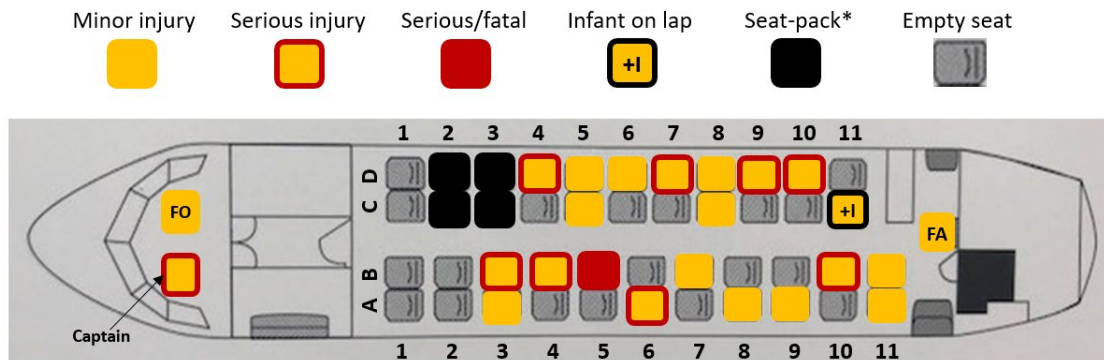
All passengers and crew were injured during the accident sequence. Many were rendered temporarily unconscious. The captain and 9 passengers were seriously injured, and 1 of the seriously injured passengers died 12 days after the accident. The severity of the injuries was somewhat distributed throughout the aircraft (Figure 24); however, the passenger who was fatally injured was seated mid-cabin, directly beneath the wing.

Figure 24. Injury distribution (Source: Avions de Transport Régional, Cabin Crew Operating Manual, Revision no. 4 [April 2018], with TSB annotations)

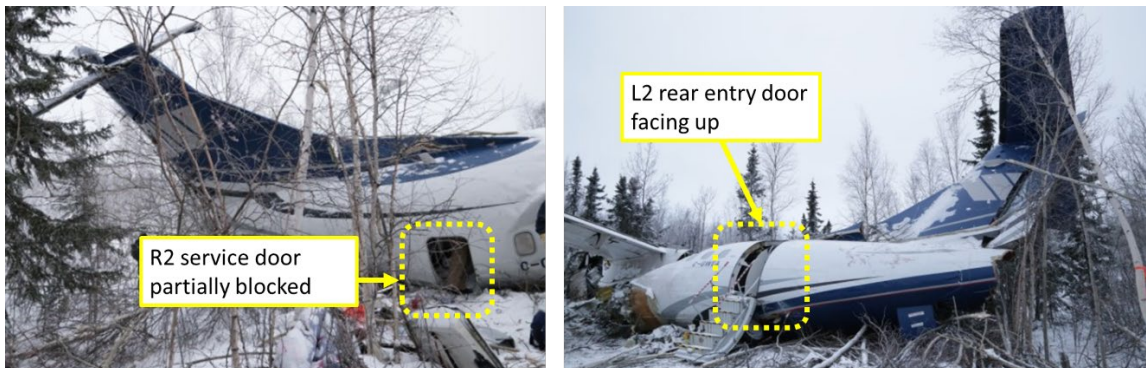
Because the main passenger cabin had rolled approximately 40° to the right, the service door (R2) was partially blocked by external terrain. The main exit point, the rear entry door (L2), was facing up, making it difficult to be opened (Figure 29).

Figure 29. Orientation of the service door (R2) (left image) and the rear entry door (L2) (right image) (Source: TSB)

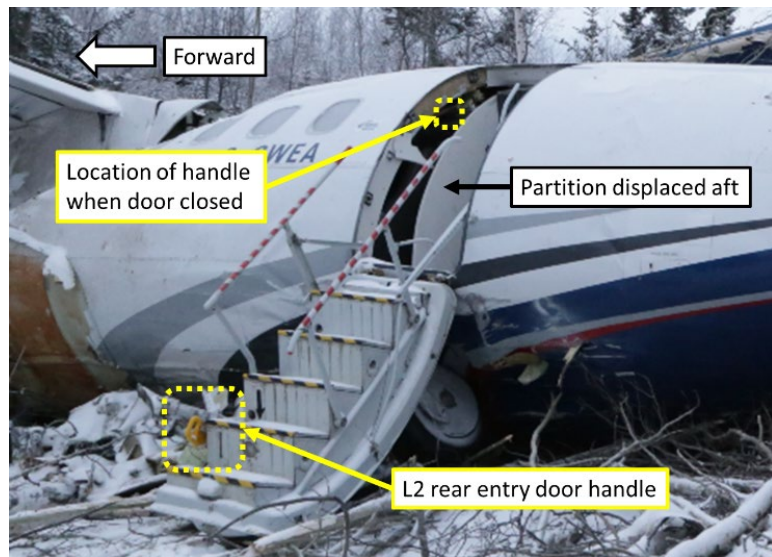
The partition that separated the passenger cabin from the rear entry door (L2) was also dislodged and fell across the door, blocking access to the door handle, which was on the other side of the partition (Figure 31).

Figure 31. Partition displaced toward the aft, blocking access to the L2 rear entry door handle (Source: TSB)

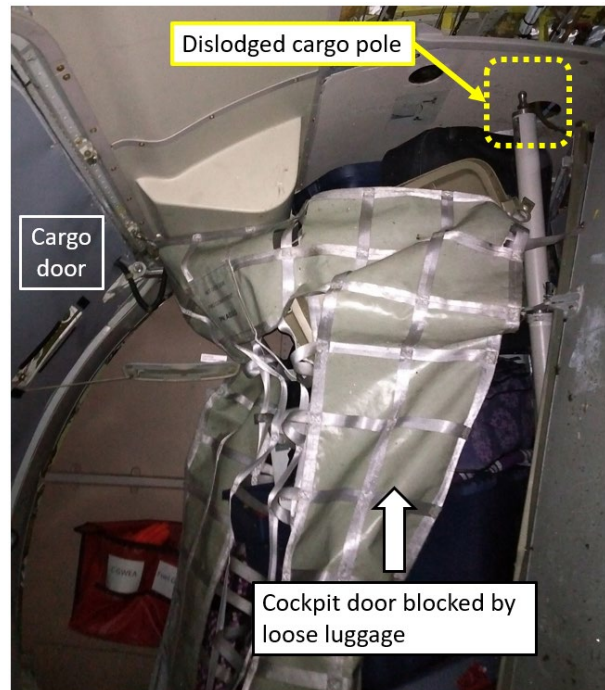
hooked onto vertical cargo poles. These cargo poles were latched into the aircraft structure. During the accident, the cargo poles became dislodged, and, although the nets remained attached, the luggage that was retained by the poles and nets came loose. The loose luggage and the dislodged poles and nets blocked the cockpit door, preventing egress from the cockpit into the main cabin of the aircraft (Figure 32).

Figure 32. Main cockpit door blocked by loose luggage as a result of dislodged cargo pole (Source: TSB)

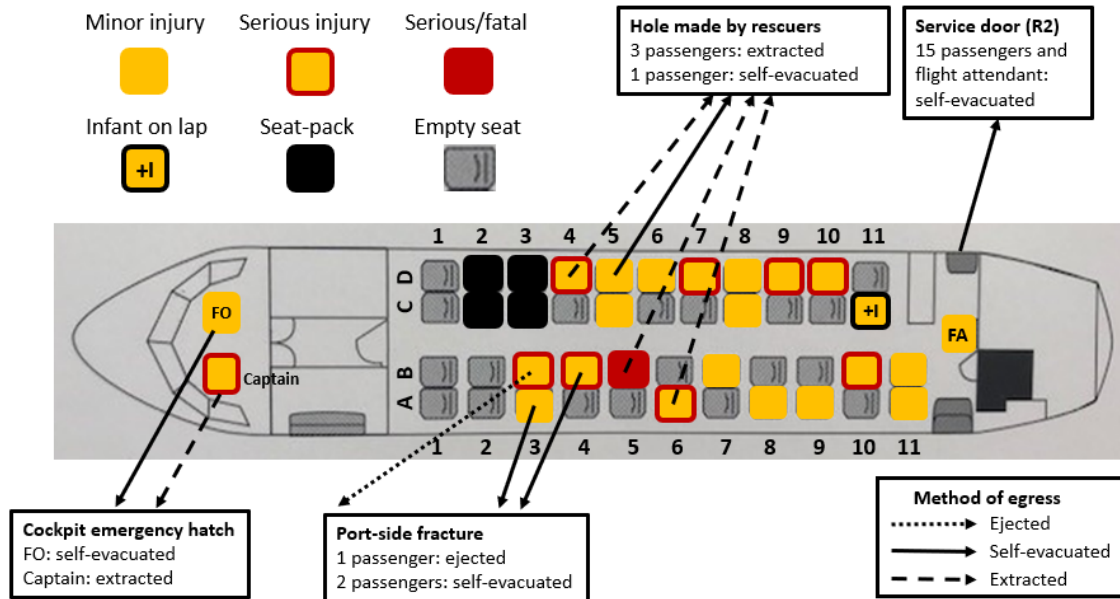
Figure 33. Seating plan of occurrence aircraft showing locations of injured passengers and methods of egress for all aircraft occupants (Source: Avions de Transport Régional, Cabin Crew Operating Manual, Revision no. 4 [April 2018], with TSB annotations)

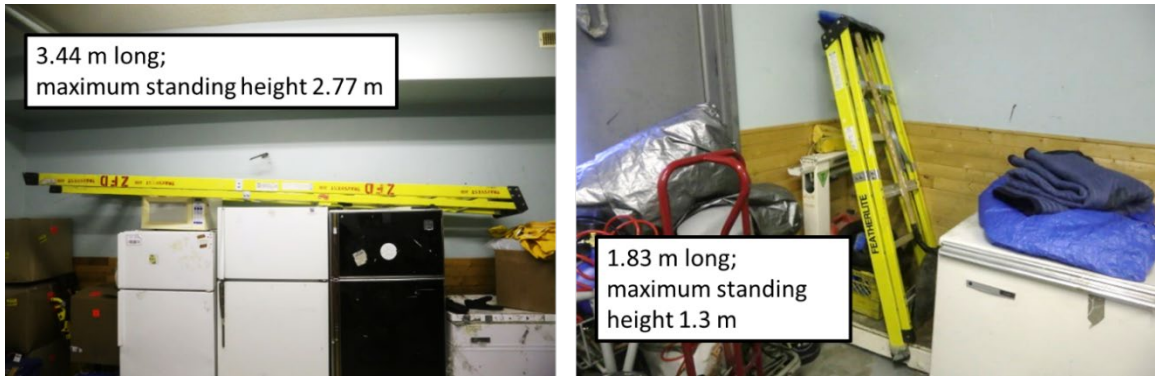
Figure 37. Photos showing ladders available at the Fond-du-Lac Airport terminal (Source: TSB)

At CZFD, there was no equipment available that would enable someone to visually inspect the top portion of an ATR 42’s critical surfaces, given their height, nor to reach them to apply de-icing fluid. The only equipment available were 2 ladders, 1 approximately 3.44 m and the other 1.83 m (Figure 37). The 3.44 m ladder had a maximum standing height of 2.77 m.

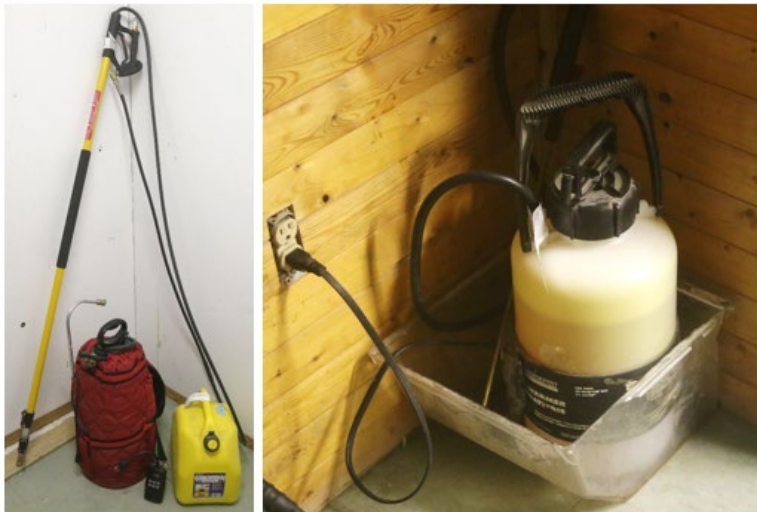
Figure 38. De-icing equipment available at Fond-du-Lac Airport: West Wind's equipment on left, another operator's equipment on right (Source: TSB)

West Wind's de-icing spray equipment at CZFD consisted of a hand-held spray system with a small-capacity heated fluid reservoir and 20 L container of additional type I fluid.²⁶⁹ Another air operator also had a small (20 L), heated hand-held spray system in the terminal building that was available to West Wind personnel on request (Figure 38).

Published de-icing standards recommend that the fluid quantity required to de-ice an aircraft is 1 L/m² of aircraft surface. In the case of an ATR 42 aircraft, more than 66 L would be required.²⁷⁰
