# AIR TRANSPORTATION SAFETY INVESTIGATION REPORT A21Q0024

## **COLLISION BETWEEN SLING LOAD AND TAIL ROTOR**

Héli-Express Inc.  
Airbus AS350 B2 (helicopter), C-GHEX  
Les Escoumins, Quebec, 1.5 NM NNE  
11 May 2021

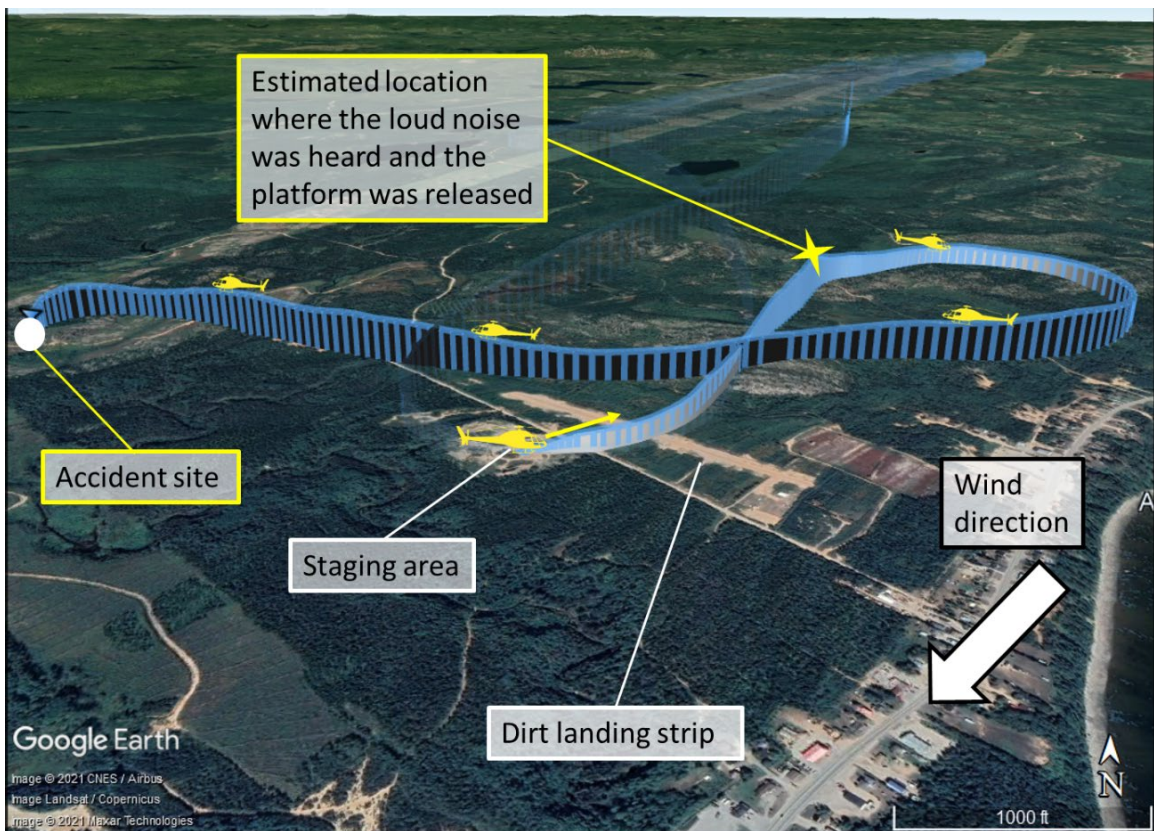
Figure 2. Map showing the occurrence helicopter's track based on data from the GPS (Source: Google Earth, with TSB annotations)

The helicopter did, however, have a satellite flight tracking system, and the pilot was using a personal GPS (global positioning system), from which it was possible to retrieve data. The GPS recorded the aircraft's GPS position, altitude, and ground speed (Figure 2).

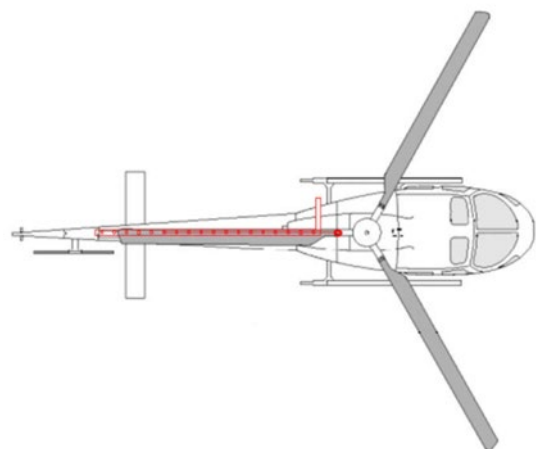
Figure 7. Illustration showing the view from the top of the helicopter with the platform on the helicopter's longitudinal axis (not to scale) (Source: TSB)

Figure 7 shows a configuration where the platform is on the helicopter's longitudinal axis. According to calculations, in this configuration, the maximum distance that could be reached by any part of the platform is 200 inches from the cargo hook. Knowing that the damage was approximately 10 inches from the tip of the platform, the distance between the cargo hook and the damage was estimated to be 190 inches. This configuration is unlikely because it was determined that extreme instability and aerodynamic drag imbalance would have been required for the platform to be in this position. Nevertheless, this configuration was examined, because it represents the theoretical maximum reach of the platform behind the cargo hook.

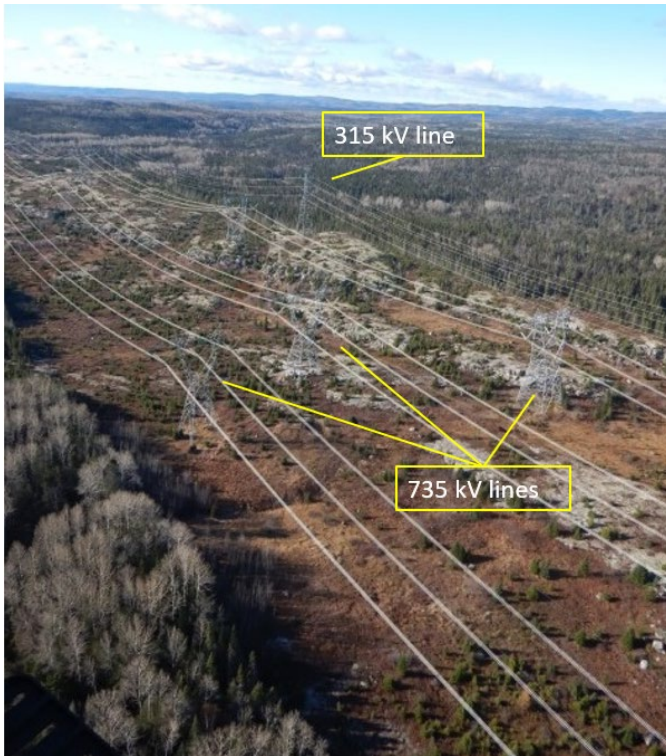
Figure 10. Aerial photo of the work area, near Les Escoumins  
(Source: TSB)

In this occurrence, GLR was awarded the contract for the replacement of 315 kV transmission line insulators spread throughout several administrative regions, including Côte-Nord. The section of transmission line requiring work was located near 3 parallel 735 kV high-voltage transmission lines (Figure 10).

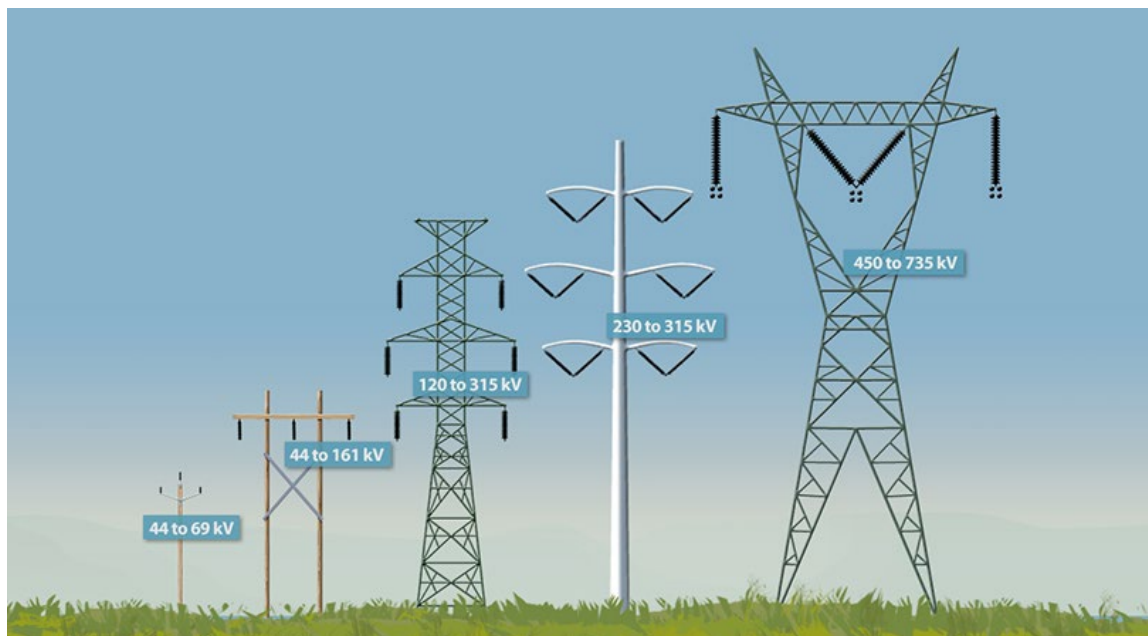
Figure 11. Line supports used on different types of transmission lines (Source: Hydro-Québec)

When work was done on 735 kV high-voltage transmission lines in the past, Héli-Express had transported and dropped off loads at the foot of hydro towers where workers were stationed. However, the wires are lower on 315 kV high-voltage lines (Figure 11).
