AIR TRANSPORTATION SAFETY INVESTIGATION REPORT A21W0045

IN-FLIGHT BREAKUP

Yellowhead Helicopters Ltd.
Bell Textron Inc. 212 (helicopter), C-GYHQ
Evansburg, Alberta, 4 NM WNW
28 June 2021

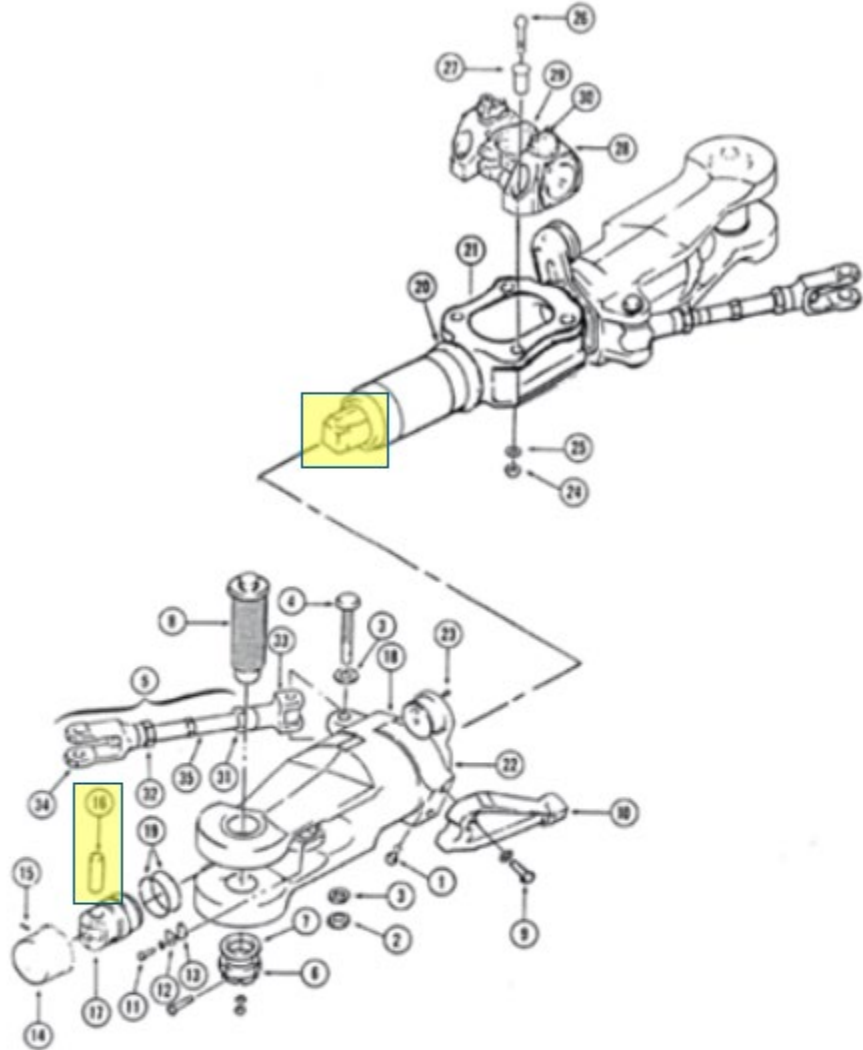
Appendix A – Main rotor hub assembly

Shaded boxes denote the strap restraining pin (16) and the strap.
