# RAIL TRANSPORTATION SAFETY INVESTIGATION REPORT R19V0002

## **MAIN-TRACK TRAIN DERAILMENT**

Canadian Pacific Railway Company  
Freight train 401-02  
Mile 128.9, Laggan Subdivision  
Partridge, British Columbia  
03 January 2019

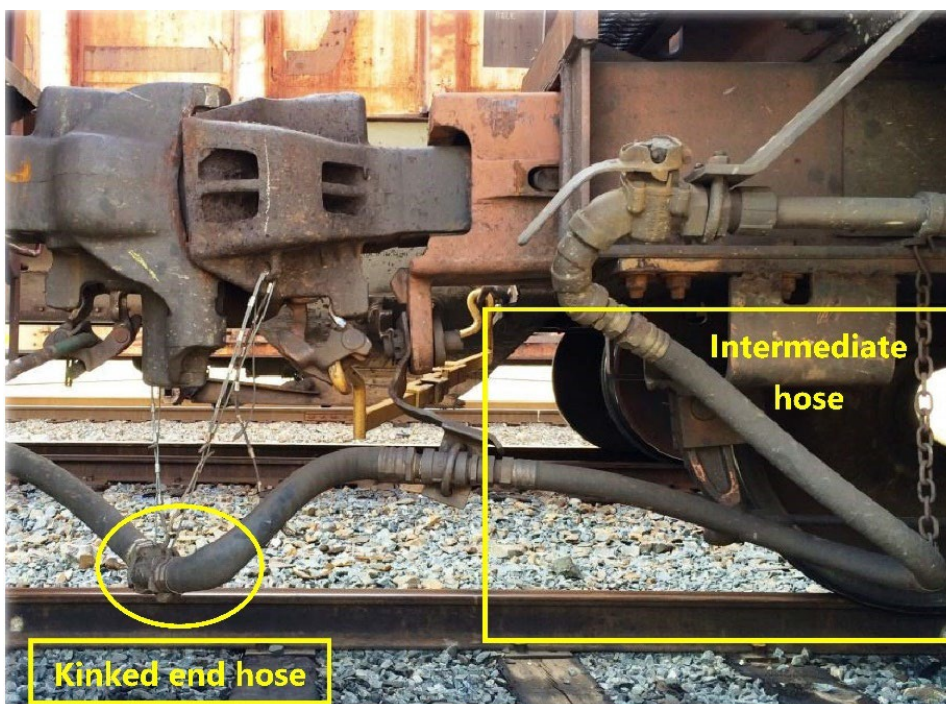
If the compressive force exerted on the air hoses and gladhand couplings becomes excessive, an undesired change in the amount of air flowing in the brake pipe could occur due to kinking (Figure 9) of the air hoses or peaking of the gladhand couplings, which could result in a localized change in brake pipe pressure.

Figure 9. Kinked end hose (Source: Y. Wang, “Brake System End Arrangement Tests,” presented at the Railway Supply Institute Expo and Technical Conference, Fort Worth, Texas, 11–13 October 2022)

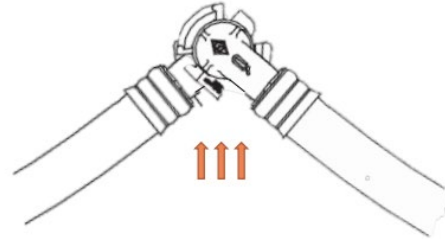
When a compressive slack adjustment occurs between cars, the alignment of the coupled gladhand couplings between adjoining cars often changes relative to each other as the gladhand couplings rotate vertically upward, a condition referred to as peaking (Figure 10).

While some degree of rotation is inconsequential, rotation in combination with the applied buff force can result in air momentarily leaking through the pneumatic seal created by the compressed gladhand coupling rubber gaskets. Because of the dynamic nature of the buff force and the swinging motion of the air hoses, the leakage rate can be highly variable, resulting in erratic airflow and localized pressure fluctuations in the brake pipe.

If the applied force results in the gladhand couplings rotating too much, the interlocked gladhand couplings eventually reach a position at which, by design, they unlock. When this happens, the gladhand couplings are pushed apart due to the force of the compressed air inside them, and the brake pipe pressure exhausts to atmosphere, resulting in an emergency application of the train's air brakes as a fail-safe measure.

Figure 10. Coupled gladhand couplings in a peaked orientation due to upward force (Source: Y. Wang, "Brake System End Arrangement Tests," presented at the Railway Supply Institute Expo and Technical Conference, Fort Worth, Texas, 11–13 October 2022.)

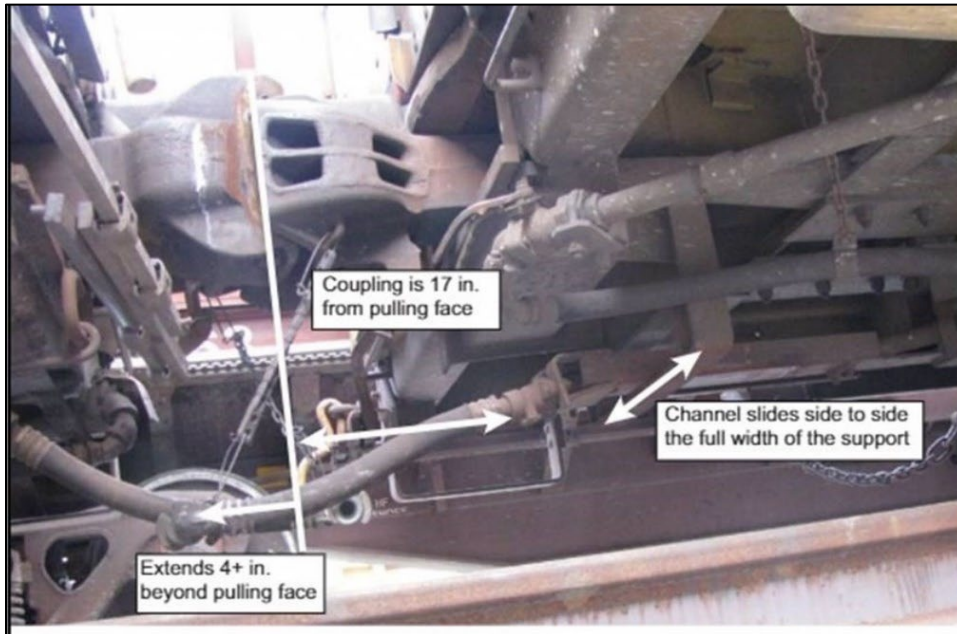
In this occurrence, 1 or more cars in the TTZX series were equipped with an older end-of-car intermediate hose and trolley arrangement based on the previous version of MSRP Standard S-4003.<sup>21</sup> Derailed cars in this series included car TTZX 85561 (position 85), which was observed to have the older trolley arrangement during site examination, and car TTZX 86441 (position 96).

In the previous version of Standard S-4003, the uncoupled resting position of the gladhand coupling extended beyond the pulling face of the coupler by about 4 inches. In addition, the end-of-car trolley used a movable channel design that could slide over the bottom support bracket. This allowed the intermediate hose to swing up to 6 inches laterally from the car centreline (Figure 11). This previous version of Standard S-4003 for end-of-car trolley arrangement was applicable to freight cars with 43-inch or 60-inch F-shank couplers and 10-inch to 15-inch EOCCDs. This version of the standard is still included in Section E of AAR's MSRP as information but no longer applies to new cars.

Figure 11. End-of-car trolley arrangement compliant with the preceding version of Standard S-4003, showing location of the angle cock and air brake hose (Source: Association of American Railroads, Field Manual of the AAR Interchange Rules [effective 01 January 2019], Rule 6, Figure 6.12)

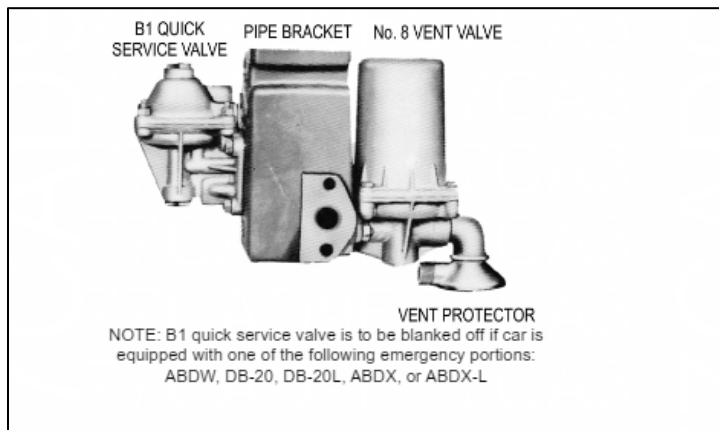
A visual inspection of car CP 315578, the front-most derailed car, revealed that the car was equipped with an A1 reduction relay valve, which includes a B1 quick service valve and a No. 8 vent valve. This configuration is contrary to Rule 4 of the *Field Manual of the AAR Interchange Rules* (Field Manual)<sup>36</sup> in effect at the time of the occurrence. As early as 2016, the Field Manual required the “blanking off” (i.e., removal) of the B1 quick service valve on long cars equipped with new-technology emergency brake portions (Wabtec ABDX or New York Air Brake DB-20) (Figure C1).

Figure C1. Instructions indicating that the B1 quick service valve should be removed (Source: Association of American Railroads, *Field Manual of the AAR Interchange Rules* (effective 01 January 2019), Rule 4, Figure 4.16)

The new-technology emergency brake portions include an accelerated application valve (AAV),<sup>37</sup> which makes the B1 quick service valve unnecessary because its intended function is better performed by the AAV feature. Consequently, when the B1 quick service valve is still functional on a car equipped with the new-technology emergency brake portion, the combined effects of the B1 and the AAV could trigger an excessive rate of reduction in brake pipe pressure when a service brake application is made, and this could result in an undesired emergency brake application.
