RAIL TRANSPORTATION SAFETY INVESTIGATION REPORT R21M0027

MAIN-TRACK TRAIN DERAILMENT

Canadian National Railway Company
Train B73041-15
Mile 18.9, Napadogan Subdivision
Pangburn Station, New Brunswick
21 August 2021

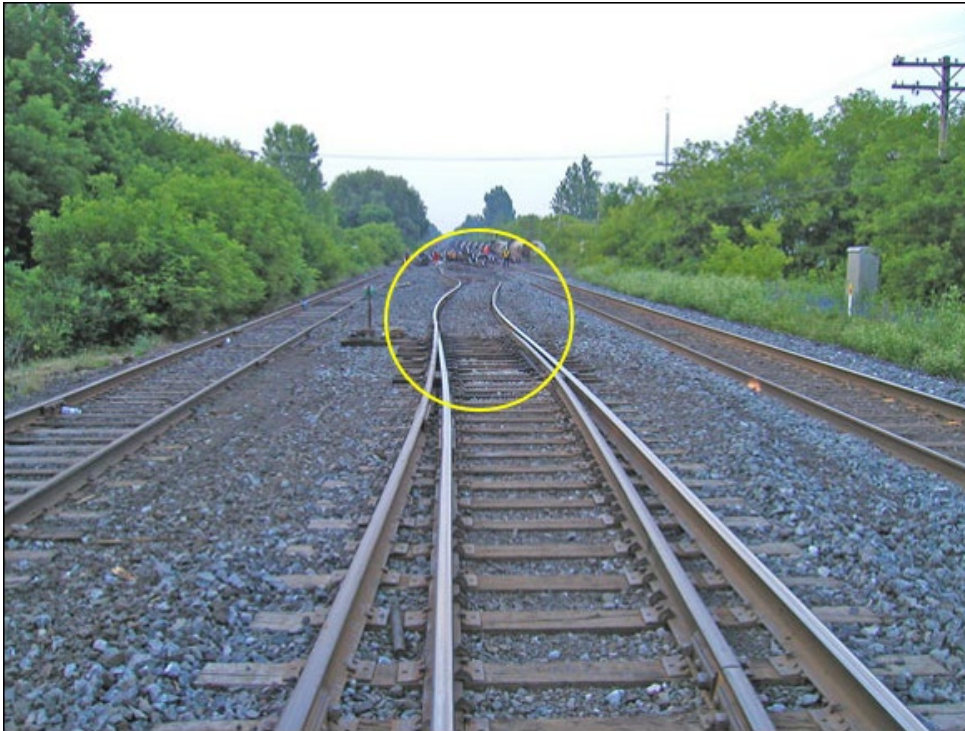
Figure 7. Track buckle (Source: TSB Railway Investigation Report R05H0013)

A track buckle is a lateral shift of the track that occurs when longitudinal compressive stress in the rail overcomes the lateral resistance of the track structure (Figure 7). Track buckles can occur when there is an increase in the longitudinal compressive stress or when there is a decrease in the lateral resistance of the track structure. Track buckles are more likely to occur in the presence of compressive stress.
