Solid waste  
disposal sites on  
federal properties  
in Quebec

Phase 2: Indian reserves

June 1984

LALONDE, GIROUARD, LETENDRE & ASSOCIATES LIMITED

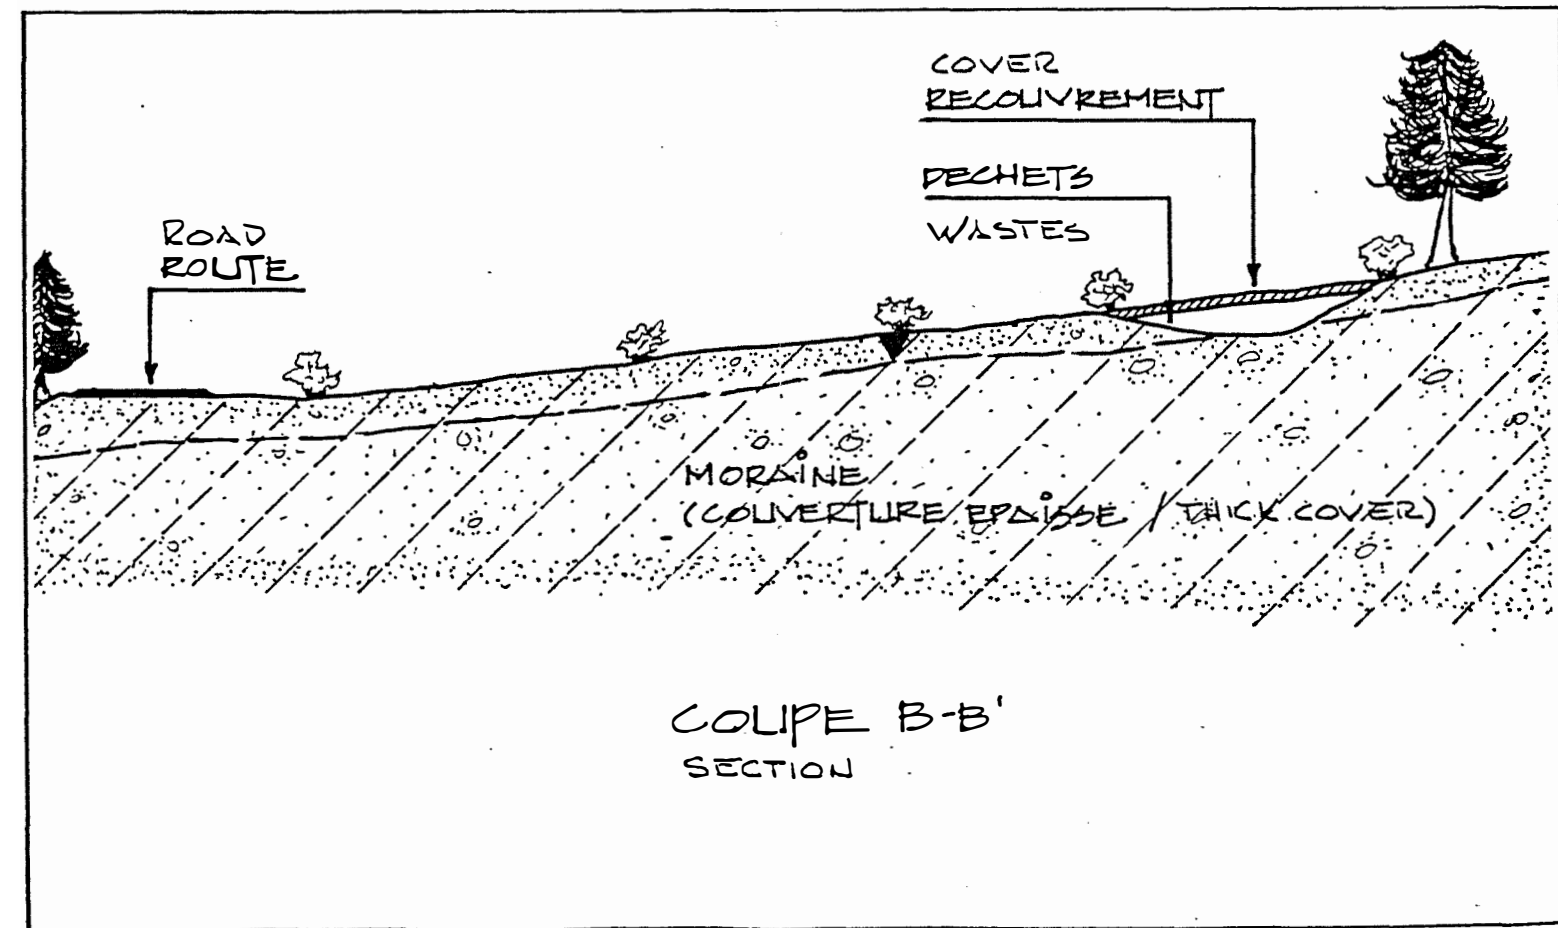
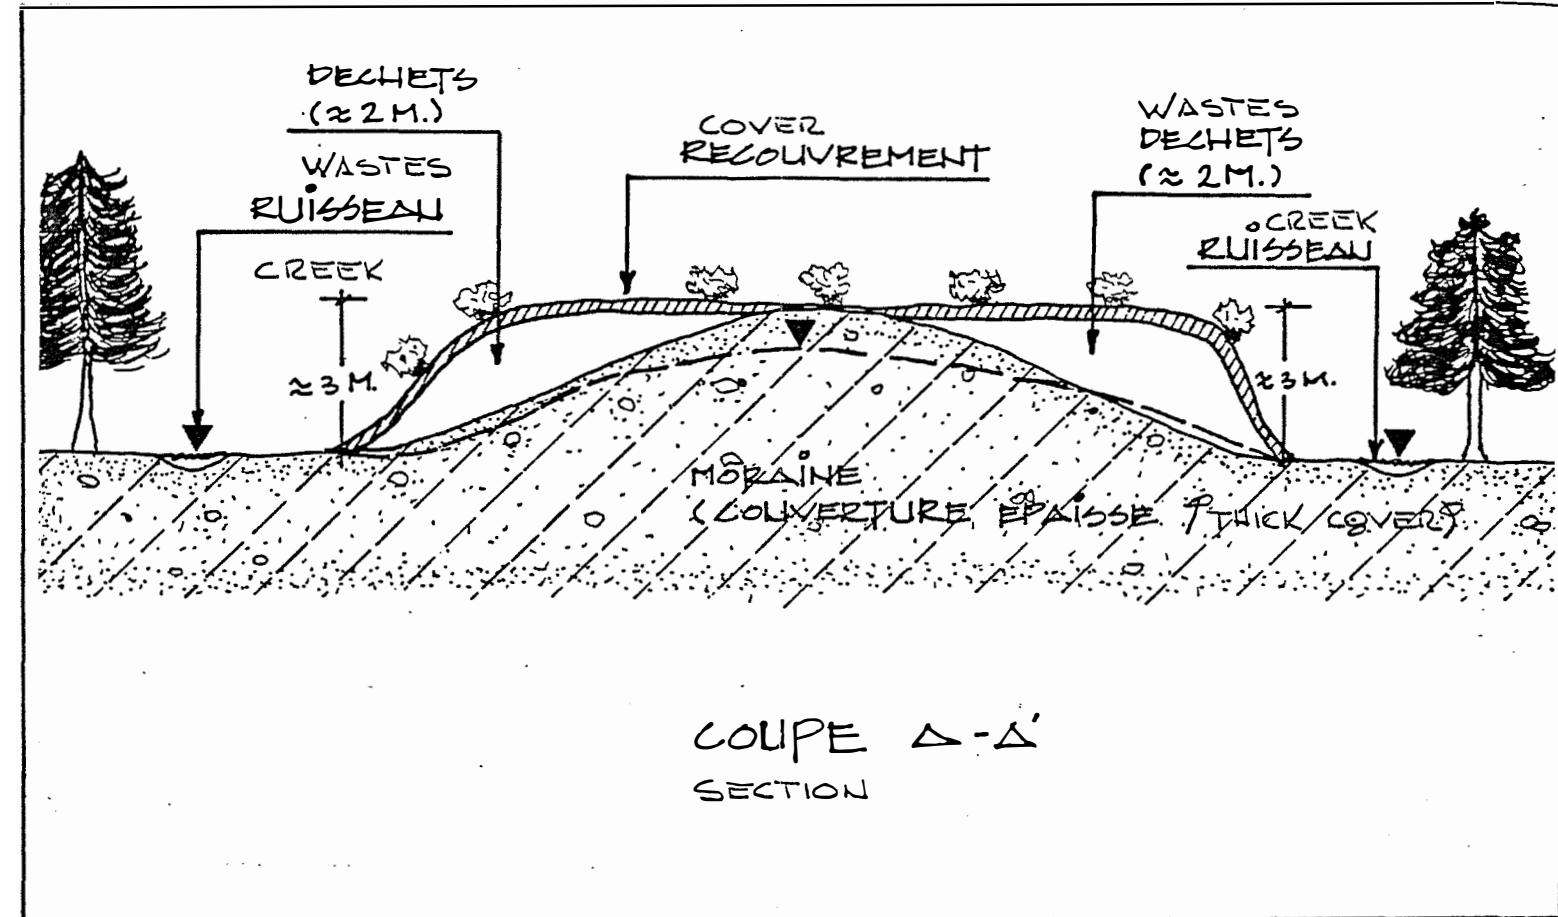
A pionner vegetation can be found on the site, a shrubby stratum near the site and trees all around. Only the site and its immediate surroundings had been deforested to allow waste disposal.

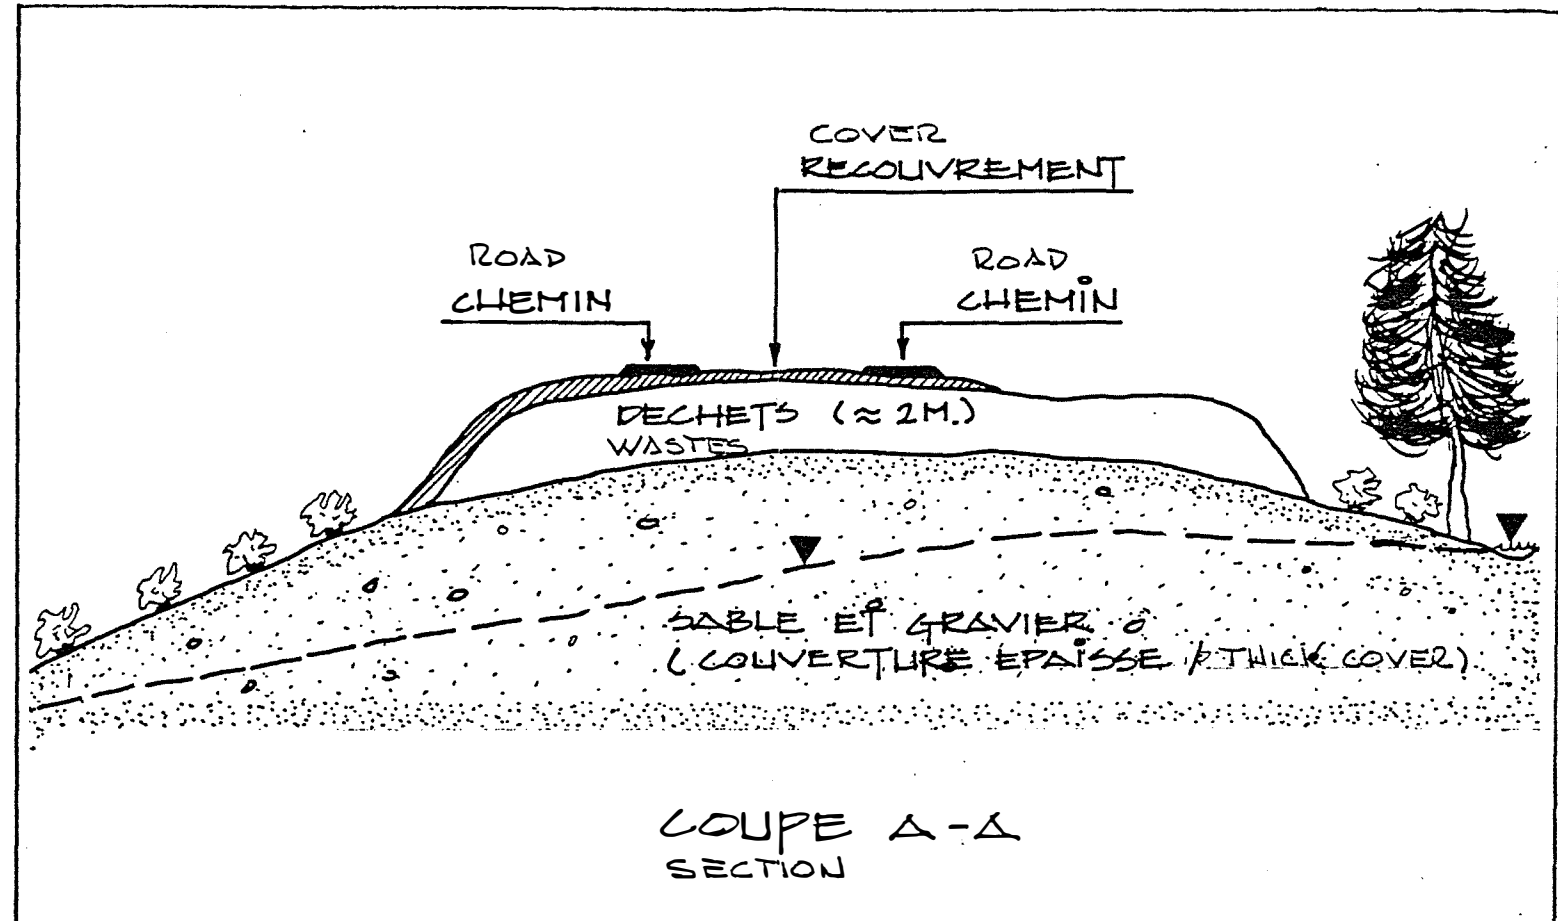
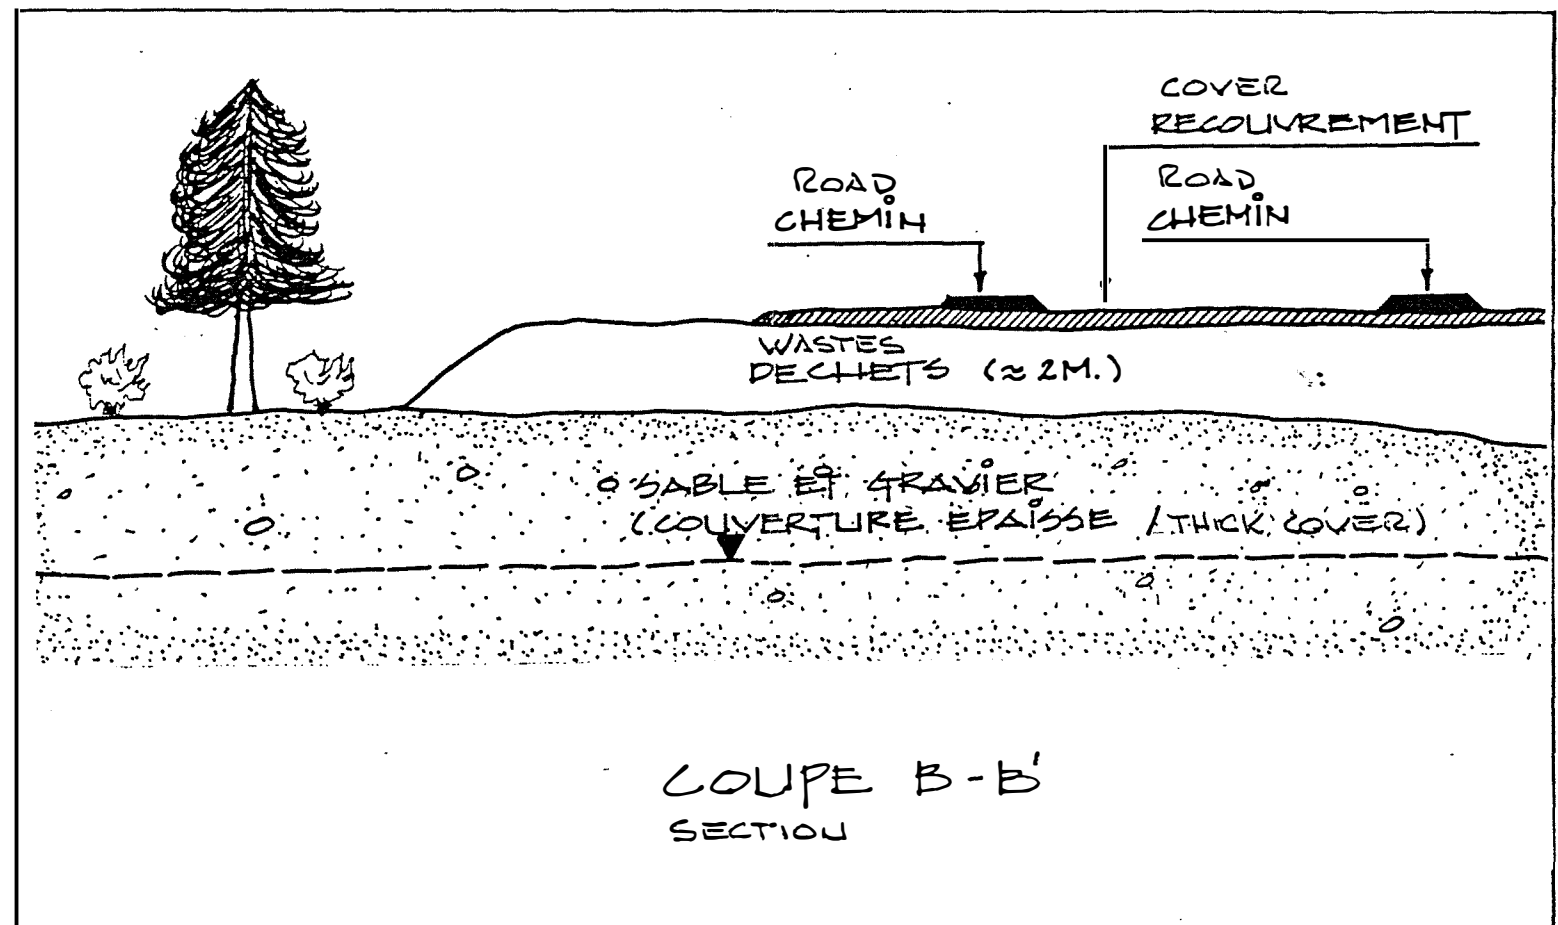
None of the drillings reached the bedrock. They went through granulated material composed of sand and gravel.

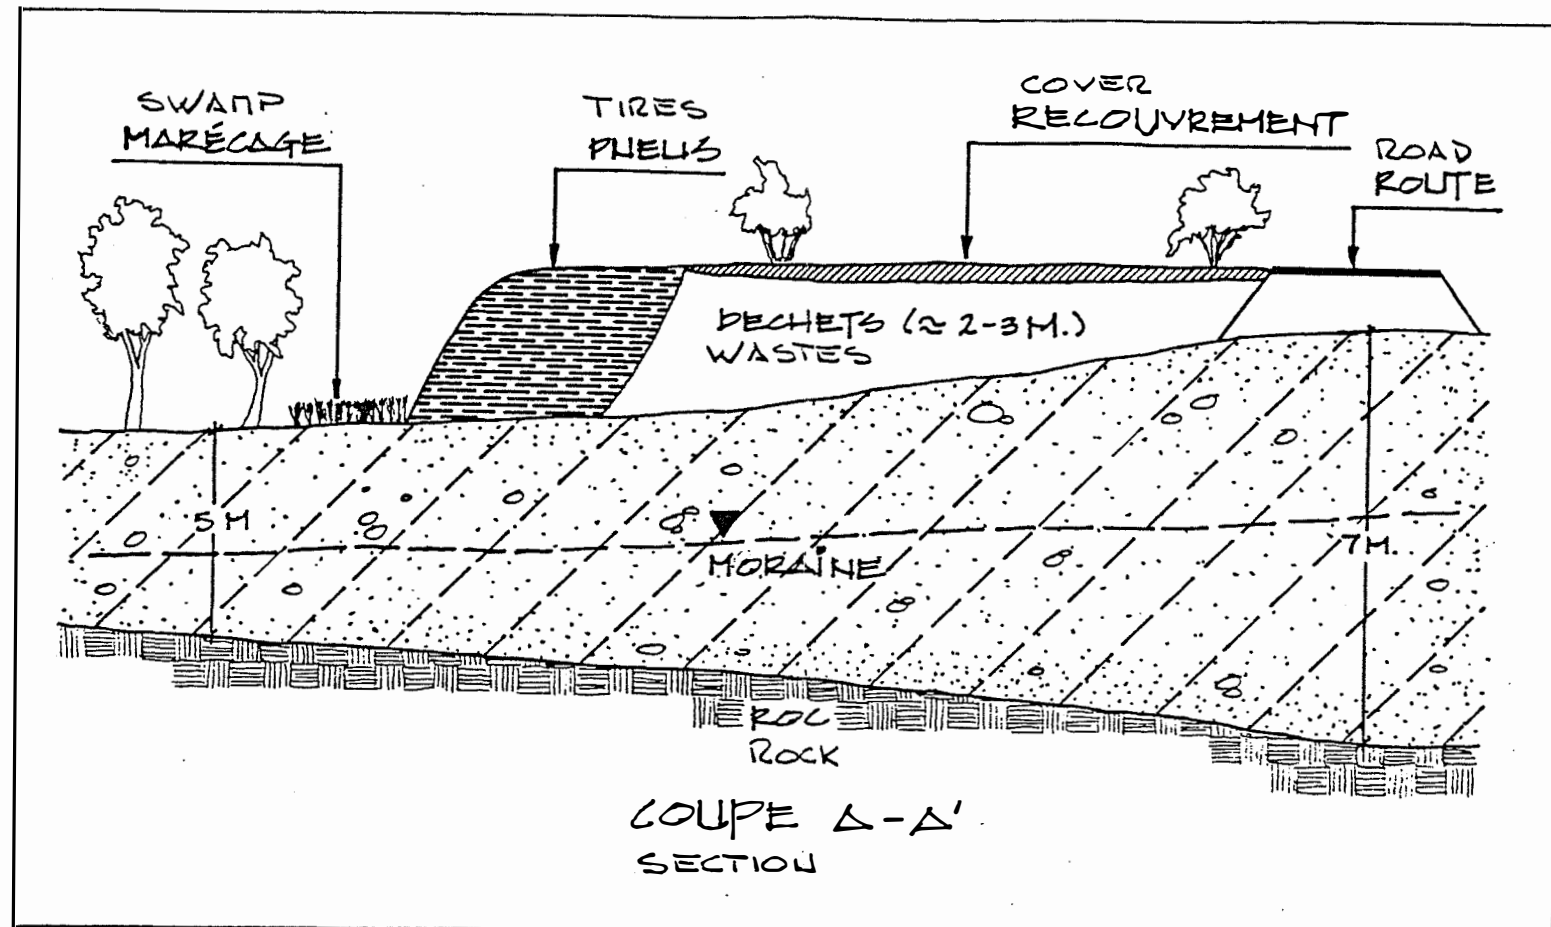
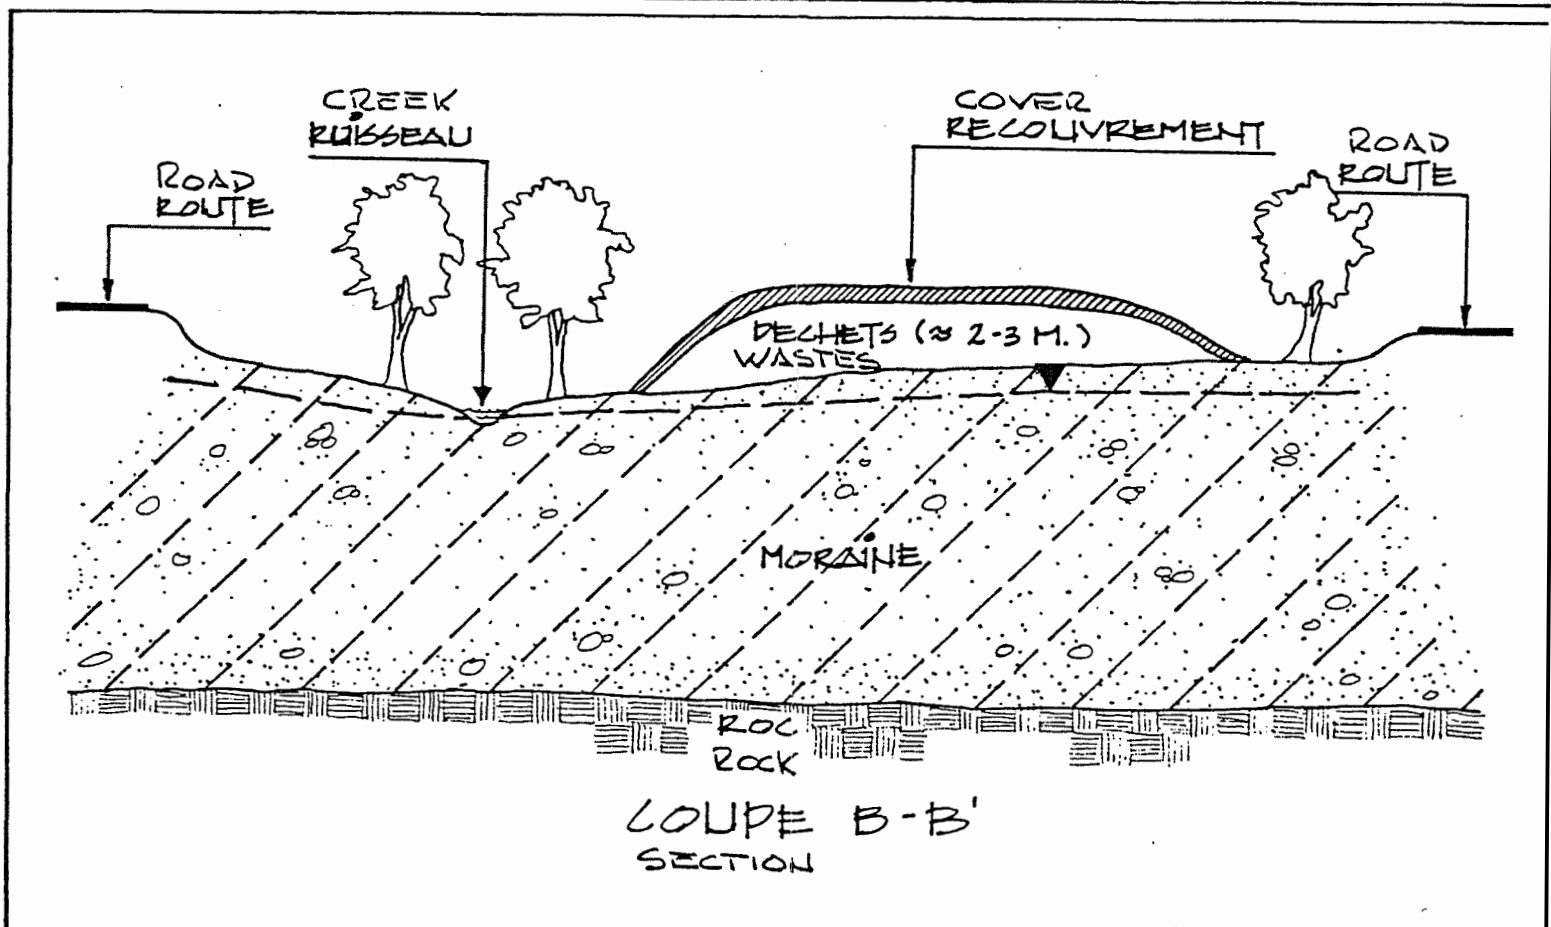
The depth of boreholes varied between 1.68 and 6.68 meters. Boreholes #1, #2A and #2 have reached refusal, probably on the bedrock, at respective depths of 6.68, 1.68 and 5.64 m.

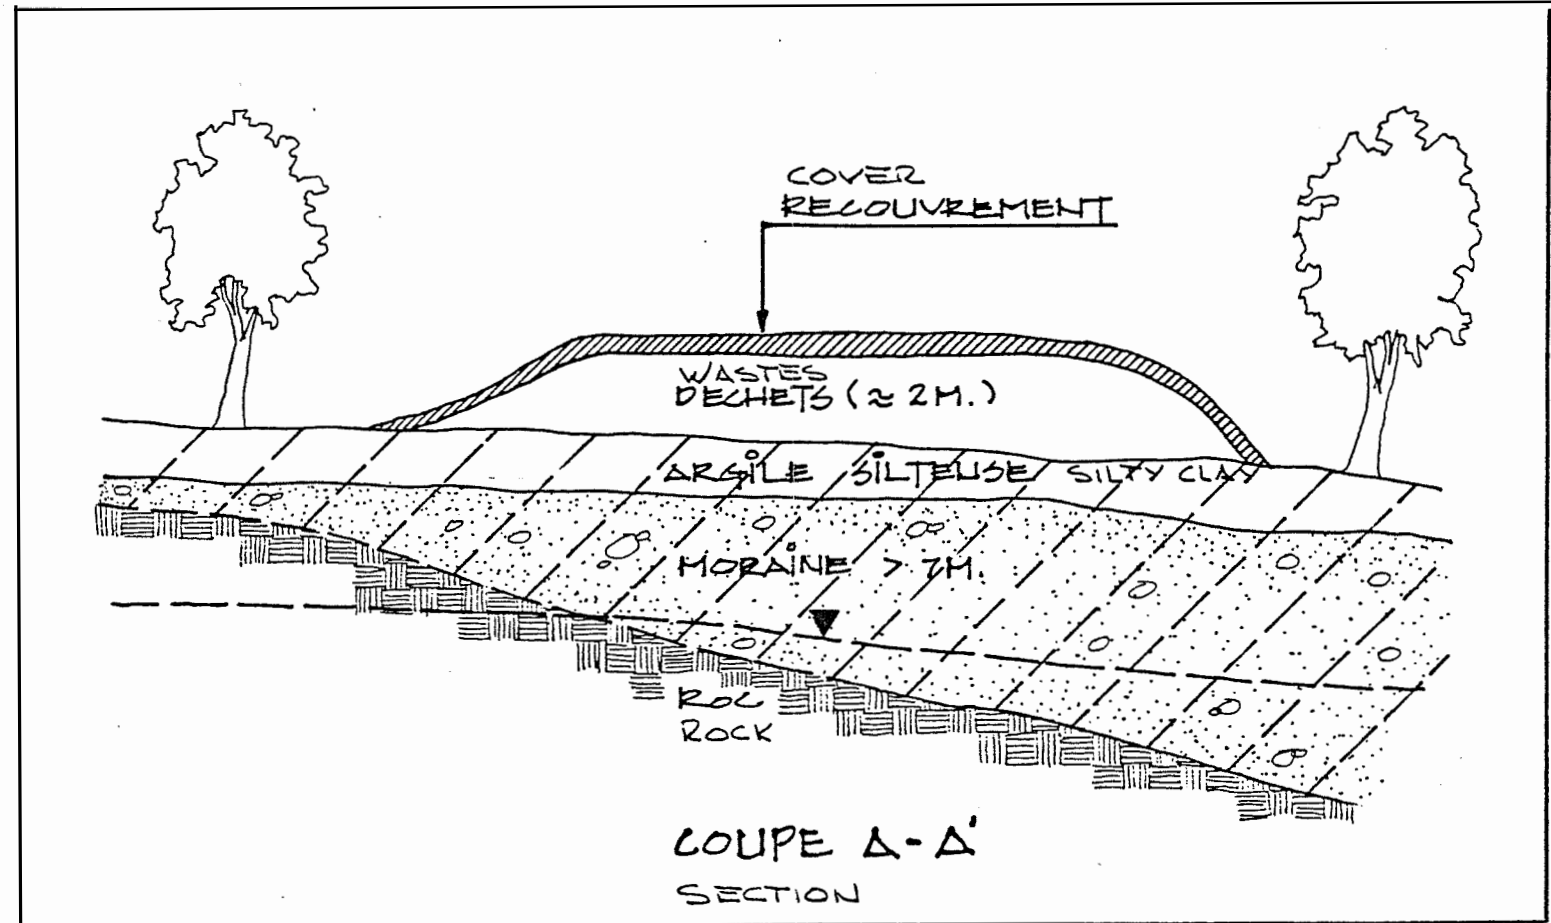
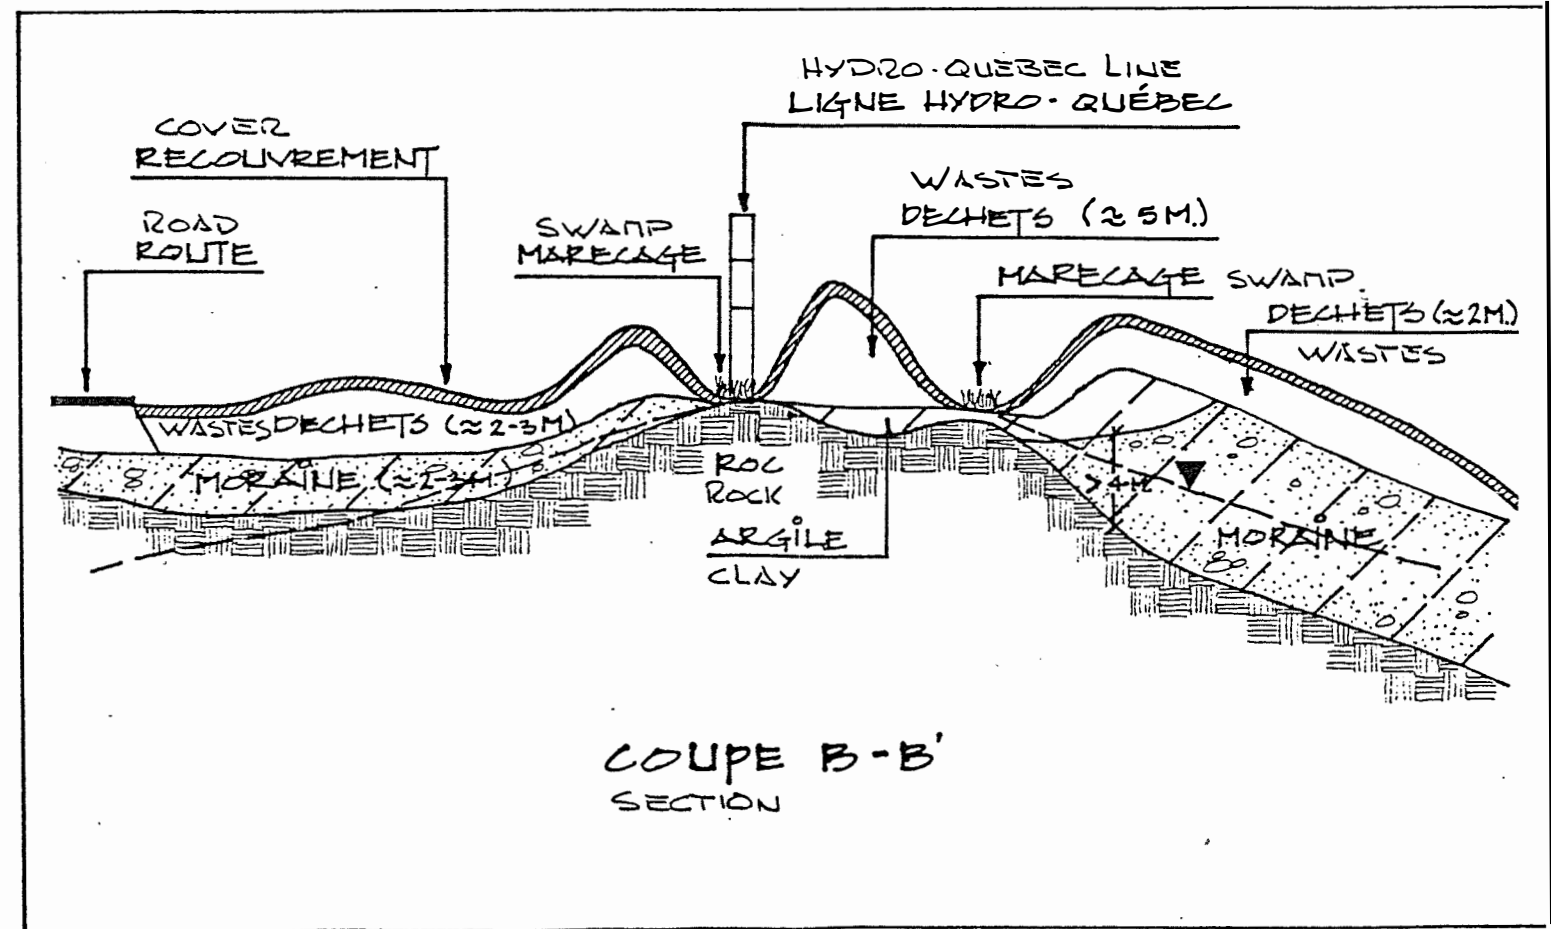
An important active quarry is located a little north from the site, on the other side of Route 132-138. A ditch coming from the top of the quarry crosses underneath the road and borders it in a northern direction up to the end of the site.

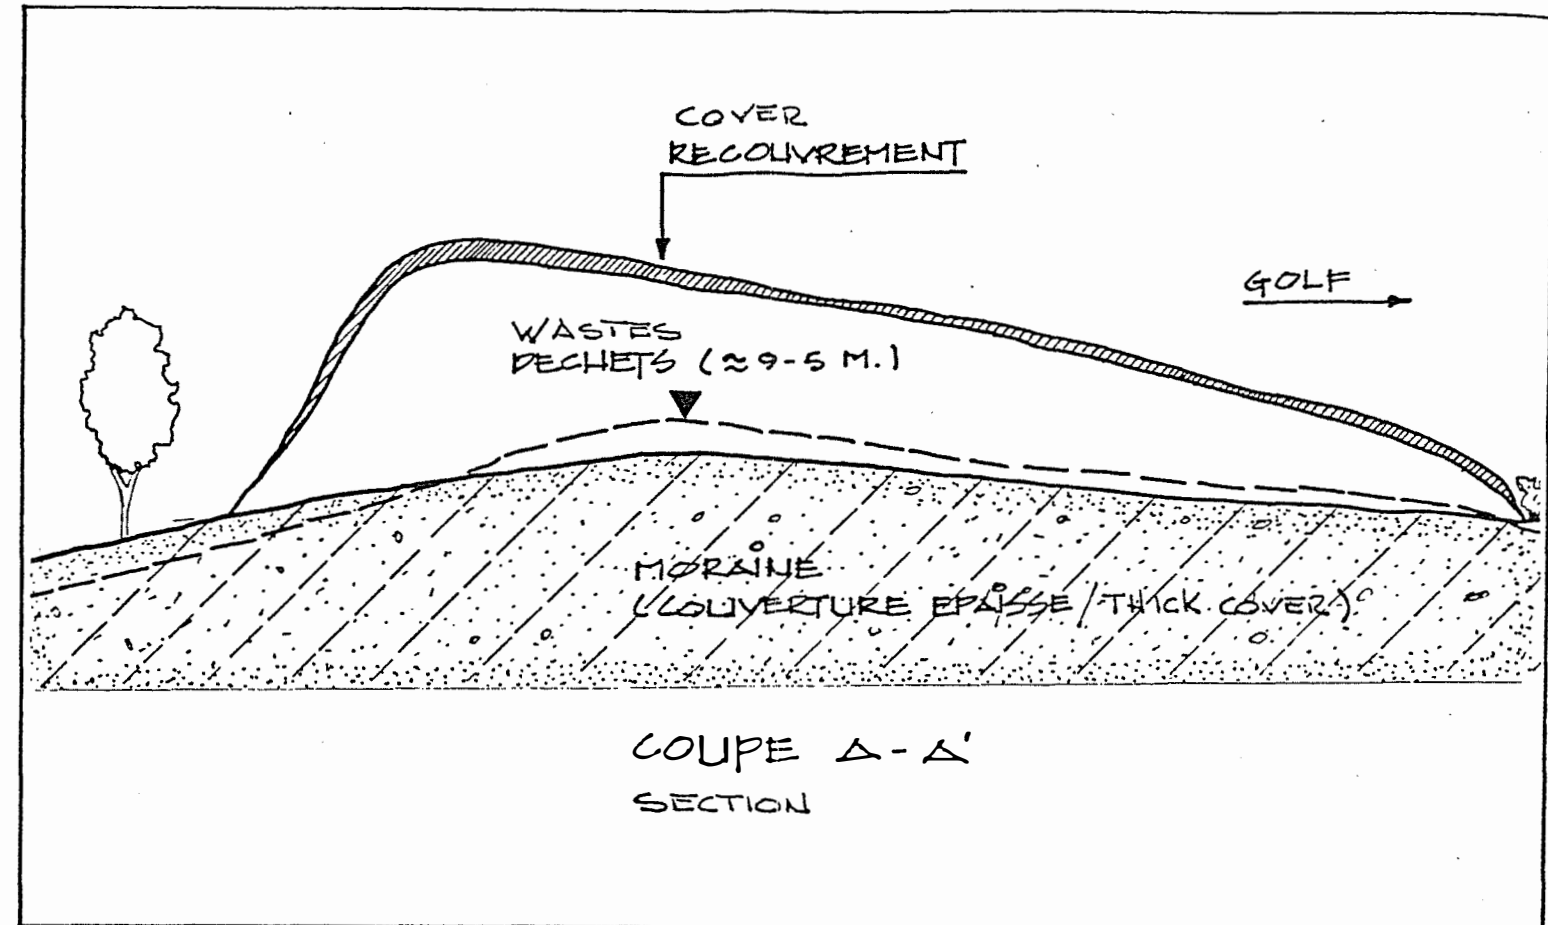
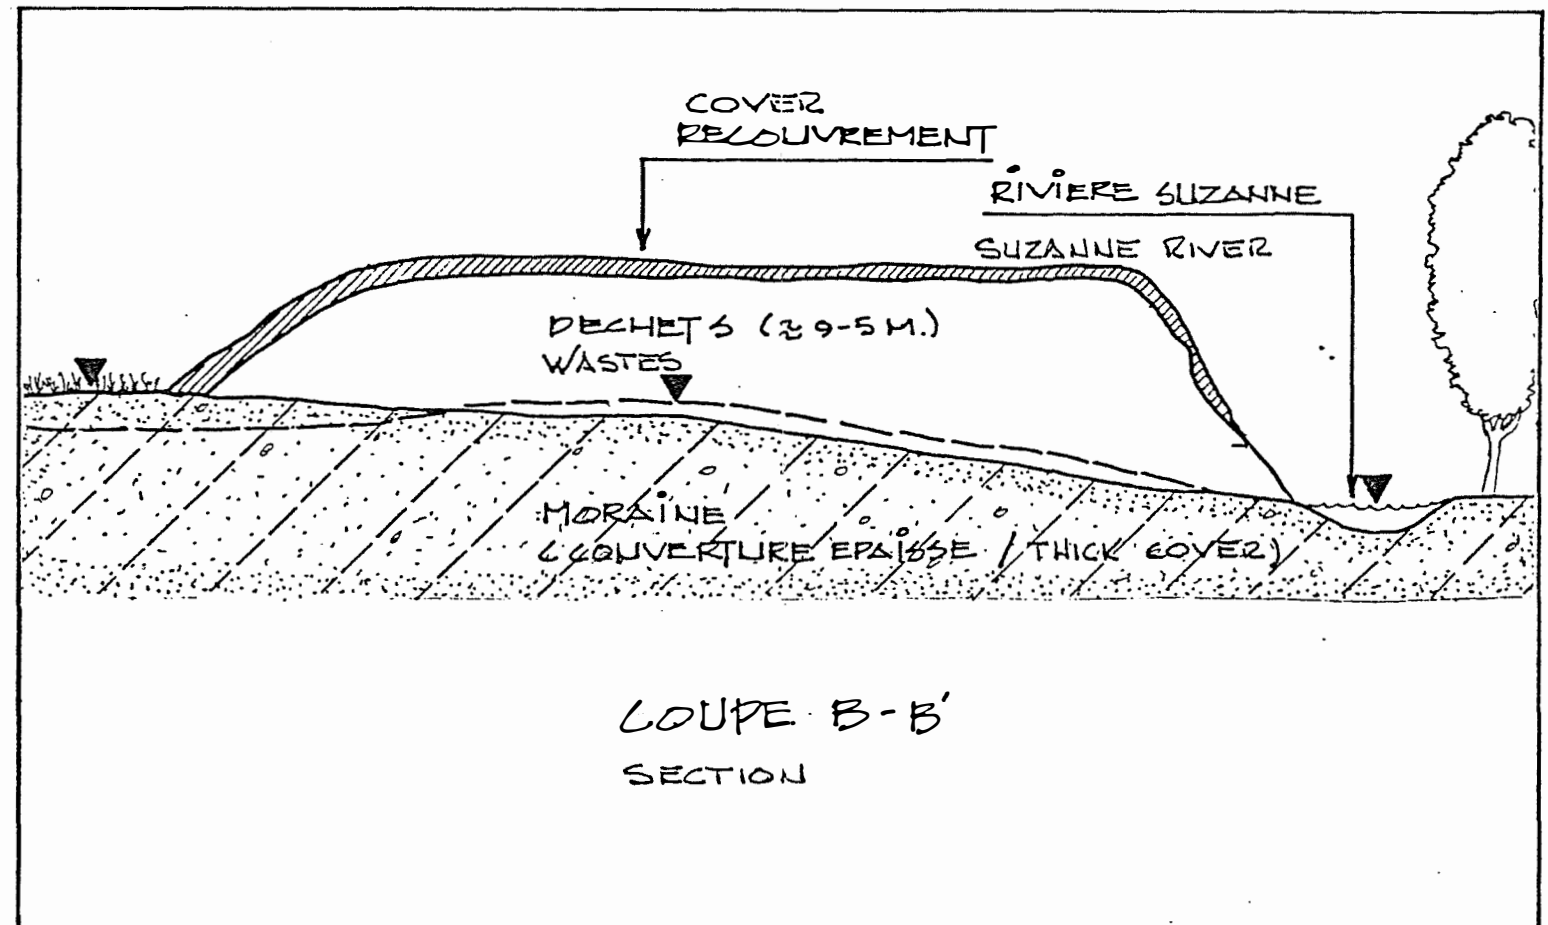
The land located west from the St-Isidore road is at the same level as the latter on a distance of about 400 m. The original ground then gradually slopes downward until a flat and marshy land which is crossed by the Suzanne River.
