RAMEA, NEWFOUNDLAND - FISH PROCESSING PLANT

PRE-DESIGN STUDY

IMPROVEMENTS TO  
SALT WATER SUPPLY SYSTEM

January 19, 1973

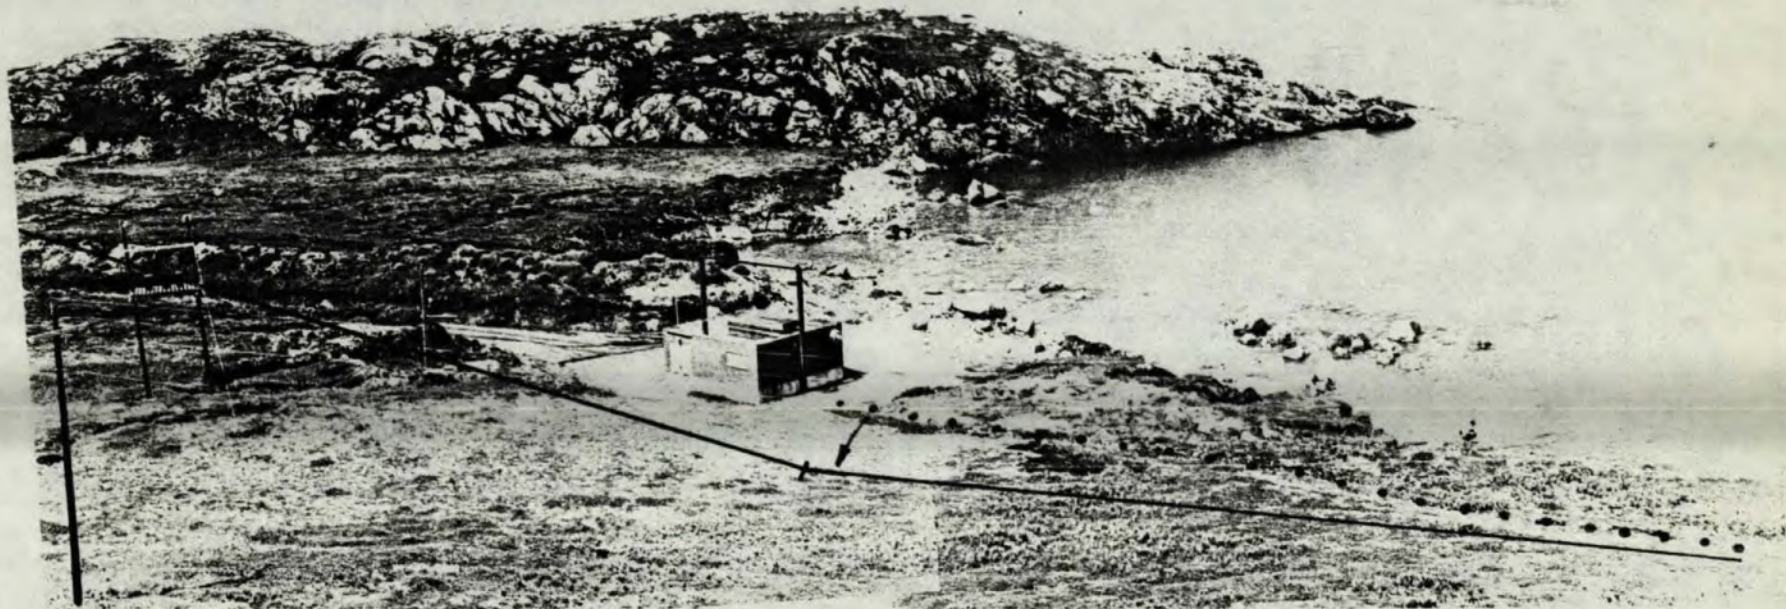
PHOTO NO. 11

A general view of the beach at high tide is shown on Photo No. 11 (opposite text page 37). It was reported by the plant operators that during westerly storms the wave uprush can completely surround the pumphouse with water, and at times flood the pumphouse floor through the door grilles, which can be seen on Photo No. 11.

would be raised to elevation 11.5 ft. The door sills of the pumphouse would be raised to elevation 11.5 ft., which would necessitate a shortening of the doors and moving of the door grilles, but would still provide adequate access into the pumphouse (see Photo No. 11 on opposite text page 37).
