Test Report

Intermediate Bulk Container Life Extension Research

Prepared for: Transport Canada
330 Sparks St.
Ottawa, ON K1A 0N5

Project: A1-019731
Report number: AST-2021-0019

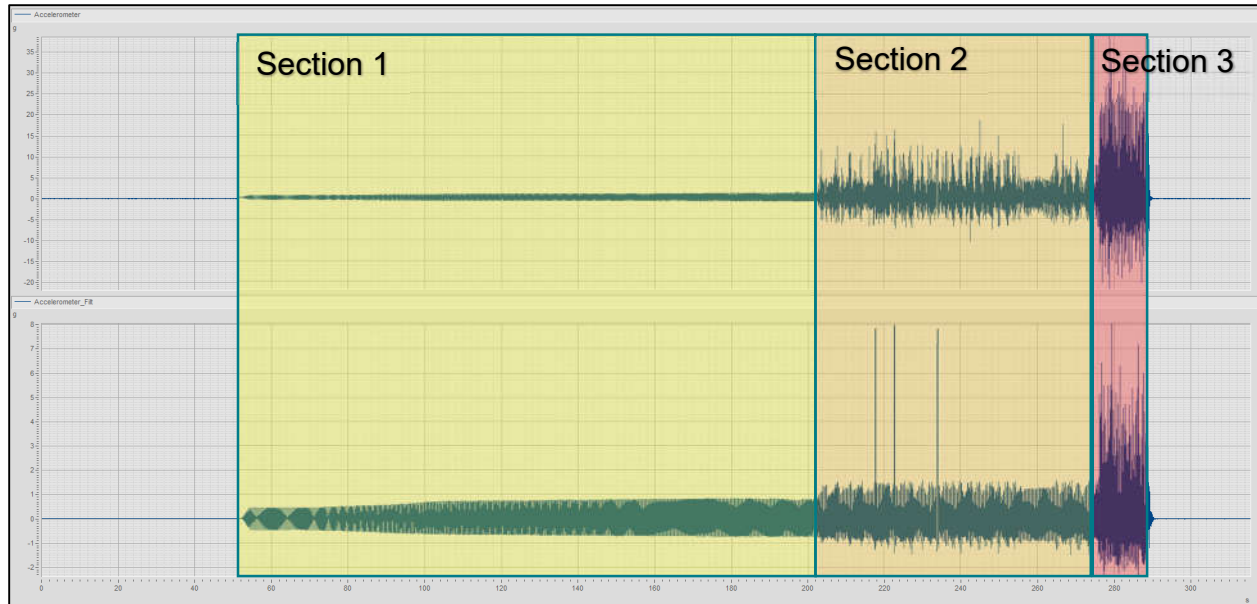
Once an unloading condition had been achieved, the vibration profile continued to be applied for a further 60 min. In reviewing the acceleration data, it was evident that it could be used as an indicator as to when an unloading condition for the IBC had been achieved. For illustrative purposes and without reference to the actual numbers, Figure 5 shows the raw acceleration data (top) and the same data filtered with a low pass filter up to 20 Hz (bottom) collected from a trial run using IBC A7.

There are clearly three distinct sections for the acceleration data. Section 1 is a smooth sine wave that increases in acceleration amplitude as the frequency increases to achieve an acceleration value above 1 g. Section 2 shows acceleration values above 1 g where the IBC is hopping in an erratic fashion. It was not possible to pass the shim under the IBC in a continuous manner, around the IBC perimeter. Section 3 shows a consistent, large amplitude acceleration, at which point the large shim could be easily passed under the full perimeter of the IBC. This was the chosen acceleration amplitude for the test run of 60 min. The acceleration amplitudes recorded are high due to the impacts that occur as the IBC contacts the support plate after lifting off. The same result was observed for the Manufacturer B and Manufacturer C IBCs.

Figure 5: Trial run raw (top) and filtered (bottom) acceleration data
