## Contaminated Aircraft Takeoff Tests for the 1998-99 Winter

**Transportation Development Centre**  
On behalf of  
**Civil Aviation**  
**Transport Canada**

October 1999

Peter Dawson and  
Medhat Hanna

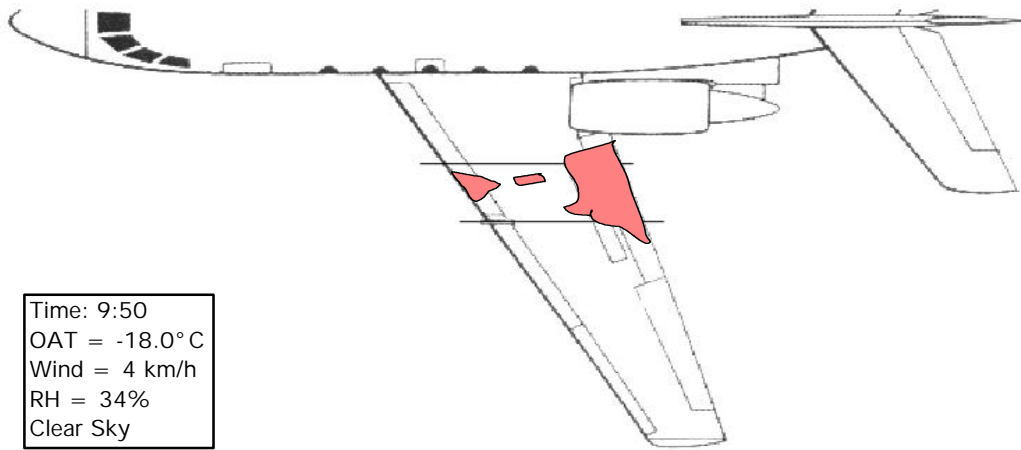
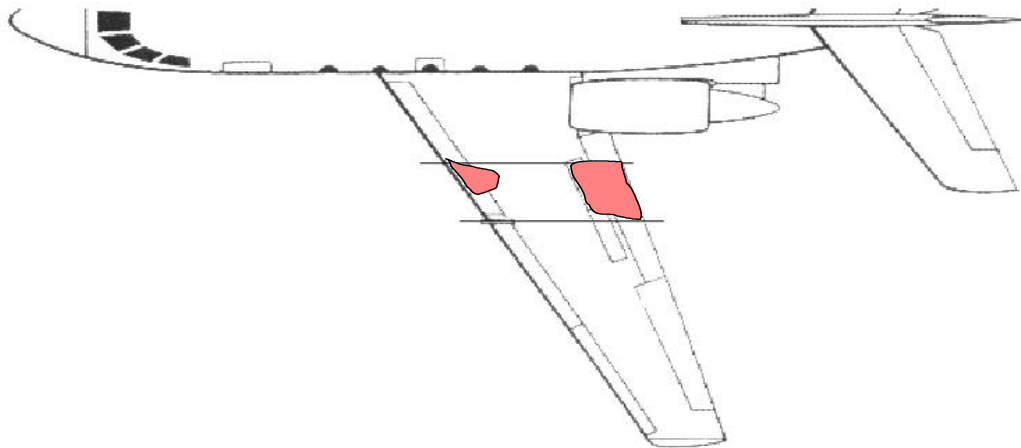
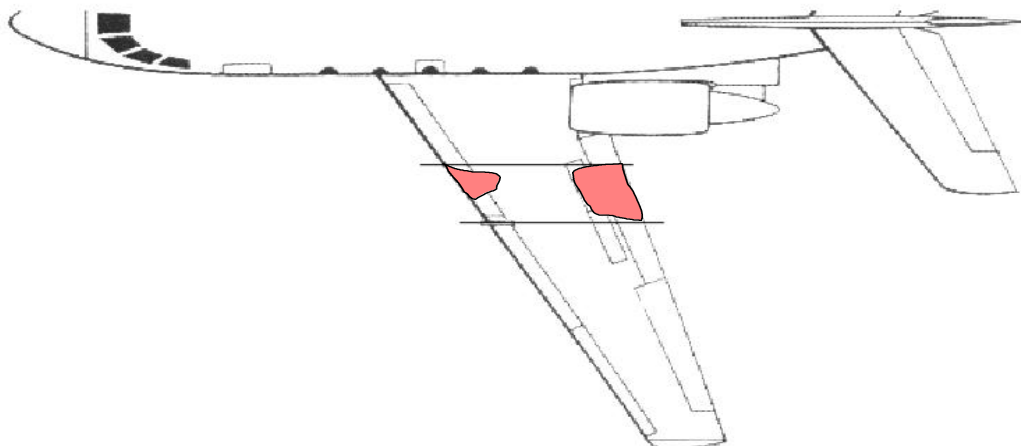
FIGURE 4.2  
**Run 2 - Failure Pattern Before Takeoff Run**  
22-Feb-99

The ground observer noted extensive fluid contamination at the leading edge and on the rear of the wing, covering the spoiler panel and the flap area (Figure 4.2). Photo Set 4.3 shows the appearance of the failed fluid on the flap area. The effect of wing temperature as a result of heat radiation from the sun was apparent in this trial, where the fuselage cast a shadow over only the inner portion of the test area. Wing surface temperature in the shaded area was measured at about  $-11^{\circ}\text{C}$  and in the sunny area was measured to be about  $-5^{\circ}\text{C}$ . The pattern of contamination for the forward part of the wing showed ice formation within the shaded, colder area of the wing surface. Photo Set 4.3 also shows ice formations on the leading edge.

a) Failure Pattern Reported by Ground Observer

b) Failure Pattern Reported by Experienced Cabin Observer

c) Failure Pattern Reported by Pilot

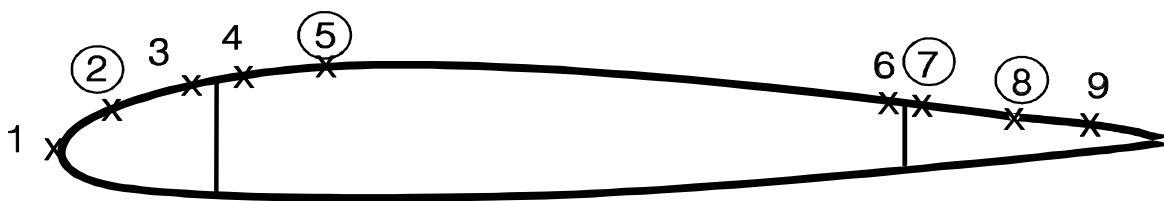
# FIGURE 4.3 FLUID THICKNESS ON AIRCRAFT

See Figure 4.3. Following contamination, the fluid film thickness could not be measured at those locations where ice had formed. This included the whole of the rear of the wing. Where a film of fluid remained, the fluid thickness was reduced by about 40 percent from that measured just after spray application. The incompletely contaminated fluid remaining on the forward part of the wing had thickness values of about 0.6 to 1 mm, as compared to 1 to 2 mm prior to contamination with freezing rain.

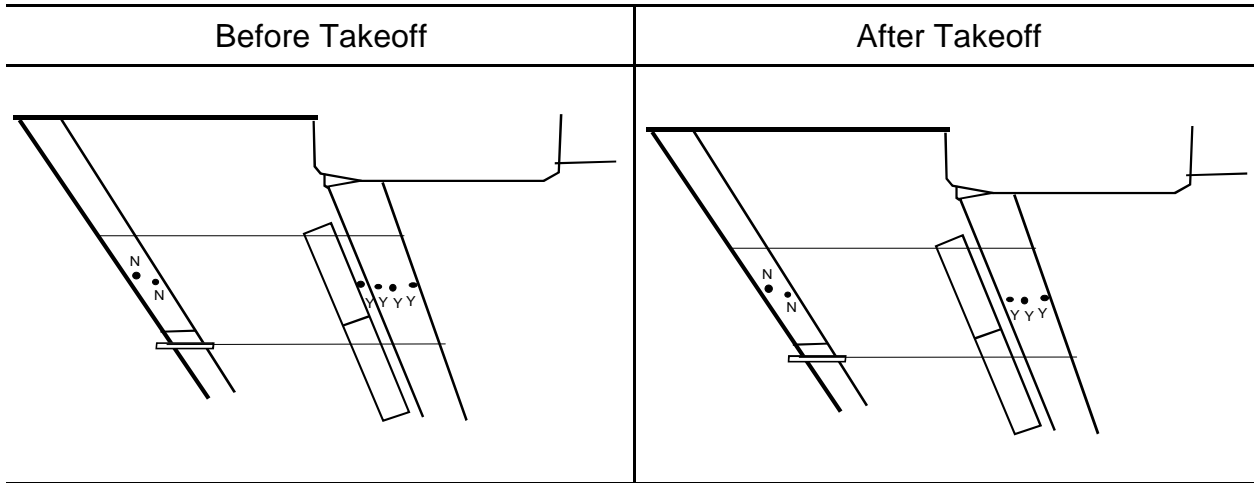
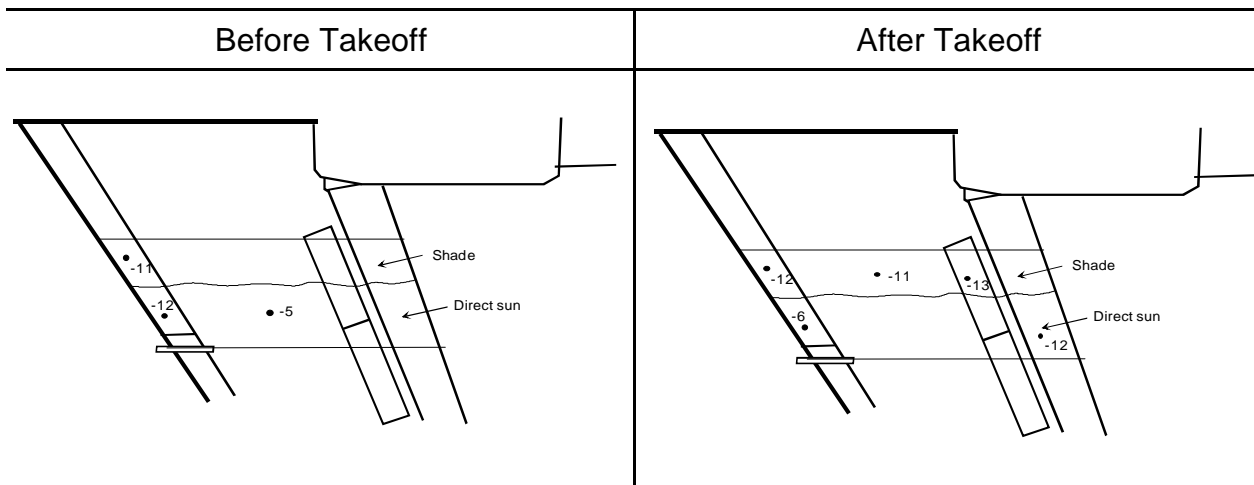
FIGURE 4.5

The ice-covered area was somewhat reduced following the takeoff run; however, it was noted that some of the ice remaining appeared to be thicker than it had been previously. Any fluid that had previously existed at non-iced areas had generally flowed off the wing. See Figure 4.5 and Photo Set 4.4.

**Run 2 - Failure Pattern After Takeoff Run**

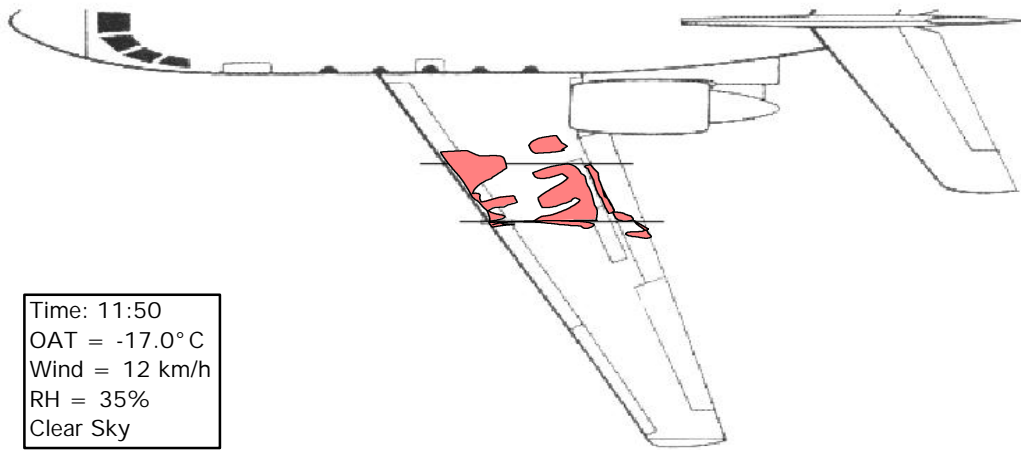
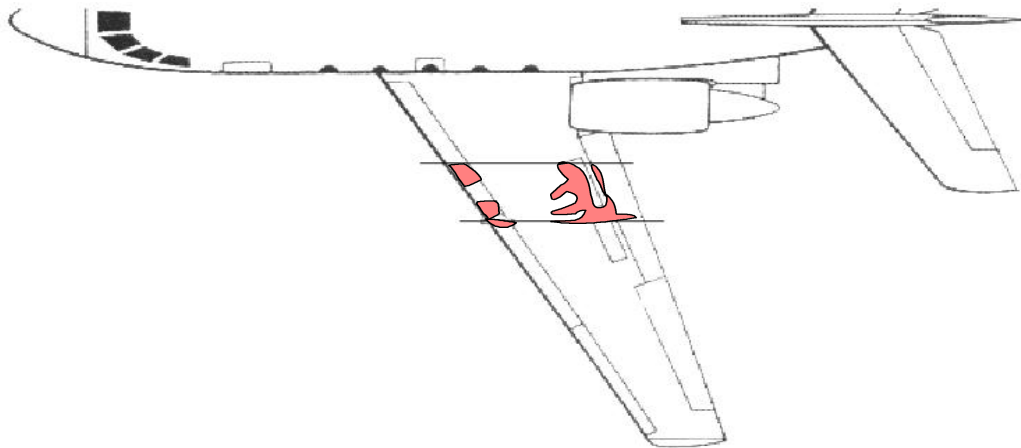
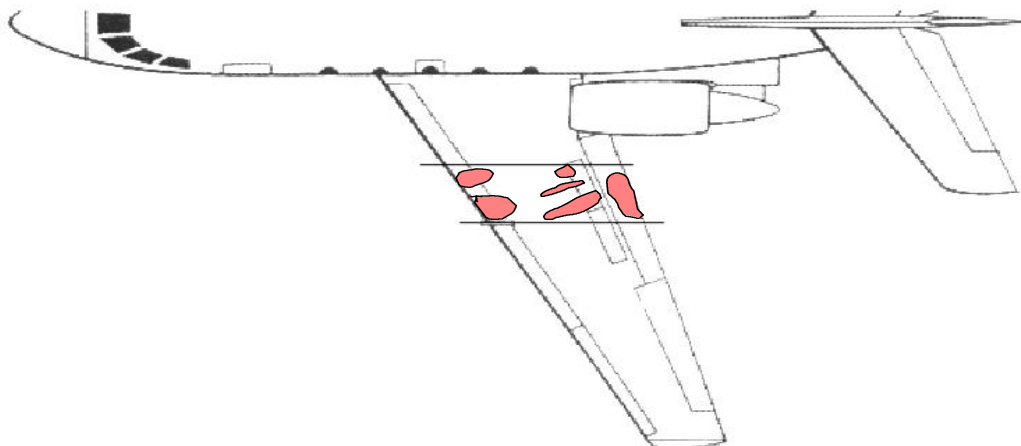
FIGURE 4.6  
**Run 3 - Failure Pattern Before Takeoff Run**  
February 22, 1999

a) Failure Pattern Reported by Ground Observer

b) Failure Pattern Reported by Experienced Cabin Observer

c) Failure Pattern Reported by Pilot

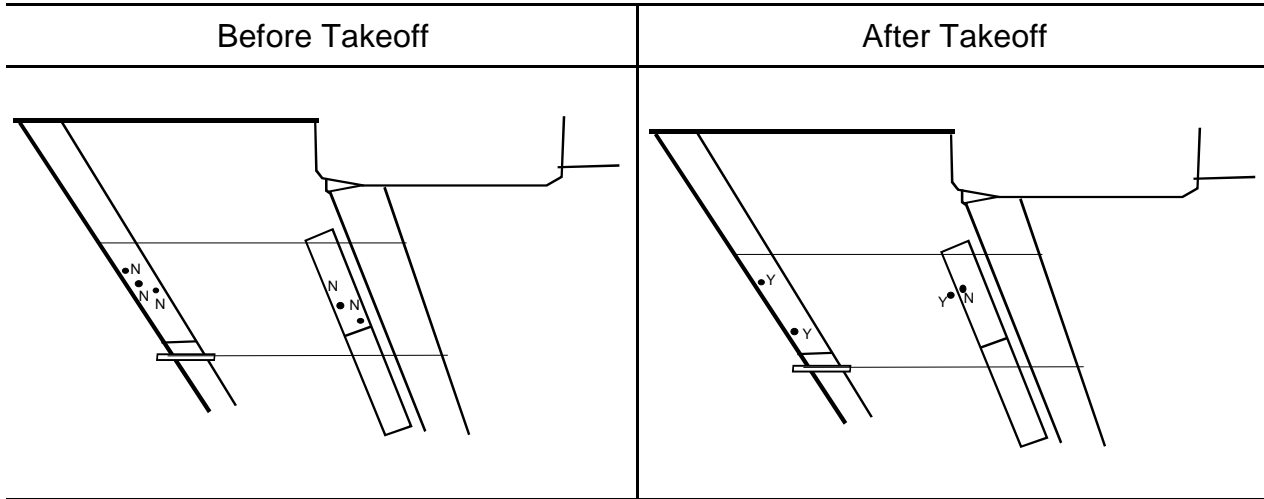
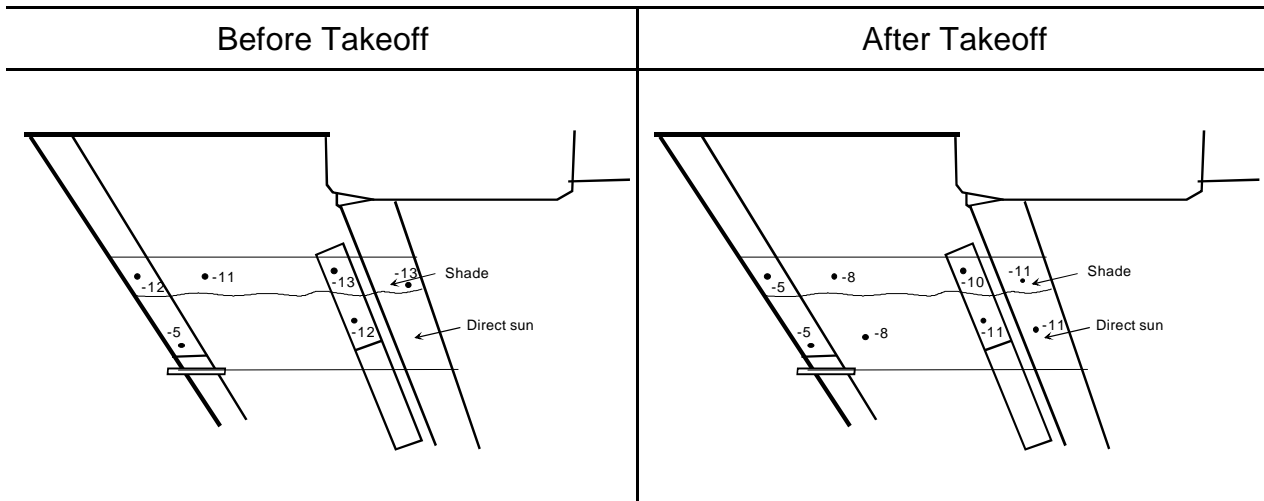
FIGURE 4.9

On return from the takeoff run, the ice-covered area had been reduced in area by about 50 percent (Figure 4.9). Photo Set 4.6 shows the ice formations remaining on the leading edge. The iced area farther back on the wing appeared to have undergone a greater reduction than that at the leading edge. This indicated either that a greater degree of adhesion existed on the leading edge or that the fluid shedding action on the takeoff run partially cleared off the rear wing contamination as the fluid was swept off the wing.

**Run 3 - Failure Pattern After Takeoff Run**

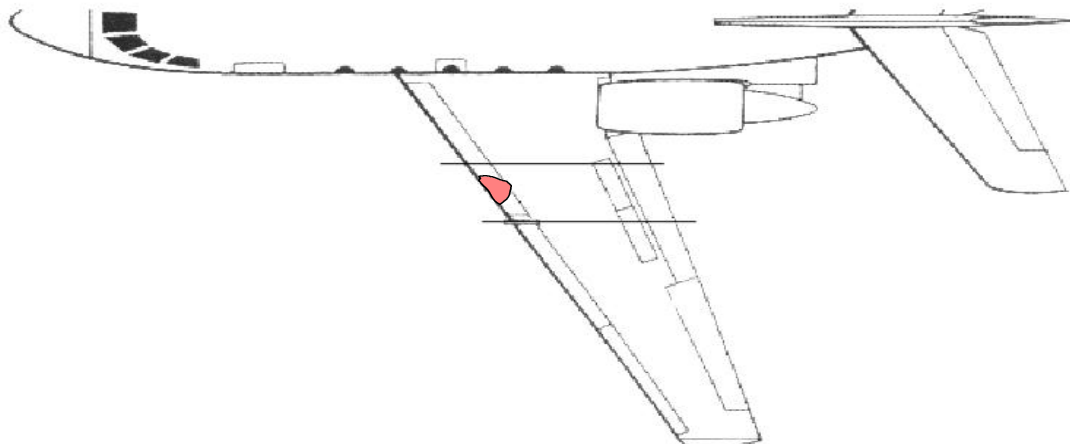
c) Failure Pattern Reported by Pilot

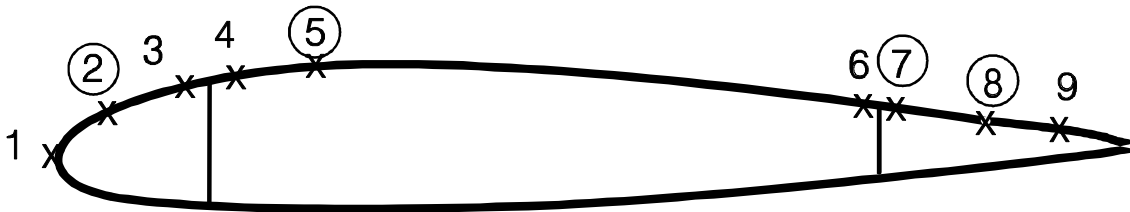
# FIGURE 4.12 FLUID THICKNESS ON AIRCRAFT

See Figure 4.12. The initial fluid application was typical in thickness, and varied from 0.8 to 1.5 mm. Following exposure to contamination, the fluid outside the iced areas took on thickness values of about 50 percent of the uncontaminated levels. It was noted that slush appeared within the fluid layer at some locations. This indicated that the frozen

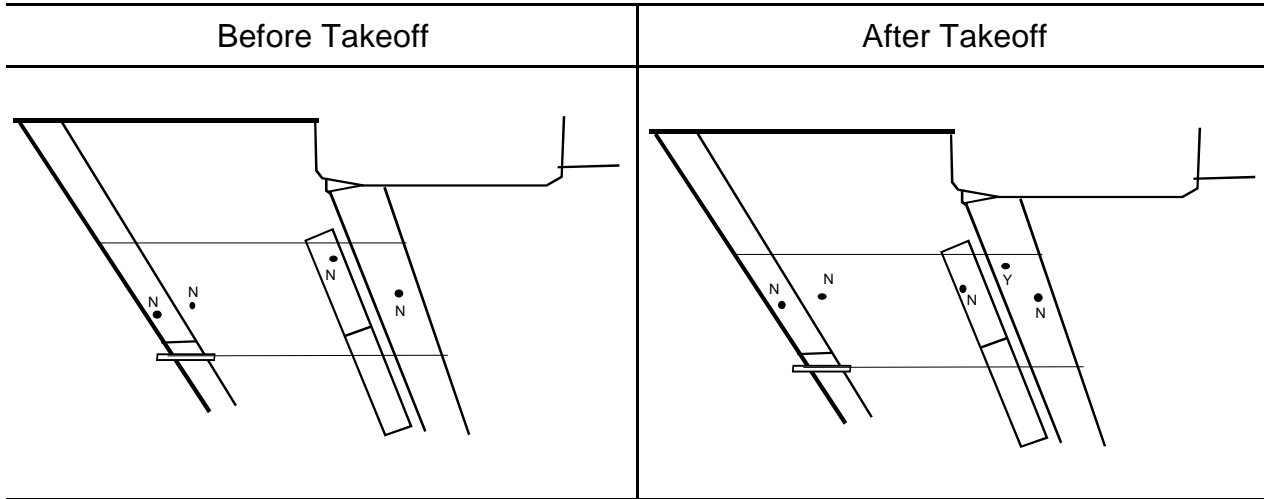
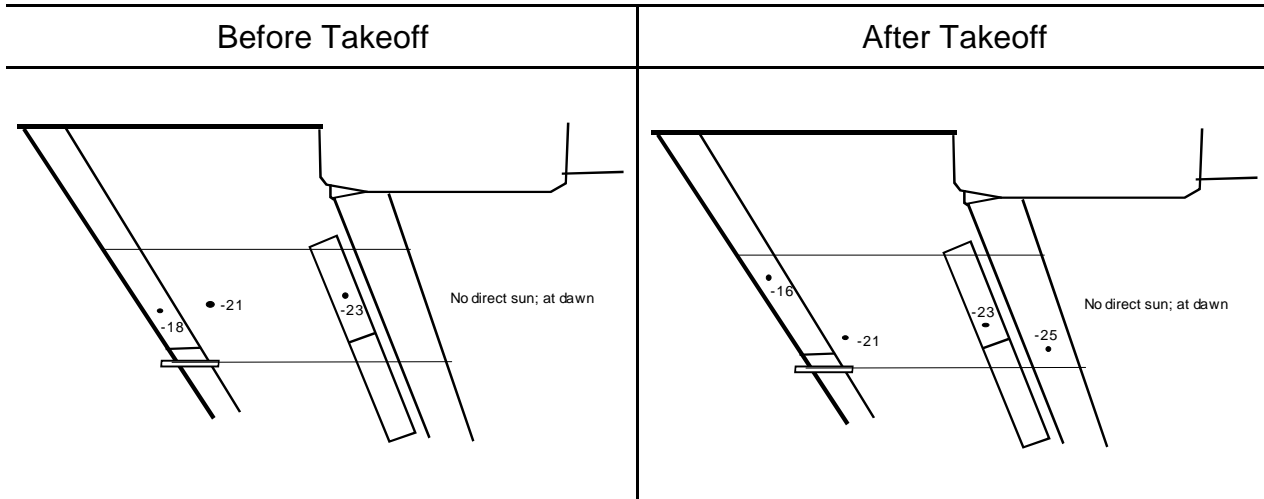
FIGURE 4.14

On return from the takeoff run, the ice-covered area showed little reduction in size (Figure 4.14). Photo Set 4.10 shows ice patches remaining on the forward wing, and ice on the flap surface.

### Run 5 - Failure Pattern After Takeoff Run

Some contaminant adhesion was noted following the takeoff run. In general, the adhesion test instrument experienced more difficulty in carving through iced areas after the takeoff run.

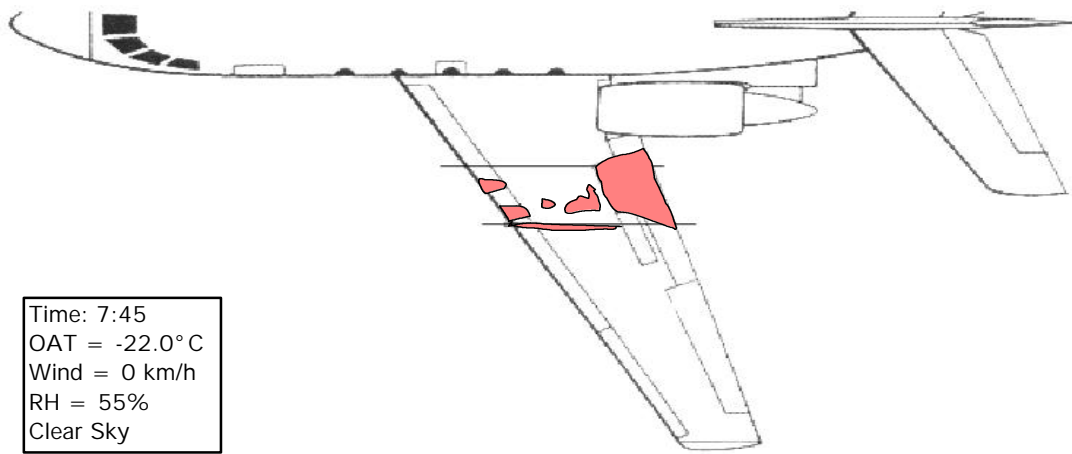
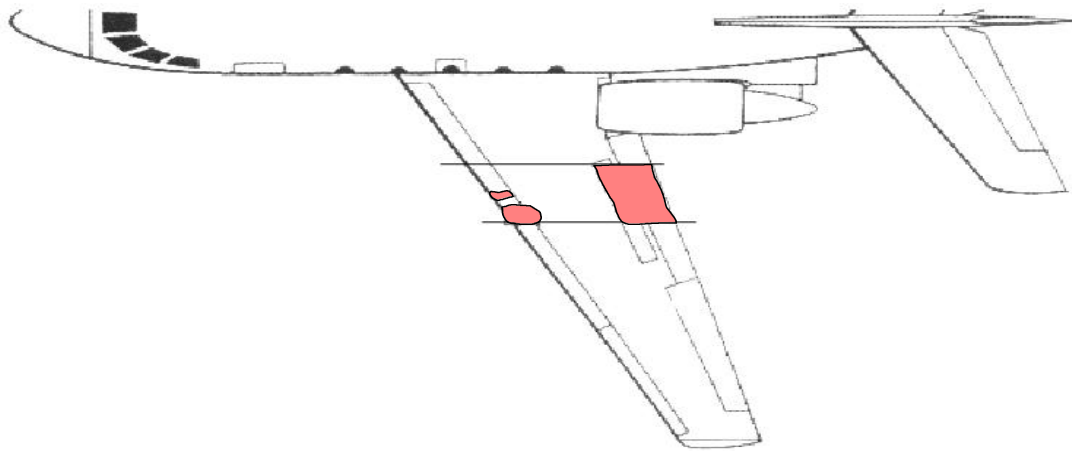
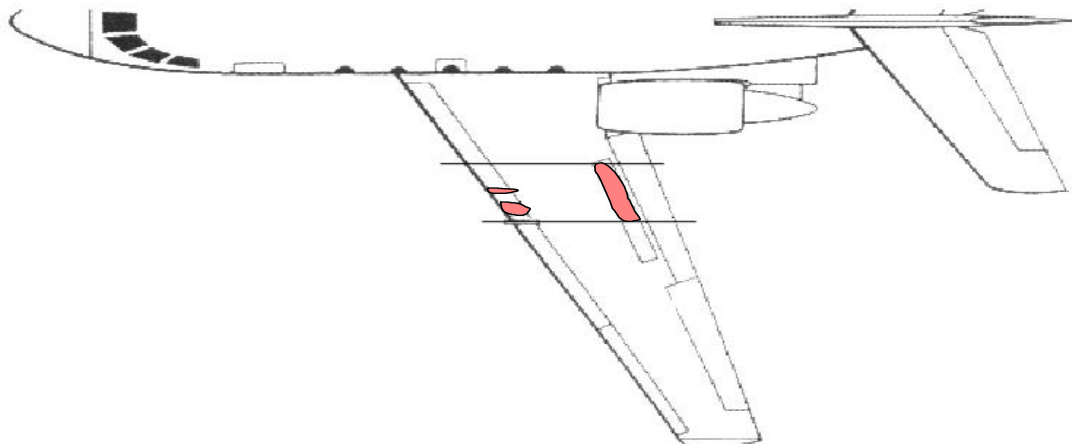
**Run 6 - Failure Pattern Before Takeoff Run**

a) Failure Pattern Reported by Ground Observer

b) Failure Pattern Reported by Experienced Cabin Observer

c) Failure Pattern Reported by Pilot

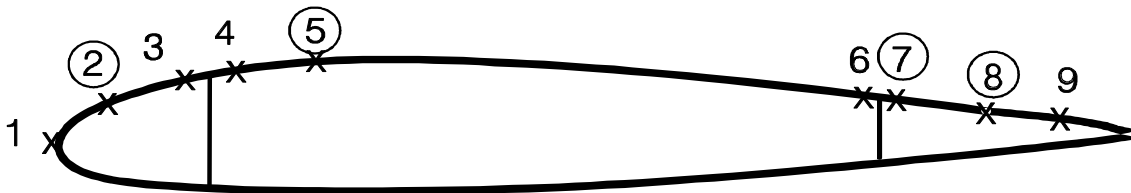
FIGURE 4.16  
**FLUID THICKNESS ON AIRCRAFT**

The initial fluid application was of typical thickness, with a slightly heavier application on the top of the main wing where the fluid layer took on a thickness value of nearly 3.0 mm. See Figure 4.16. Following contamination, any fluid existing outside of the iced areas exhibited

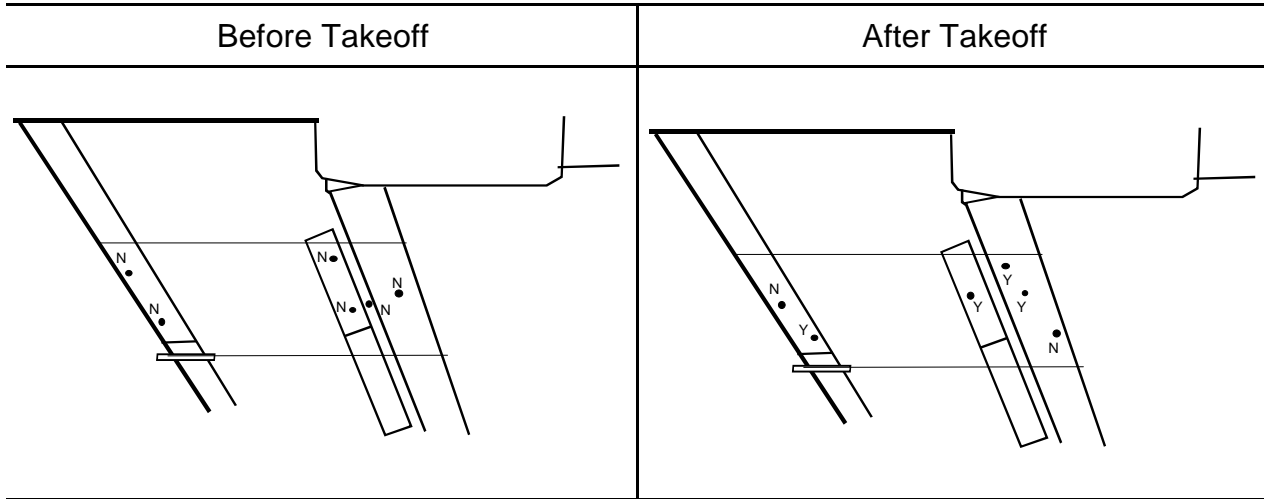
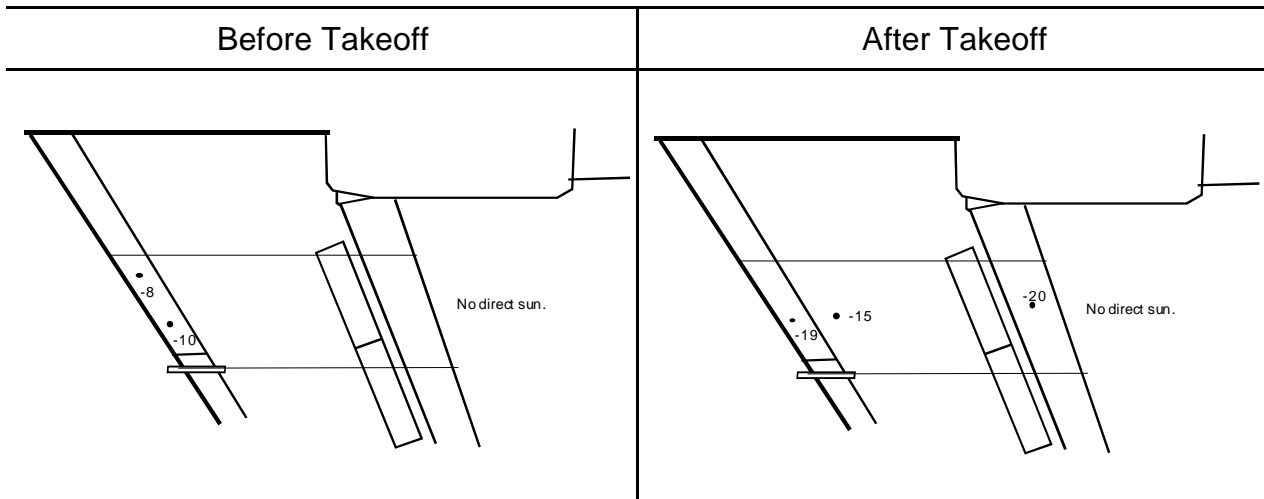
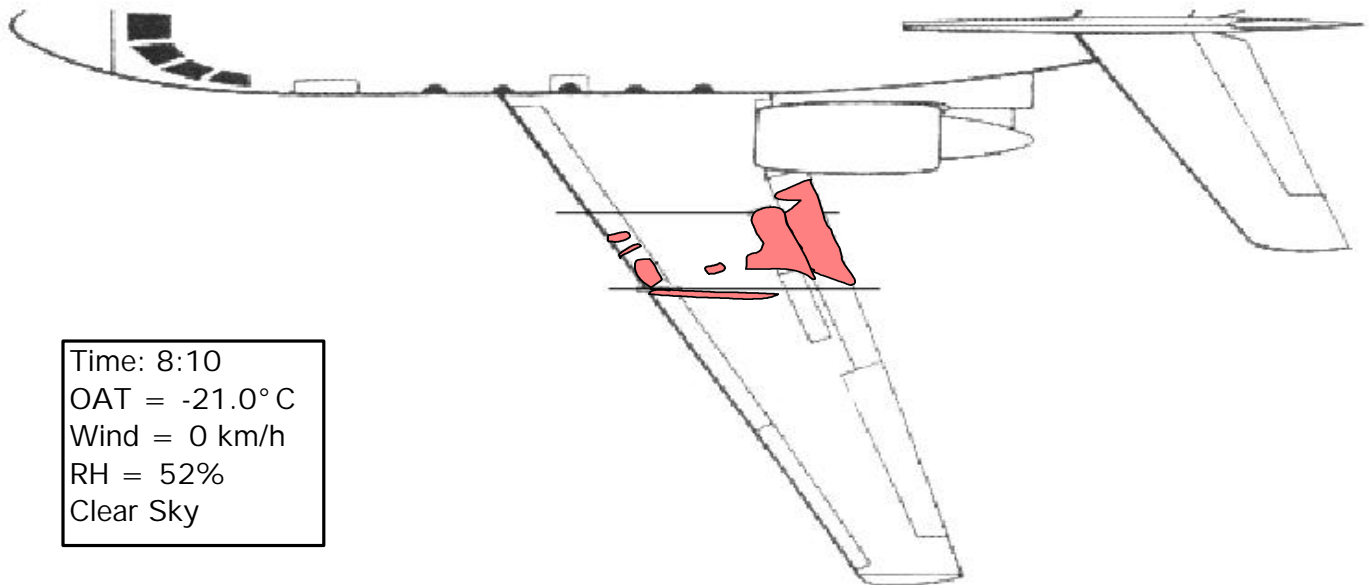
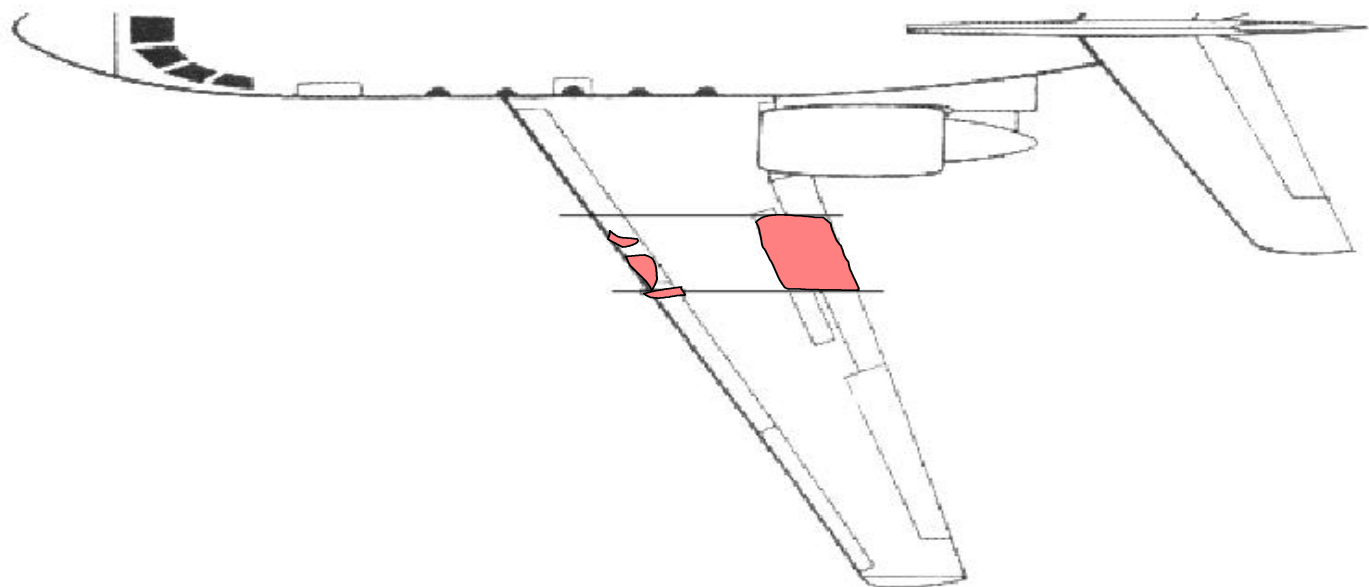
FIGURE 4.18

On return from the takeoff run, the ice-covered area at the rear of the wing showed little reduction in size (Figure 4.18 and Photo Set 4.12). The ice patches on the leading edge appeared to have grown in a lateral direction.

An increased level of adhesion was noted following the takeoff run.

**Run 6 - Failure Pattern After Takeoff Run**

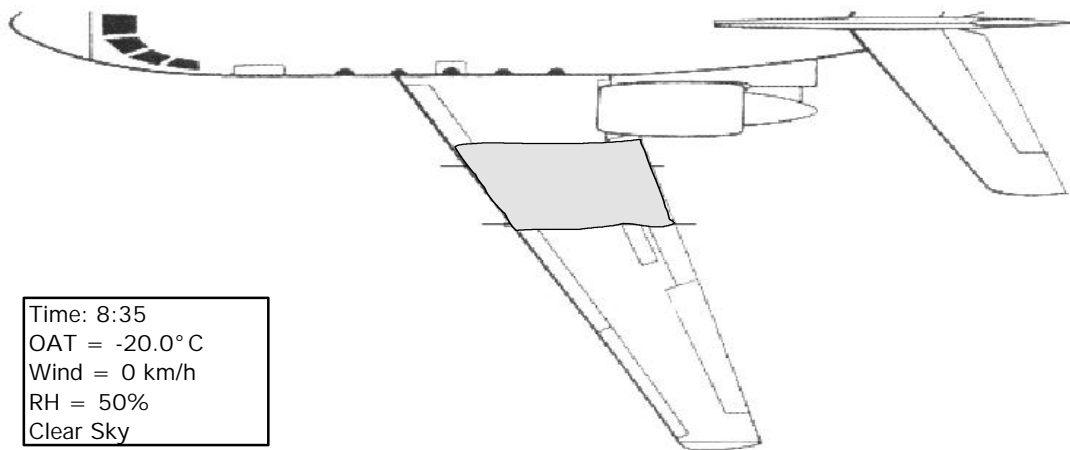
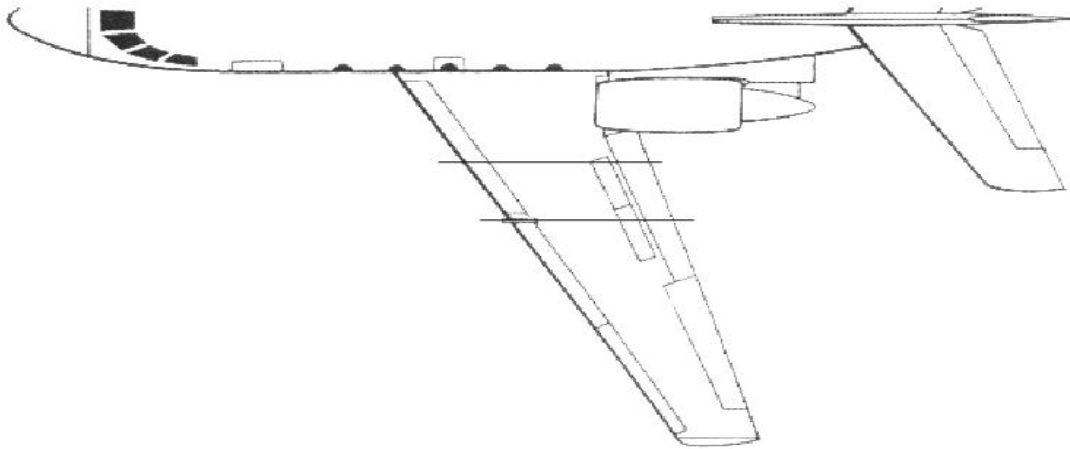
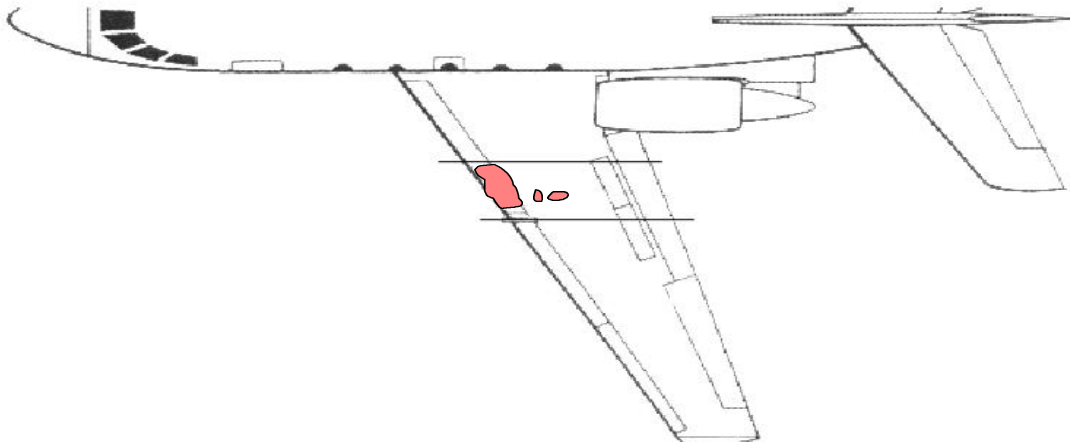
FIGURE 4.19  
**Run 7 - Failure Pattern Before Takeoff Run**  
 February 23, 1999

This trial was initially intended to result in an iced area of 5 percent of the test area. The artificial freezing rain application resulted in a thin layer of fused ice over the fluid layer. This ice layer covered the entire test area. See Figure 4.19 and Photo 4.13. The resultant level of contamination was identified as 100 percent.

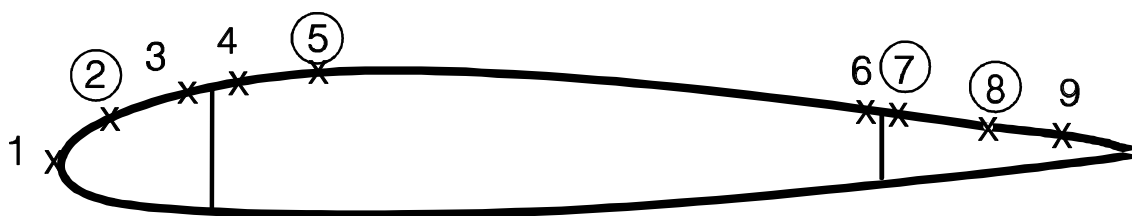
# FIGURE 4.20 FLUID THICKNESS ON AIRCRAFT

See Figure 4.20. The initial fluid application was very similar to Run 4. Following contamination, the fluid still retained a thickness of 75 to 80 percent of stabilized thickness of the same uncontaminated fluid.

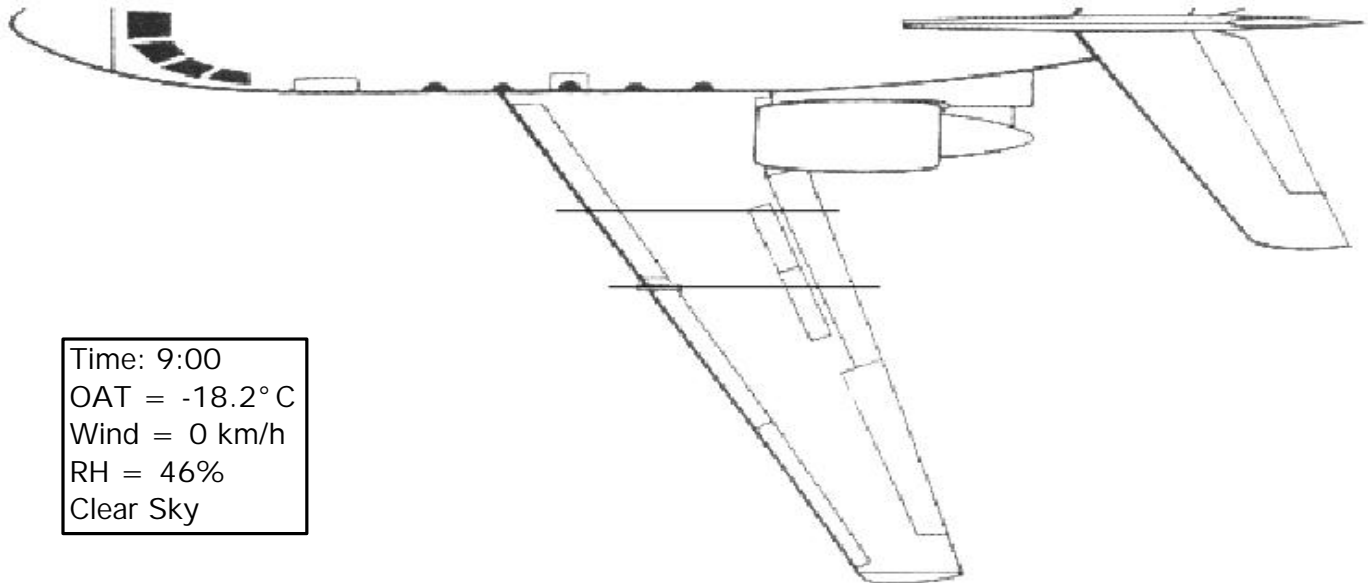
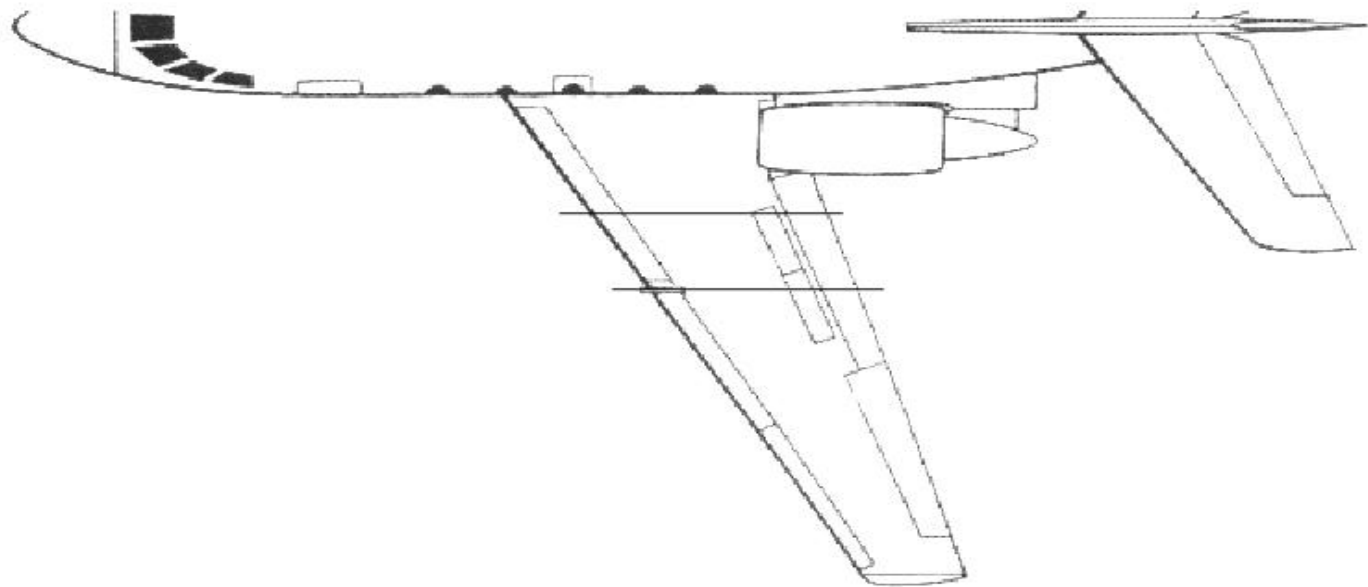
**Run 7 - Failure Pattern After Takeoff Run**

On return from the takeoff run, it was observed that the entire fluid layer had been eliminated from the wing (Figure 4.22). The results are similar to those of Run 4, which also employed the propylene glycol-based fluid, but with no contamination. No solids remained, and any fluid that remained on the wing took on the appearance of lateral ridges running perpendicular to the wing chord. Photo 4.14 shows the clean wing following the takeoff run.

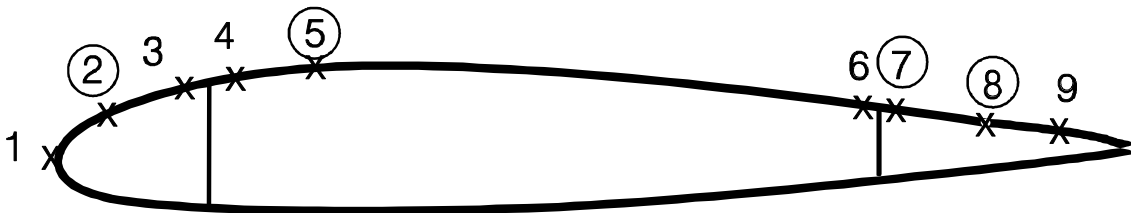
FIGURE 4.24  
**FLUID THICKNESS ON AIRCRAFT**

The initial fluid application was of typical thickness and appearance. See Figure 4.24. Following contamination, the fluid layer over the forward part of the wing exhibited thickness values equivalent to about 50 percent of the uncontaminated fluid. On the rear of the wing, the fluid thickness was closer to initial values except at the trailing edge of the flap, where the thickness was reduced to about 50 percent of its initial measured value.

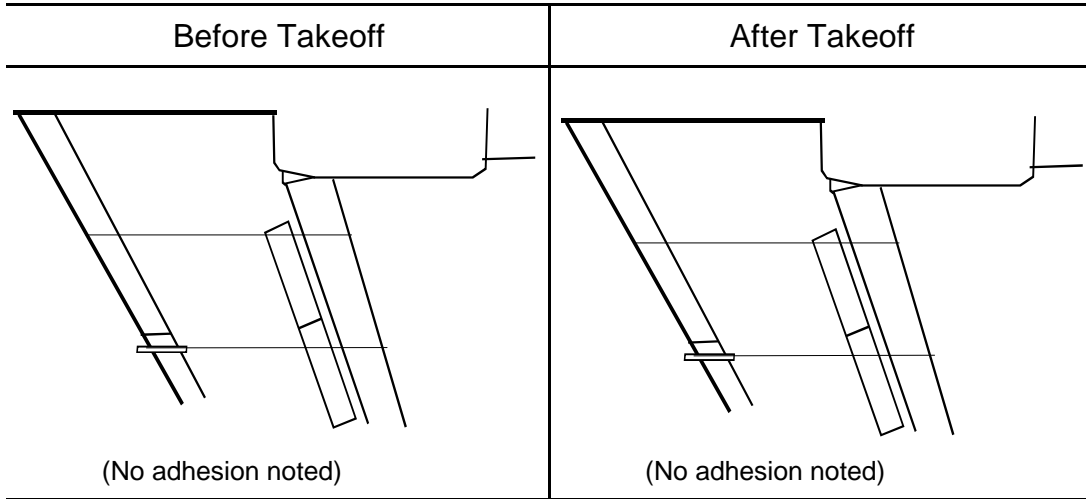
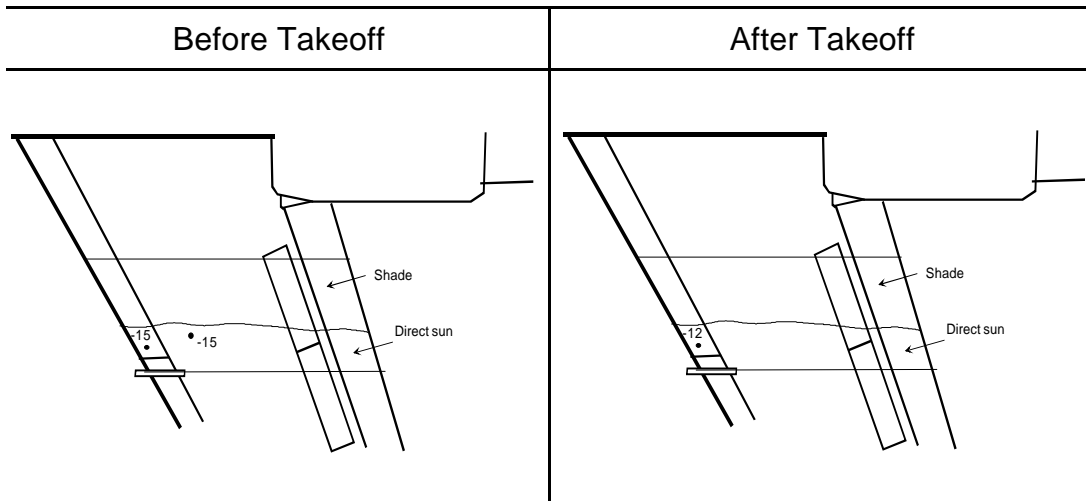
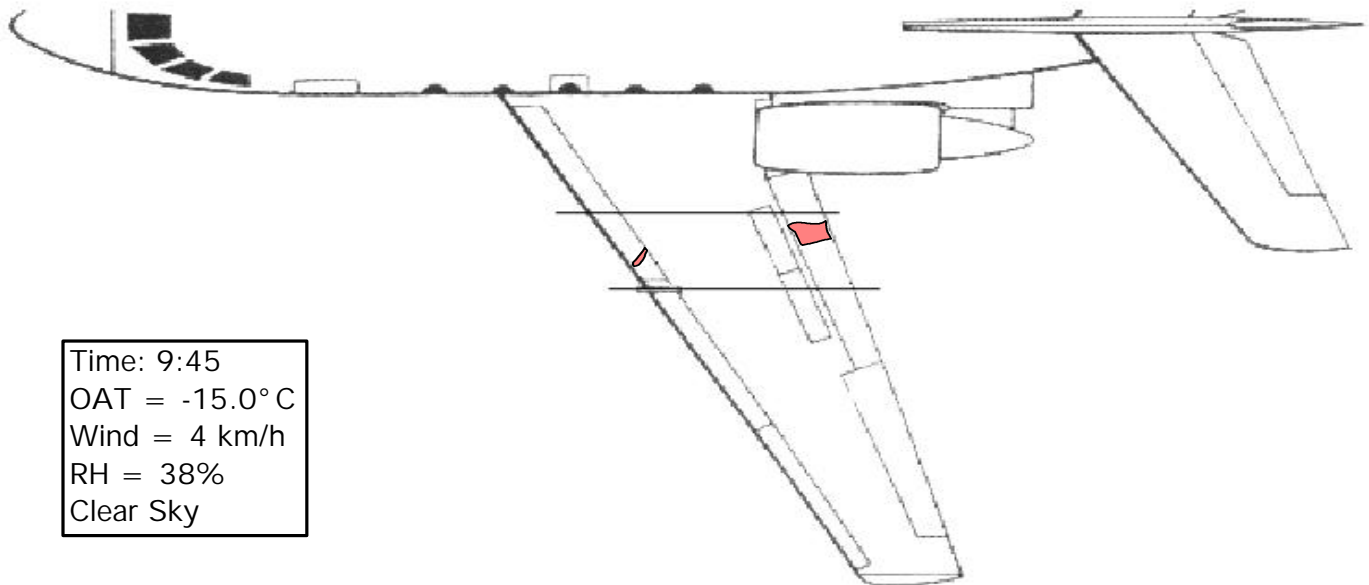
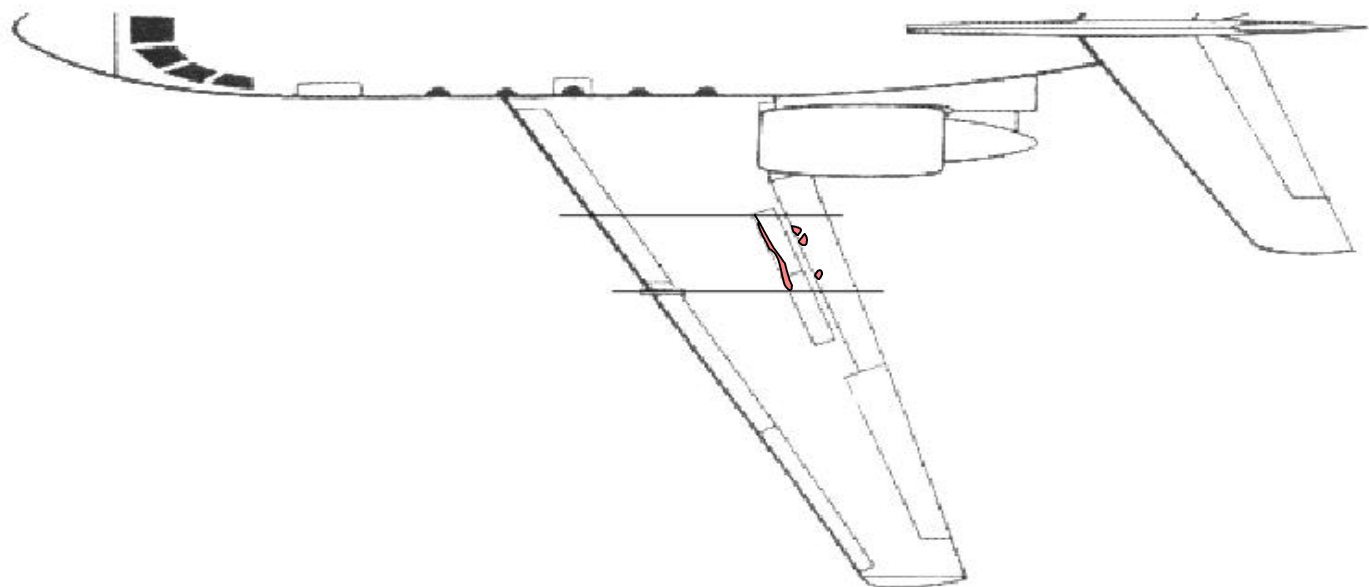
FIGURE 4.26

On return from the takeoff run, the ice on the spoiler panel had disappeared, but the ice patch on the flap remained (Figure 4.26 and Photo 4.16). The ice patch at the seam in the leading edge was somewhat reduced in size but was still visible.

### Run 8 - Failure Pattern After Takeoff Run

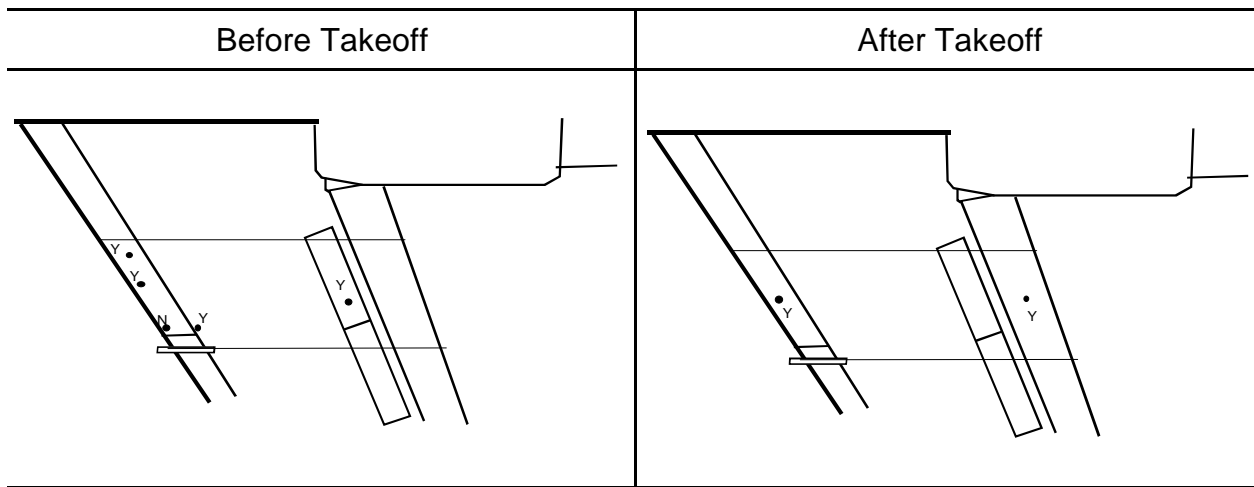
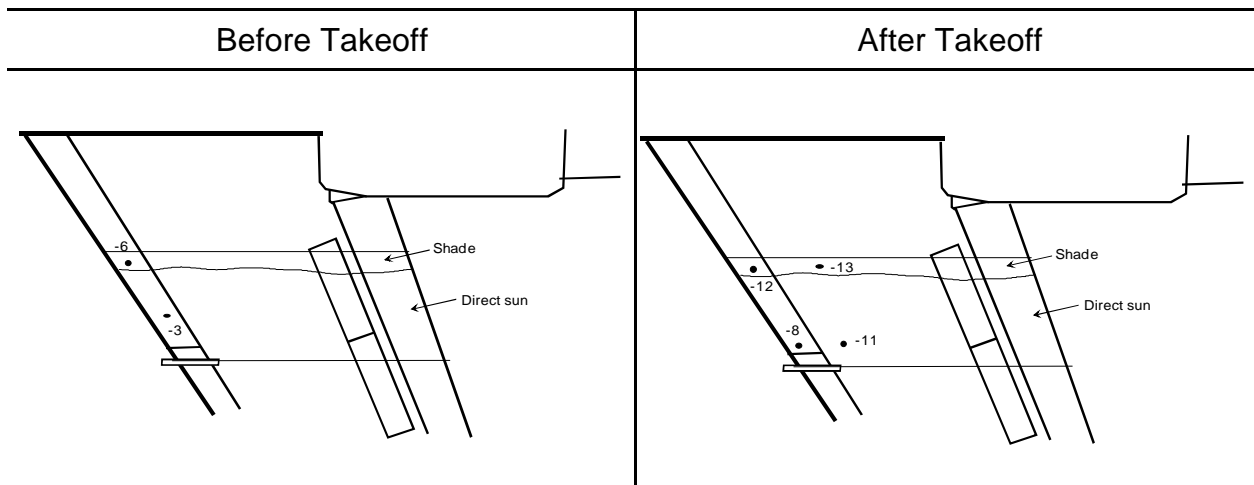
FIGURE 4.30

On return from the takeoff run, it was observed that those areas where, prior to takeoff, a light layer of ice had formed on the fluid surface were now clean of ice *and* of fluid. Areas where ice of substantial thickness had formed prior to the takeoff run remained ice-covered after the aircraft returned to the inspection pad. See Figure 4.30 and Photo 4.18.

**Run 9 - Failure Pattern After Takeoff Run**

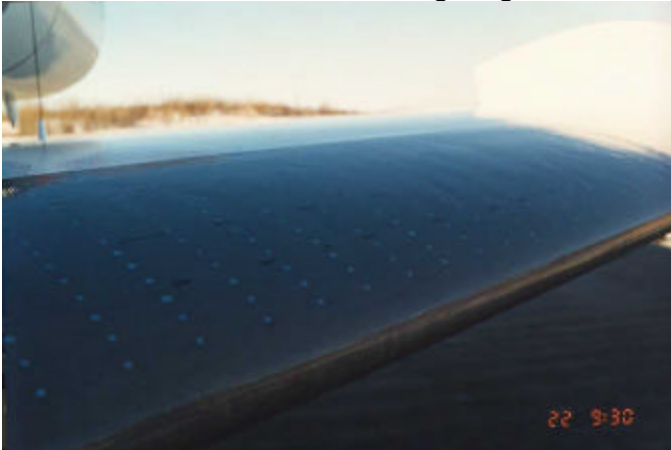
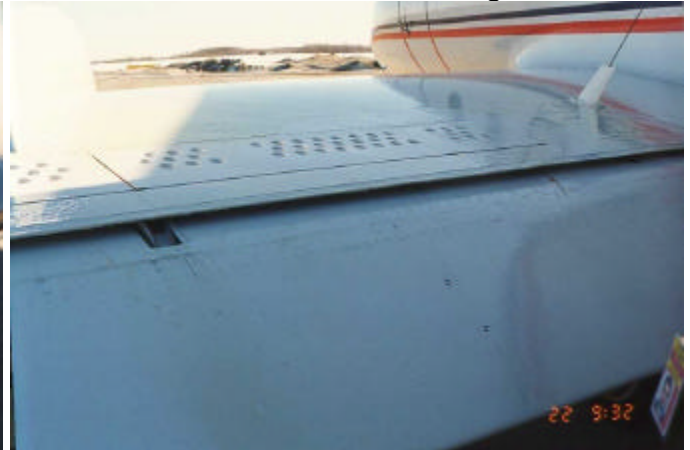
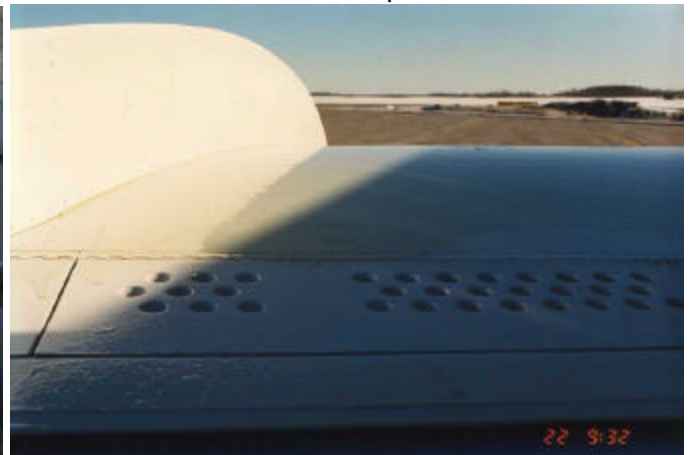
Photo Set 4.2  
Run 1 - Appearance of Fluid Following Takeoff Run

Thin Film on Leading Edge

Film on Rear of Wing

Puddling Ahead of Spoiler Panel

Fluid Ahead of Spoiler Panel

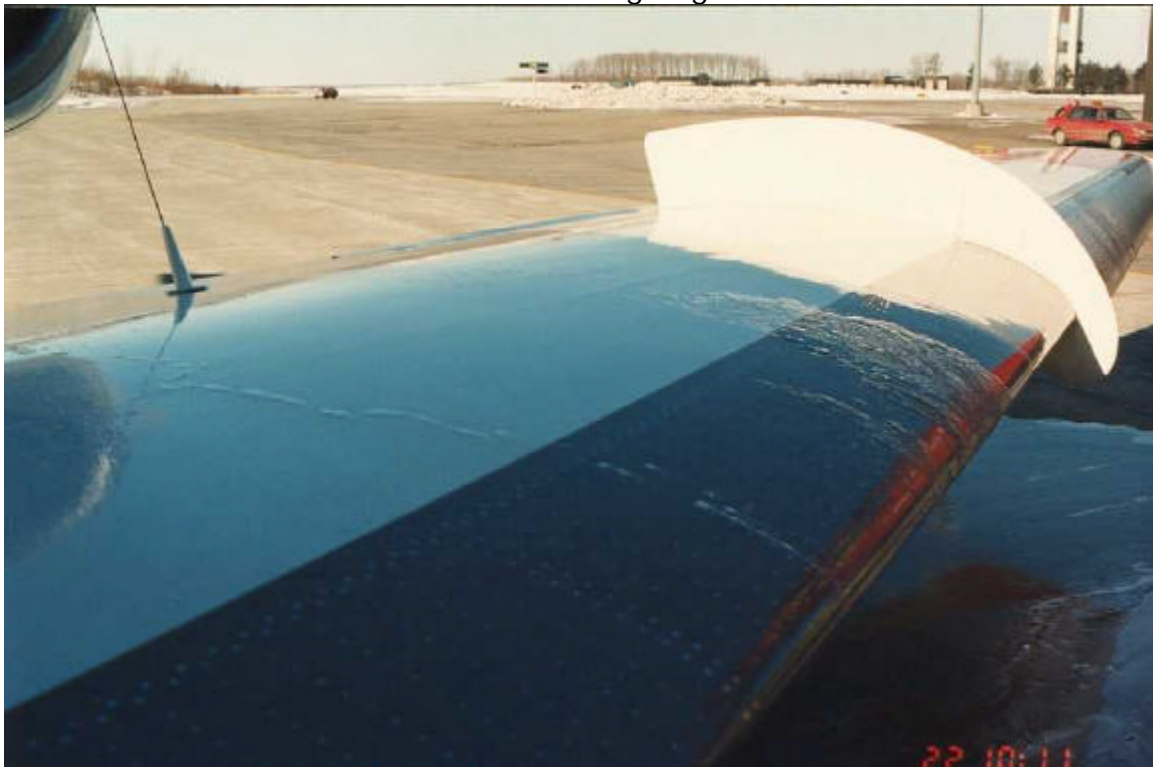
Ice on Leading Edge
