## Contaminated Aircraft Takeoff Tests for the 1998-99 Winter

**Transportation Development Centre**  
On behalf of  
**Civil Aviation**  
**Transport Canada**

October 1999

Peter Dawson and  
Medhat Hanna

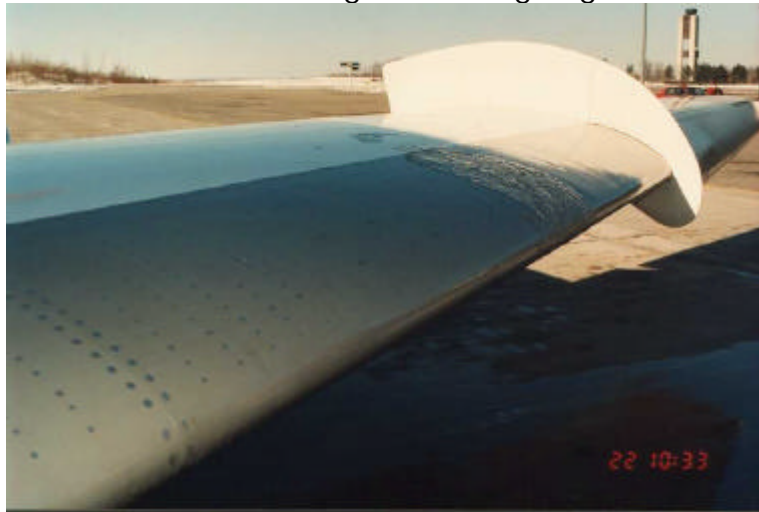
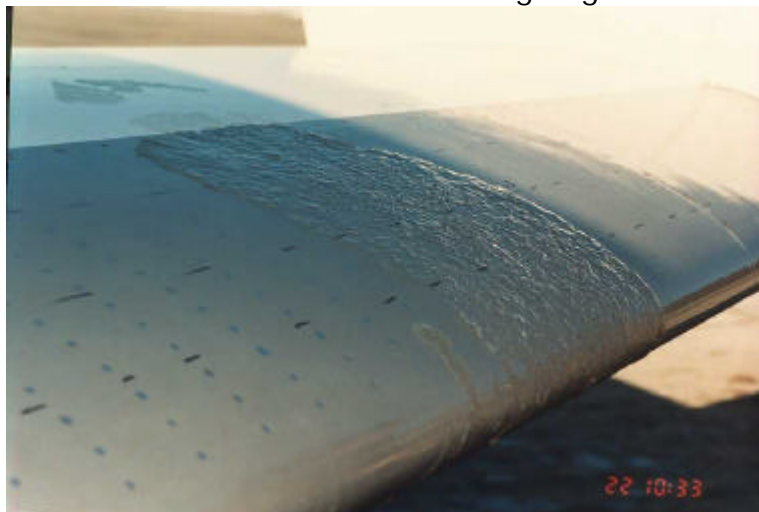
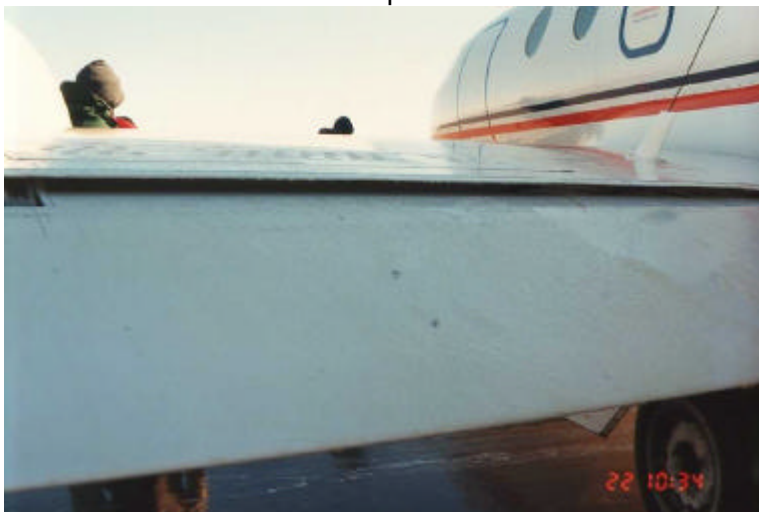
Photo Set 4.4  
Run 2 - Appearance of Fluid Following Takeoff Run

The ice-covered area was somewhat reduced following the takeoff run; however, it was noted that some of the ice remaining appeared to be thicker than it had been previously. Any fluid that had previously existed at non-iced areas had generally flowed off the wing. See Figure 4.5 and Photo Set 4.4.

Ice Remaining on Leading Edge

Texture of Ice on Leading Edge

Ice on Flap Surface

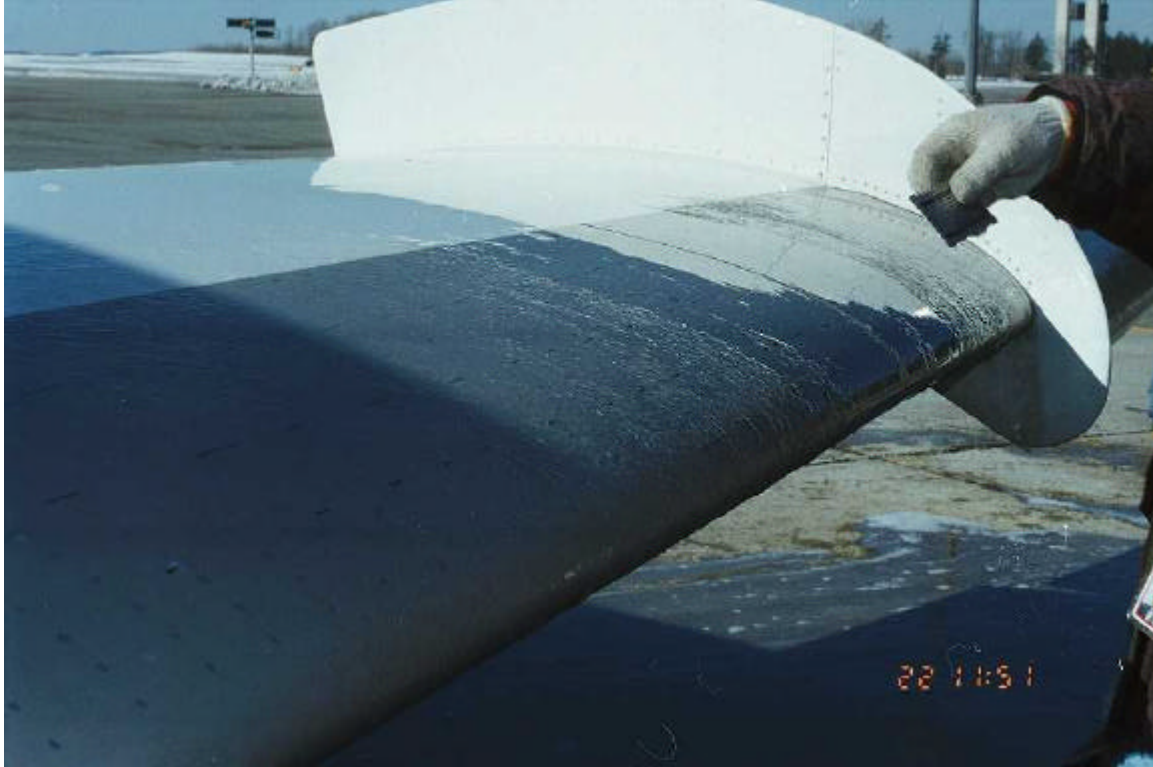
Photo 4.5  
**Run 3 - Appearance of Fluid Prior to Takeoff Run**  
**Ethylene Glycol-Based Type IV Fluid at 10 Percent Contamination**

Ice on Leading Edge

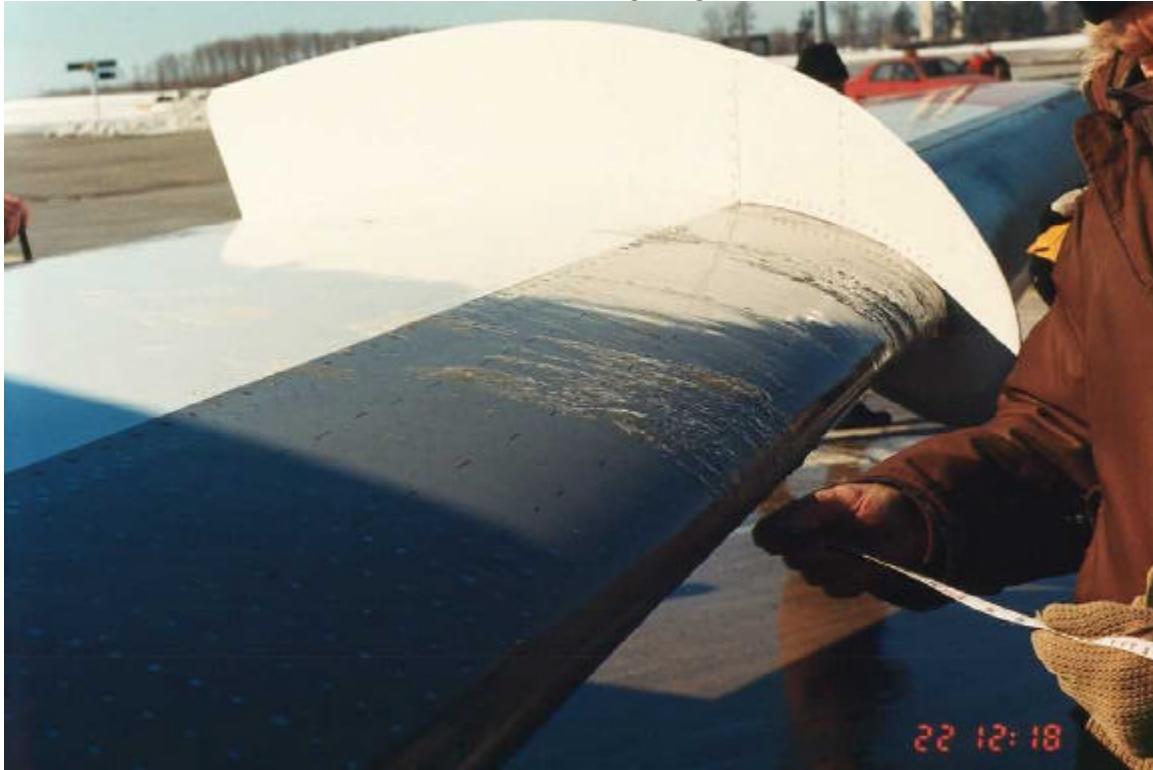
Photo Set 4.6  
Run 3 - Appearance of Fluid Following Takeoff Run

Ice on Leading Edge

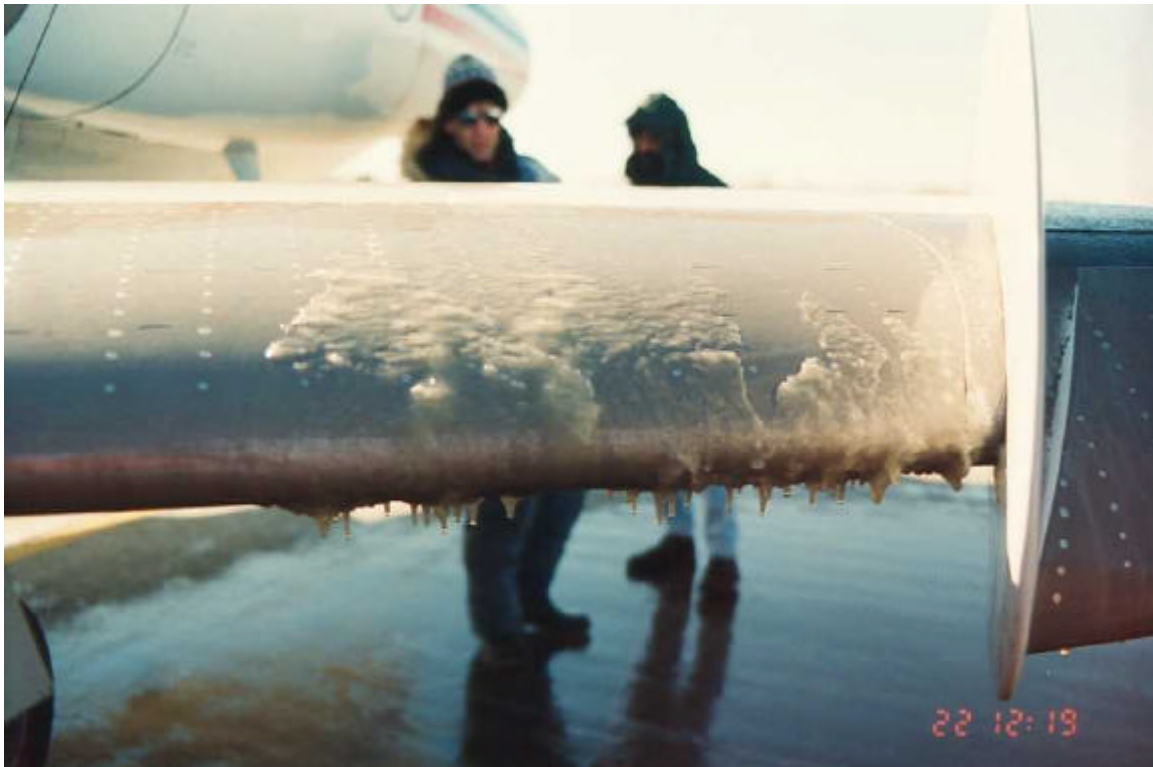
Ice Texture

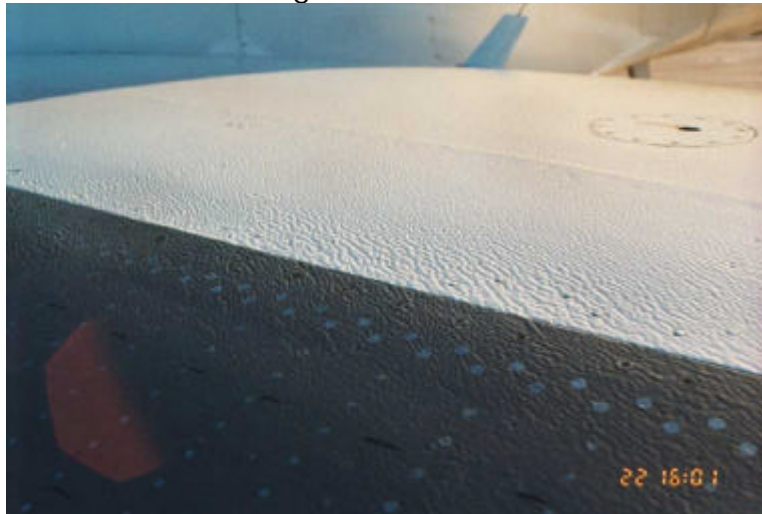
Photo Set 4.8  
Run 4 - Appearance of Fluid Following Takeoff Run

Ridges in Fluid Film

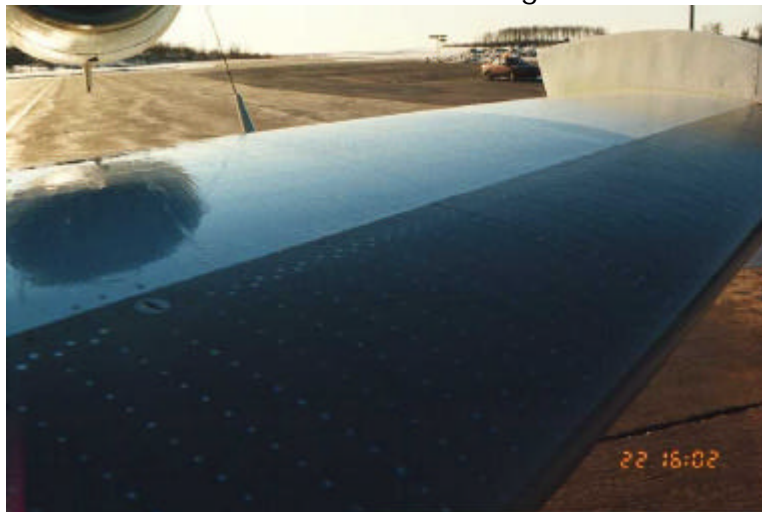
Thin Film Remaining

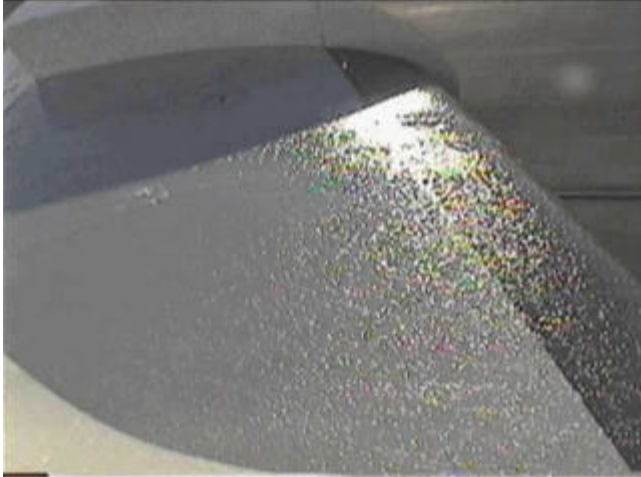
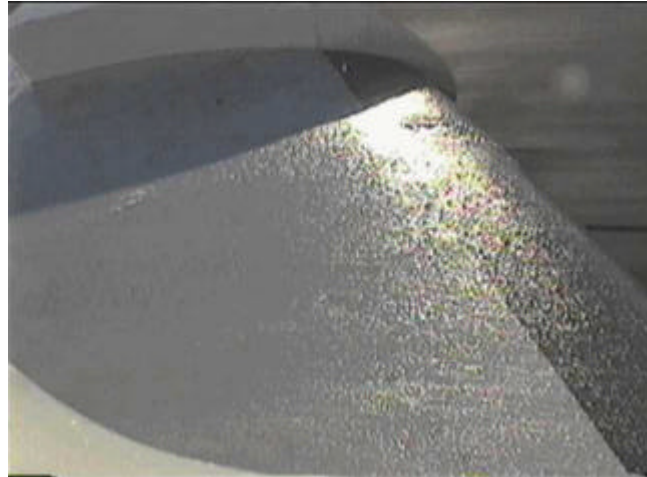
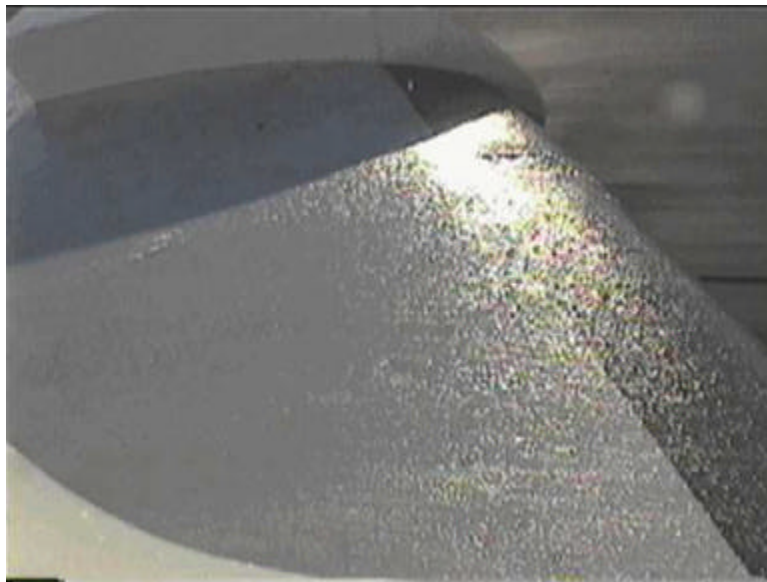
Video Image Set 4.2  
**Run 5 - Ethylene Glycol-Based Fluid, at 40 Percent Failure**

Wing Surface Appearance During Takeoff

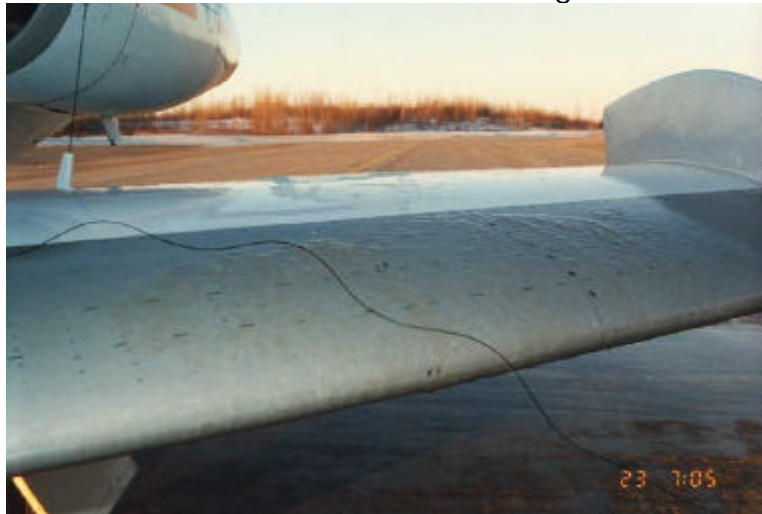
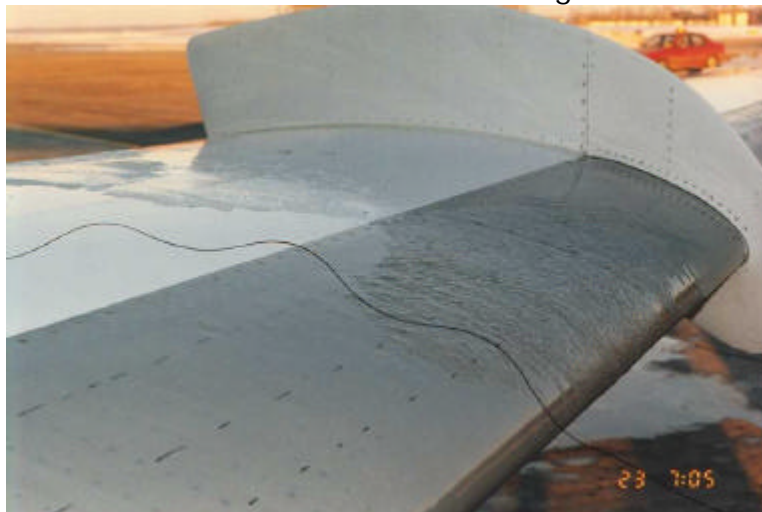
Photo Set 4.10  
Run 5 - Appearance of Fluid Following Takeoff Run

Ice on the Forward Wing

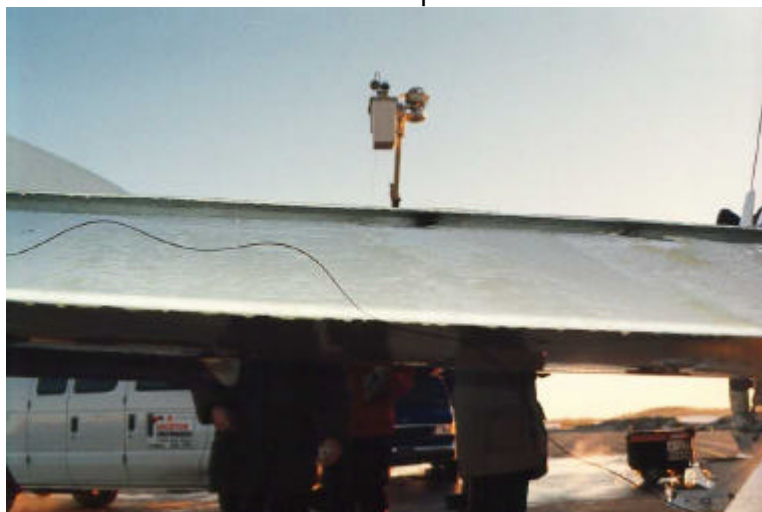
Ice on the Flap Surface

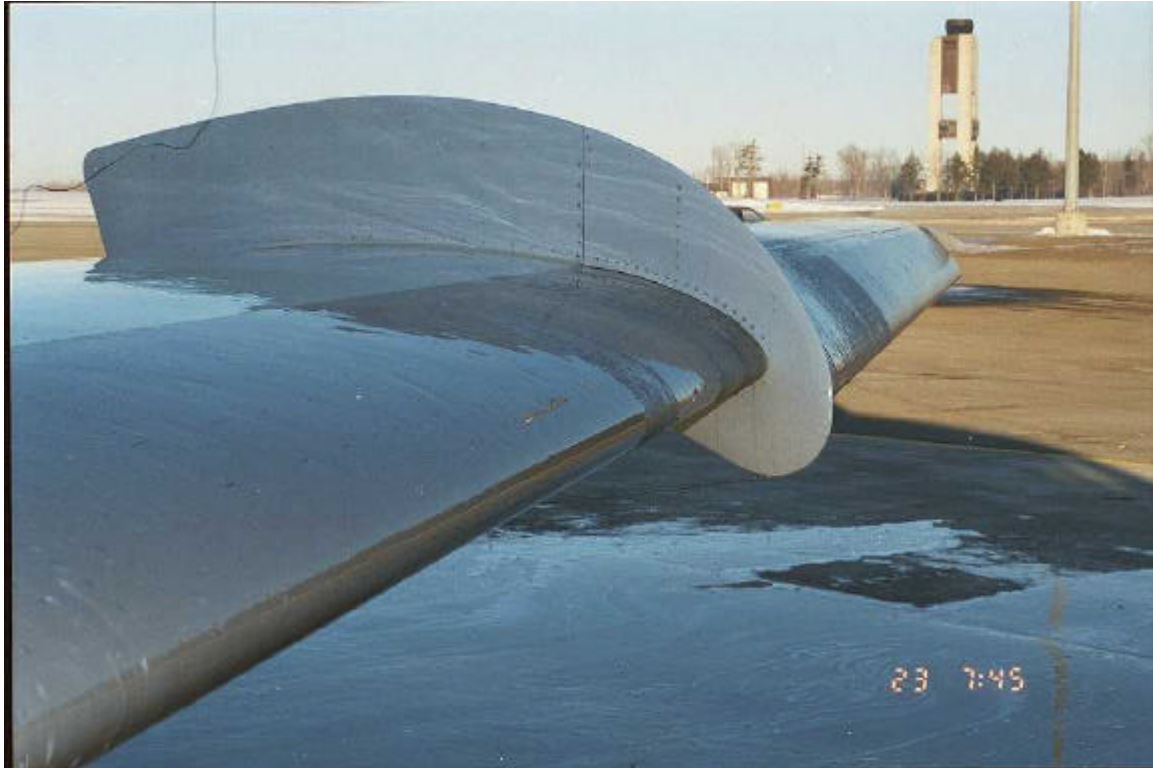
Photo 4.11  
**Run 6 - Appearance of Fluid Prior to Takeoff Run**  
**Ethylene Glycol-Based Type IV Fluid at 5 Percent Contamination**

This trial was initially intended to result in an iced area of 1 percent of the test area. In an attempt to contain the extent of icing to that level, the freezing rain spray was terminated at the first sign of icing, which in this case occurred on the leading edge. See Figure 4.15 and Photo 4.11. As in the previous test, freezing of contamination continued after the spray had ceased, resulting in a final iced area of about 5 percent.

Ice on the Leading Edge

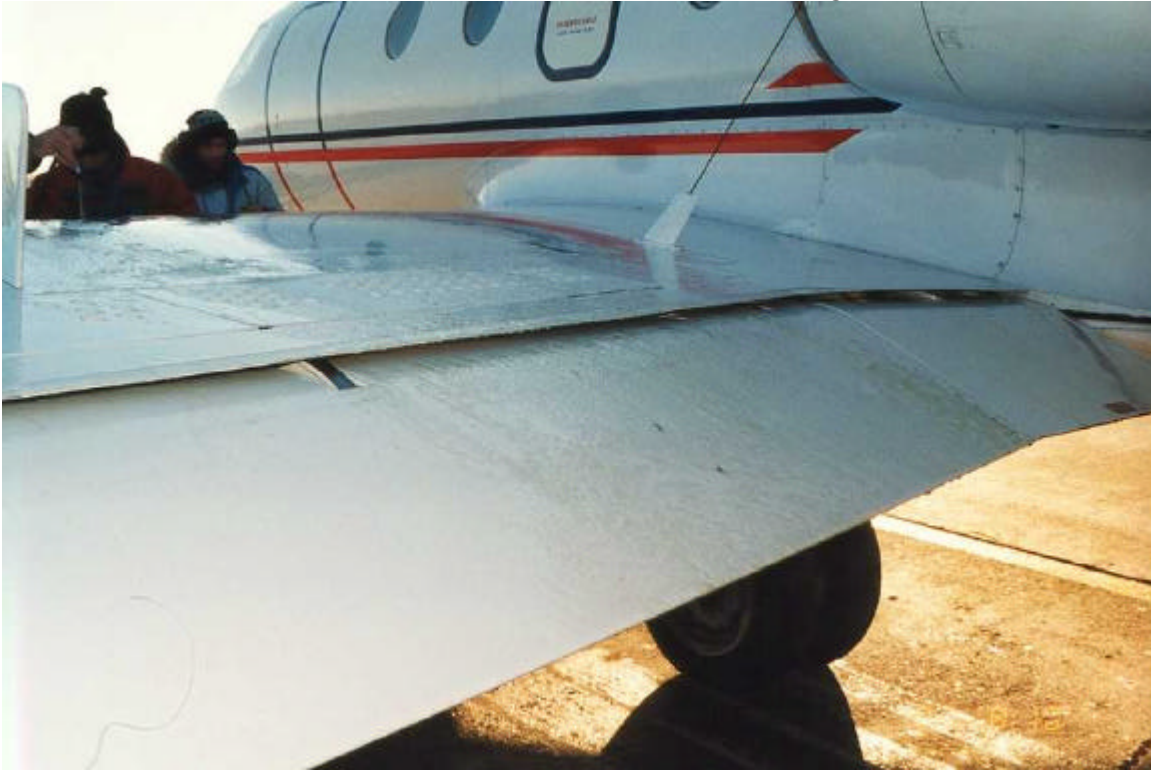
Photo Set 4.12  
Run 6 - Appearance of Fluid Following Takeoff Run

On return from the takeoff run, the ice-covered area at the rear of the wing showed little reduction in size (Figure 4.18 and Photo Set 4.12). The ice patches on the leading edge appeared to have grown in a lateral direction.

Ice Patches on the Rear of the Wing

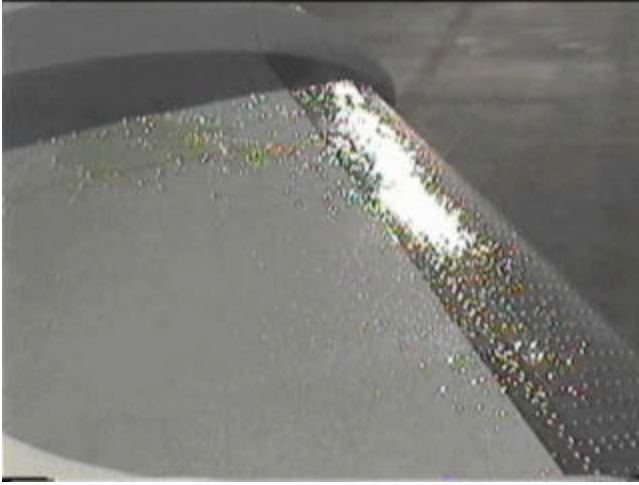
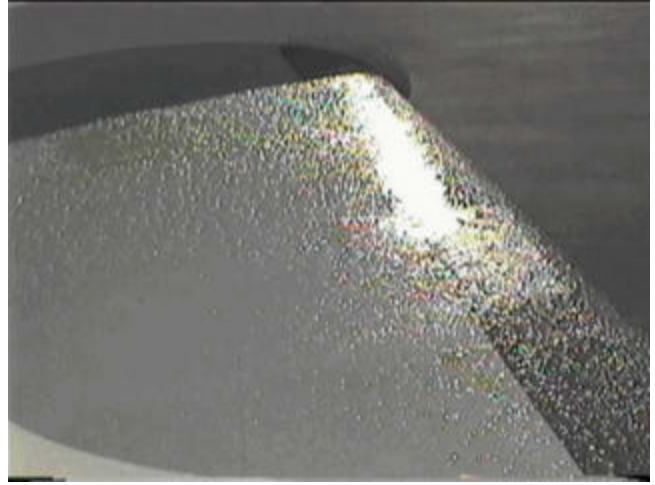
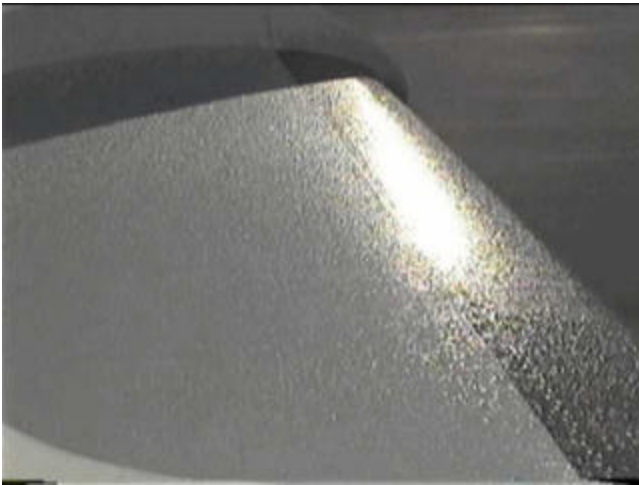
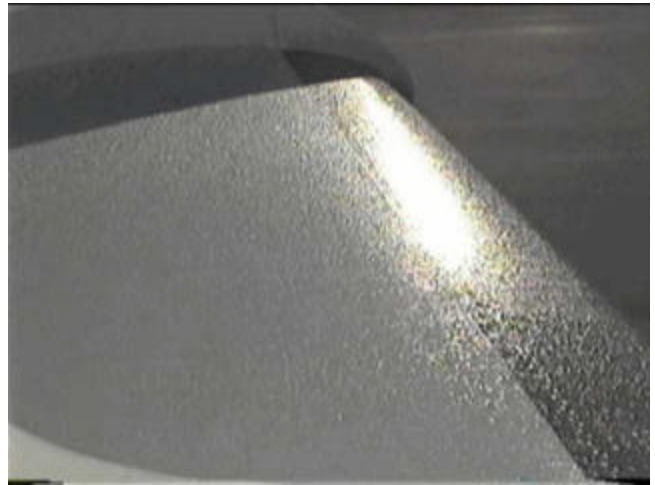
Video Image Set 4.4  
Run 7 - Propylene Glycol-Based Fluid, at 100 Percent Failure

Wing Surface Appearance During Takeoff

Run 7, the takeoff run conducted with a contamination level of 100 percent, demonstrated that complete elimination of propylene glycol-based fluid can be expected when reasonable levels of contamination are experienced, even at low temperatures. This result is attributable to the nature of failure of propylene glycol-based fluids, whereby failures at low temperatures typically occur on the top surface of the fluid, overlying a thick layer of essentially uncontaminated fluid.

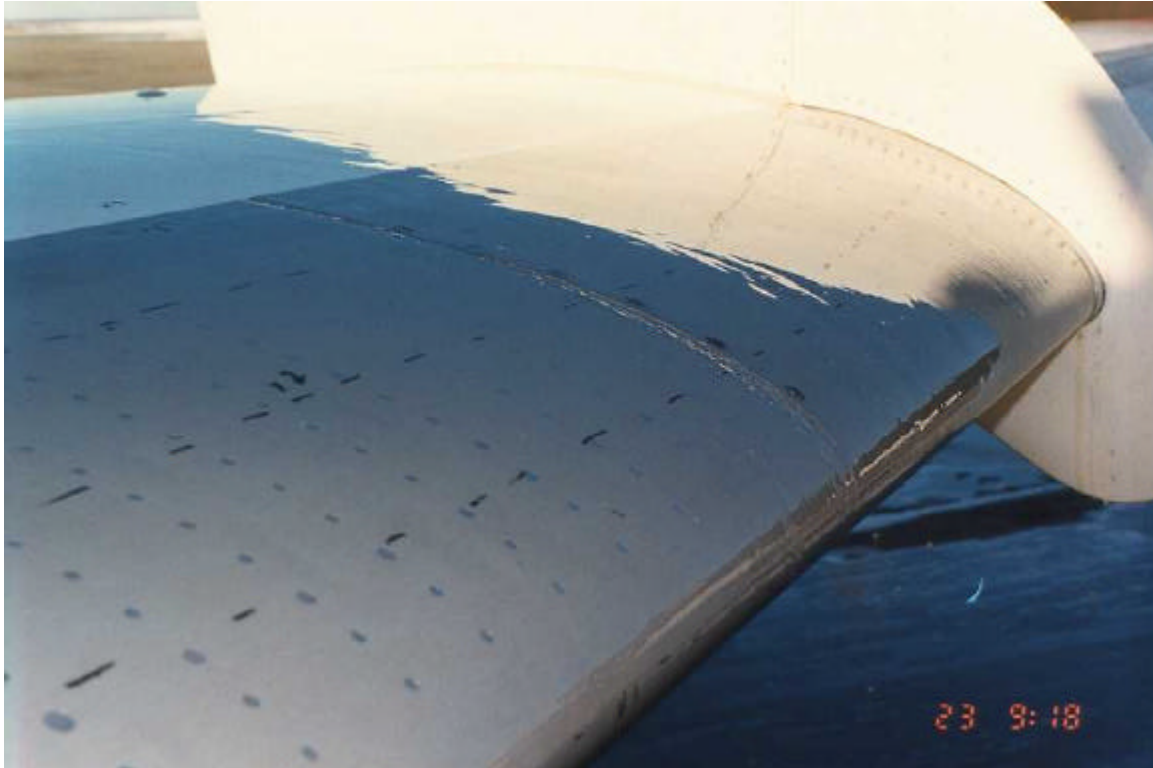
Photo 4.15  
**Run 8 - Appearance of Fluid Prior to Takeoff Run**  
**Ethylene Glycol-Based Type IV Fluid at 1 Percent Contamination**

A small ice patch (Figure 4.23 and Photo 4.15) appeared on the leading edge and slightly larger patches were observed on the spoiler panel and on the flap. The wing observer noted that flow off from the top of the main wing eroded the fluid in these areas, leading to failures. The iced area on the leading edge was located at a seam in the leading edge structure. This area had also been the site of initial failures in previous tests.

Ice at Seam on Leading Edge

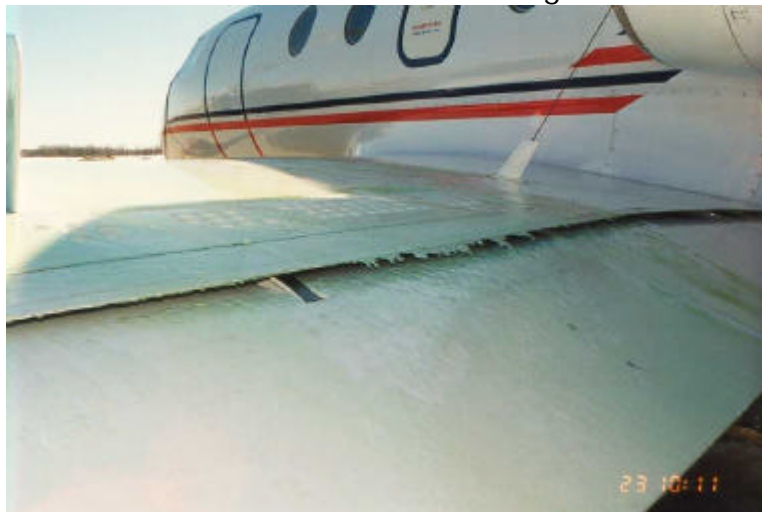
Ice Crust on Rear Wing

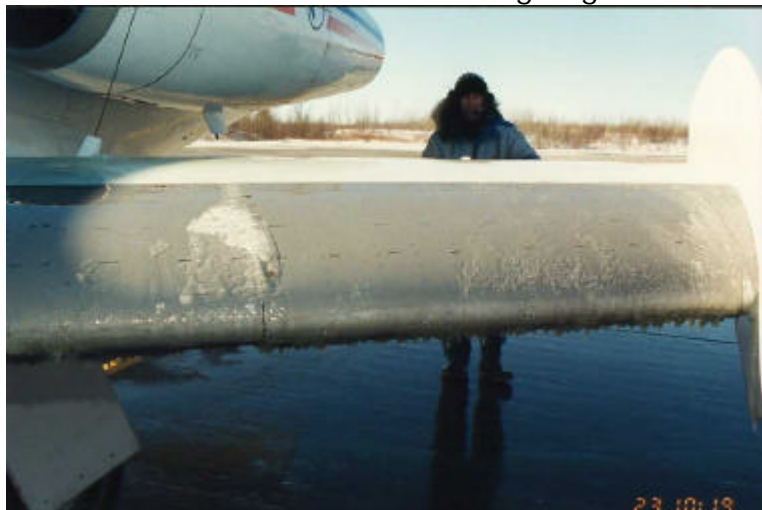
Ice Formation on Leading Edge

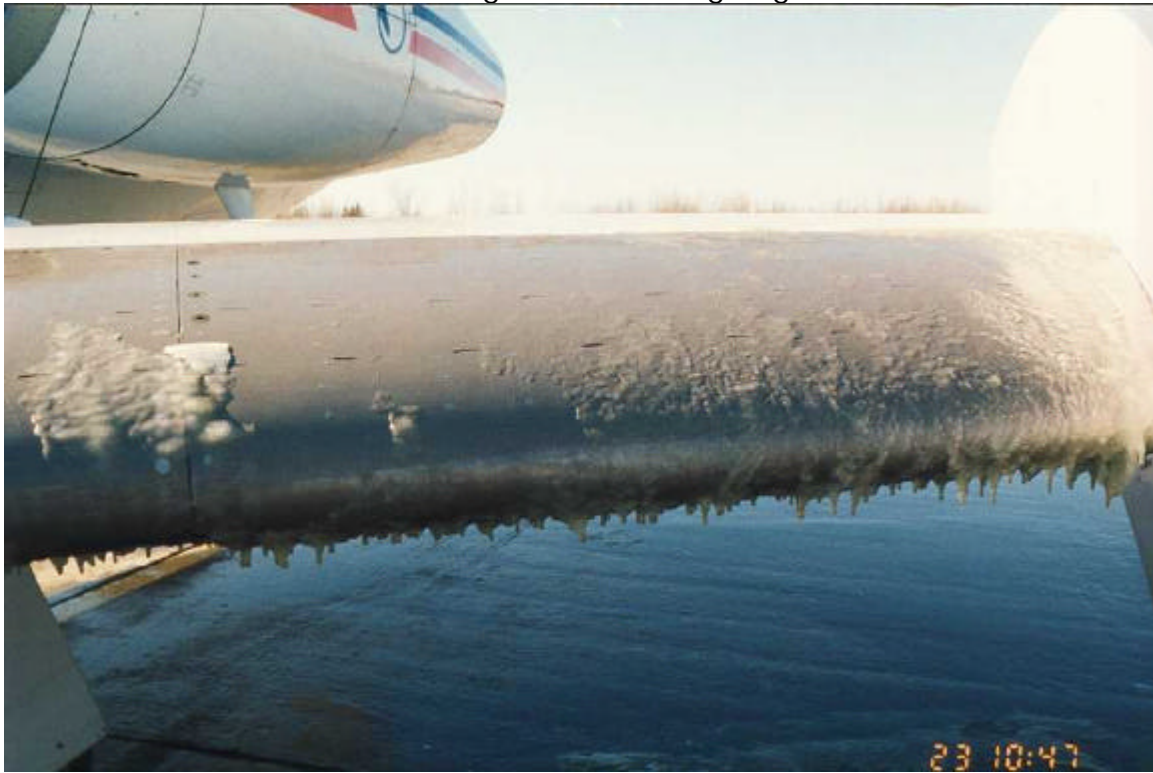
Photo 4.18  
Run 9 - Appearance of Fluid Following Takeoff Run

On return from the takeoff run, it was observed that those areas where, prior to takeoff, a light layer of ice had formed on the fluid surface were now clean of ice *and* of fluid. Areas where ice of substantial thickness had formed prior to the takeoff run remained ice-covered after the aircraft returned to the inspection pad. See Figure 4.30 and Photo 4.18.

Remaining Ice on Leading Edge
