AIR TRANSPORTATION SAFETY INVESTIGATION REPORT A23O0008

LOSS OF CONTROL IN FLIGHT

Chartright Air Inc. (dba Chartright Air Group)
Cessna 560 Encore, C-FYMM
Vicinity of Cayuga, Ontario
27 January 2023

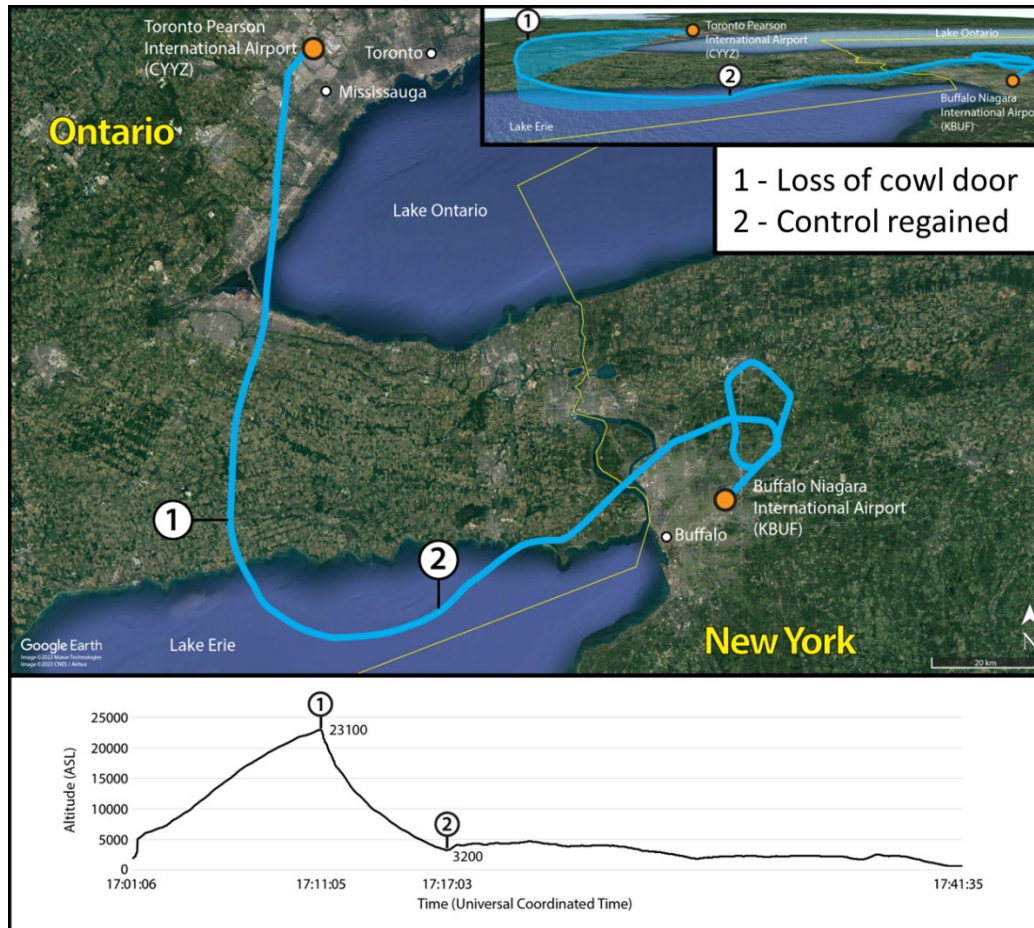
At approximately 1211, while the aircraft was in climb over Cayuga, Ontario (approximate location), at an altitude of approximately 23 000 feet above sea level (ASL), the whole upper cowl door and most of the lower cowl door on the left engine partially detached from the nacelle, before becoming completely detached, resulting in a sudden increase in parasite drag on the left side of the aircraft. The aircraft suddenly yawed and rolled to the left, and the flight crew then lost control of the aircraft as it rapidly lost altitude. The flight crew subsequently declared an emergency by transmitting a Mayday call, and at approximately 3200 feet ASL, they regained control of the aircraft and stopped the descent (Figure 1).

Figure 1. Occurrence aircraft's flight path and vertical profile (in inset), indicating where the left engine lost its cowl doors (point 1) and where the flight crew regained control of the aircraft (point 2) (Source of main and inset images: Google Earth, with TSB annotations based on automatic dependent surveillance – broadcast data)
