AIR TRANSPORTATION SAFETY INVESTIGATION REPORT A23P0123

COLLISION WITH TERRAIN

Privately registered
De Havilland DHC-2 (Beaver), C-GSBA
Campbell River Airport, British Columbia, 10 NM SSE
20 September 2023

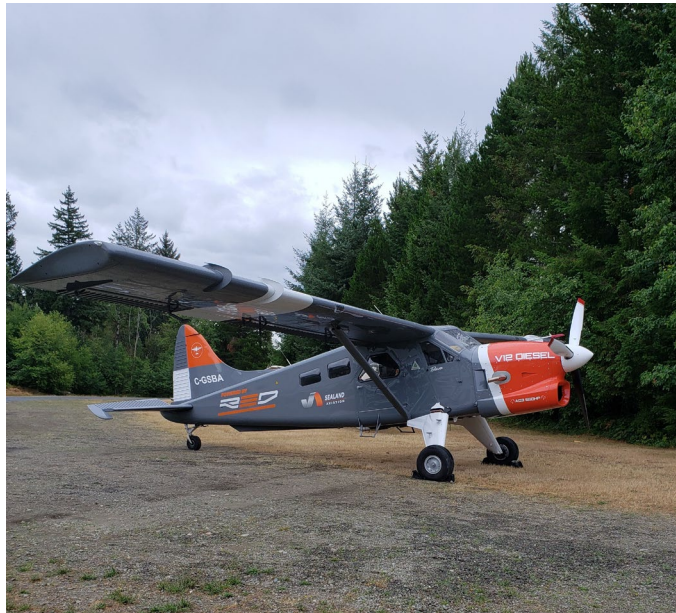
The occurrence aircraft (Figure 2) was manufactured by De Havilland Aircraft of Canada Ltd. in 1954. It was operated by the United States (U.S.) Army before being sold to a civilian operator in the U.S. in the 1970s. In June 2020, the aircraft was registered privately in Canada to Sealand Aviation Ltd. and was subsequently partially disassembled and rebuilt. During this rebuild, the aircraft was equipped with a RED A03-005 engine.

Figure 2. Occurrence aircraft equipped with the RED A03-005 engine (photo taken before the occurrence) (Source: Third party, with permission)

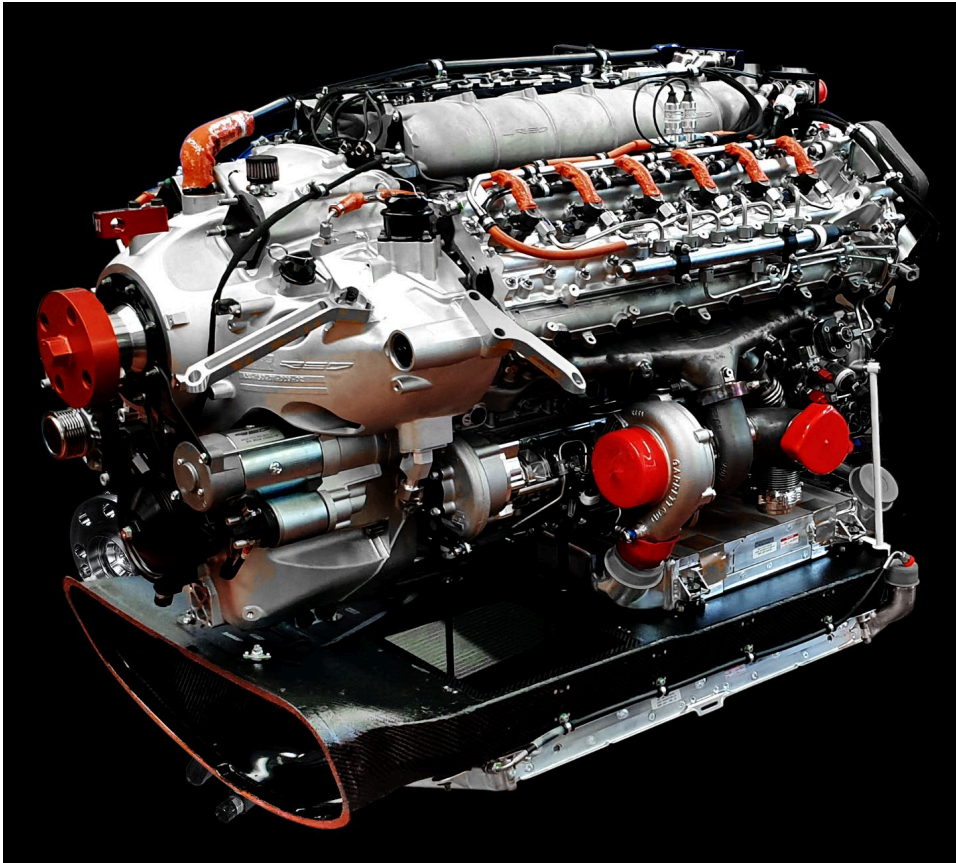
The RED A03-005 engine (Figure 3) is a 12-cylinder, twin turbocharged, high-compression-ignition engine with two 6-cylinder banks capable of independent operation. The engine is controlled by a full-authority digital engine control (FADEC) system, which is in turn controlled by an electronic engine control unit (EECU). A single cockpit lever is used to command both the engine power and the blade angle of the reversing MT-Propeller GmbH MTV-9-E-C-R(M) variable-pitch propeller driven by the engine. The propeller rotates counterclockwise (as viewed from the pilot's seat) at a maximum of 2127 rpm. The engine is rated to a maximum of 550 hp and is approved for operation with kerosene-type fuels, including jet fuel.

Figure 3. The RED A03-005 engine (Source: Third party, with permission)
