RAIL TRANSPORTATION SAFETY INVESTIGATION REPORT R19T0147

EMPLOYEE FATALITY

Canadian National Railway Company
Remote control locomotive system
Dual hump yard assignment YDHF60
Mile 0.0, Halton Subdivision
MacMillan Yard
Vaughan, Ontario
15 August 2019

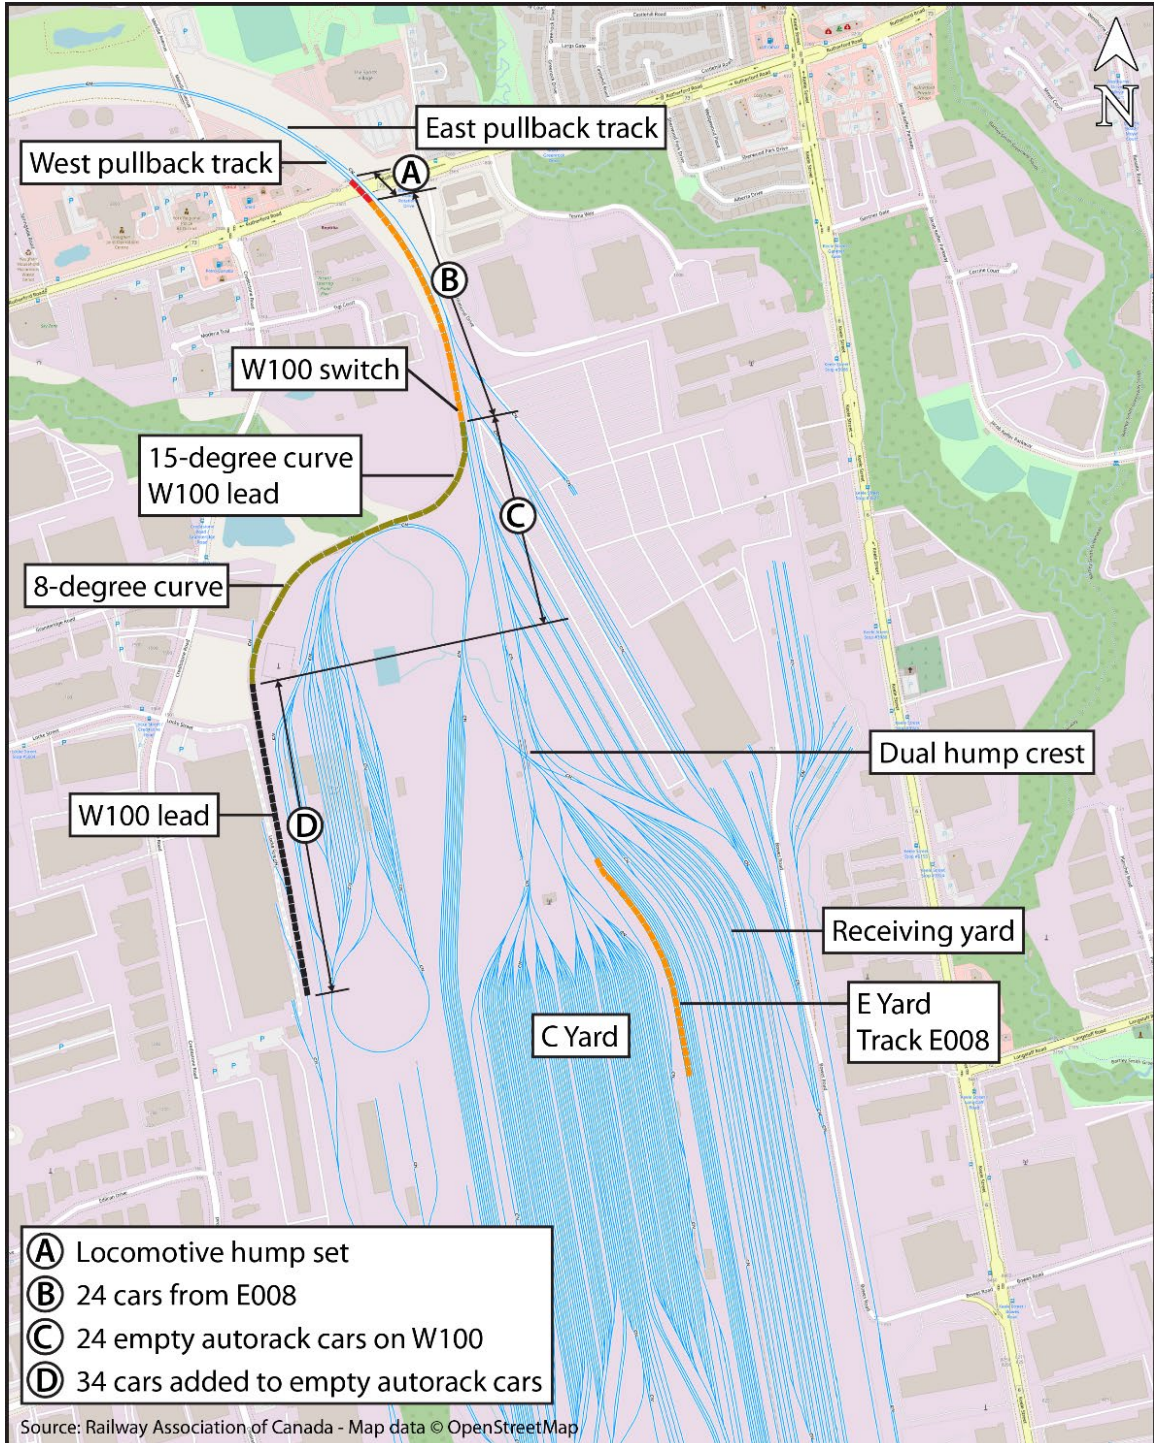
Figure 4. Layout of the north end of Canadian National Railway Company MacMillan Yard showing estimated assignment location prior to commencing northward movement (Source: Railway Association of Canada, map data from OpenStreetMap with TSB annotations)

The autorack cars were left standing at the north end of W100 and secured with a hand brake applied to each of the 3 northern-most cars. These 3 autorack cars were located along the 8-degree right-hand curve, with their A-end leading (Figure 4). Since the 3 cars were oriented the same way, each of their hand brakes was located on the north side of the track, which corresponds to the outside of the right-hand curve and the inside of the left-hand curve.

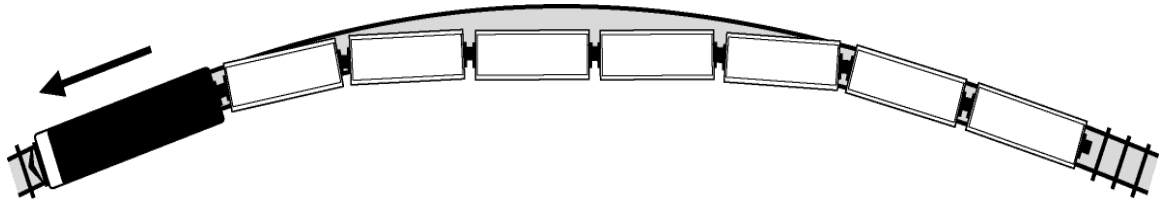
Figure 12. Pulling movement string-lining to the inside of a curve
(Source: Canadian National Railway Company)

¹³ As a train pulls through a curve, the draft (tension) forces tend to pull the wheel flanges against the inside rail of the curve. If sufficient force is present, a freight car wheel may climb, or lift, onto the head of the inside rail of a curve and derail.

The manual also identifies that the risk of string-lining increases when handling light cars within a heavy train. However, the manual does not include more specific guidance for identifying conditions that are conducive to string-lining, nor does it contain tips for preventing a string-line event.

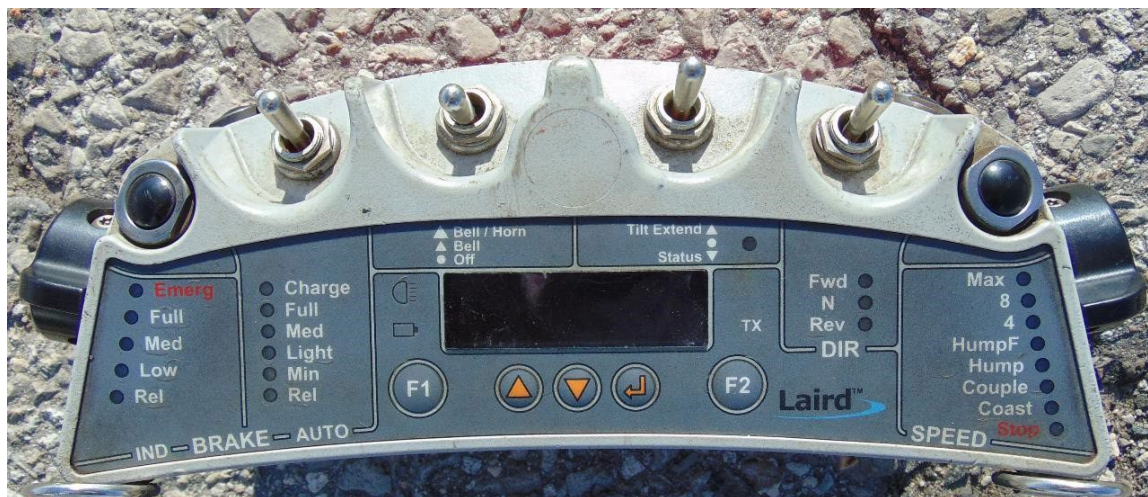
Figure 13. Operator control unit otherwise known as a Beltpack (Source: TSB)

In this case, the Beltpack involved was equipped with (but not limited to) a speed selector, a forward and reverse selector, and a brake selector that includes an emergency brake feature (Figure 13). The Beltpack was found damaged, which indicates that a loss of communication occurred.

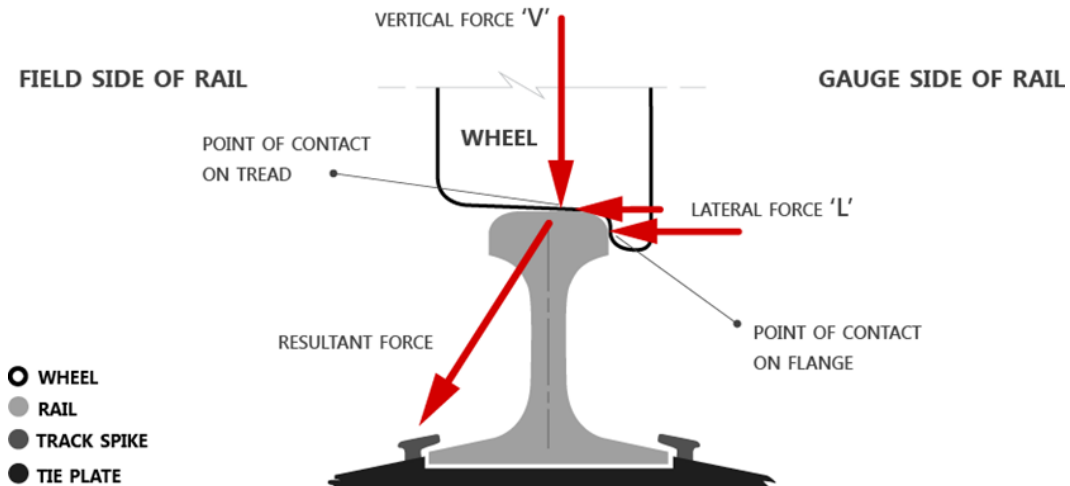
Figure 16. Lateral-to-vertical forces between wheel and rail (Source: Association of American Railroads)

A combination of lateral (L) and vertical (V) forces exists at the wheel-rail interface (Figure 16). The ratio of lateral-to-vertical (L/V) forces indicates the potential for a derailment to occur. When a high lateral force and low vertical force are present (e.g., as with an empty car), the high lateral force will tend to push the wheel flange up and over the gauge face of the rail, resulting in a wheel-climb derailment.

- A truckside L/V ratio in excess of 0.65 is indicative of the potential for a freight car truck to roll a rail and cause a derailment.
- A single-wheel L/V ratio in excess of about 0.82 is indicative of the potential for a freight car to wheel climb (or lift) on the head of a rail and cause a derailment. This can occur within about 6 feet of movement.¹⁹ When this happens, short wheel flange marks are often observed on the top of the low rail. Empty long cars equipped with long-travel EOCCDs, such as autorack cars and centrebeam bulkhead flat cars, are particularly vulnerable to these forces.
