RAIL TRANSPORTATION SAFETY INVESTIGATION REPORT R22V0238

COLLISION BETWEEN A TRAIN AND A TRACK UNIT

Canadian Pacific Railway Company
Freight train 302-25 and hi-rail vehicle L15034
Mile 116.7, Shuswap Subdivision
Near Campbell Creek, British Columbia
29 December 2022

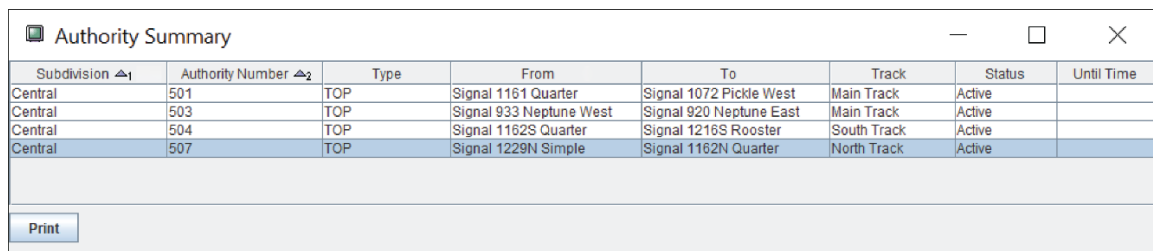
Figure 5. Screenshot of the Authority Summary table in the EIC application (Source: Canadian Pacific)

To cancel a TOP in the EIC application, a foreman must use the touch-screen display; with limited screen space, the information is displayed in a small font. All active TOPs are listed in the Authority Summary window from which the foreman can select the TOP to cancel (Figure 5).
