Nanaimo River Chinook Salmon Recovery Plan Habitat Assessment Report

D. R. Clough

Canadian Contractor Report of Hydrography and Ocean Sciences 59

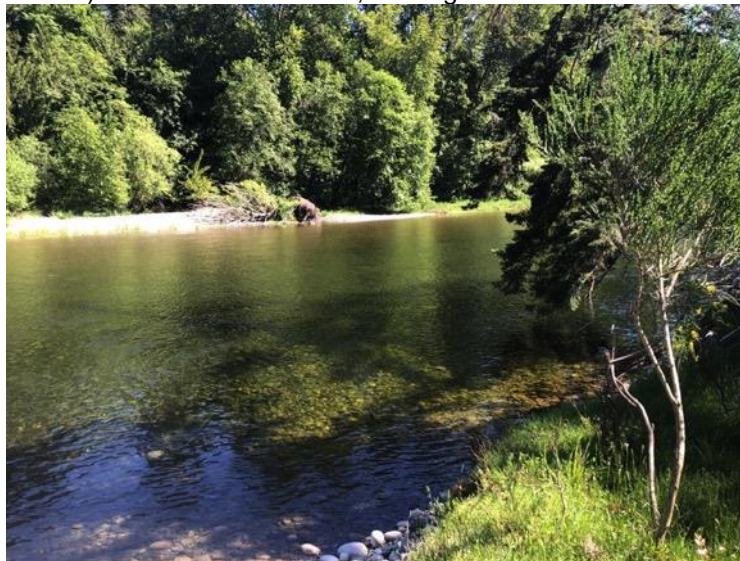
7.) Pool 2 is 309m long with good riparian depth but poor instream cover

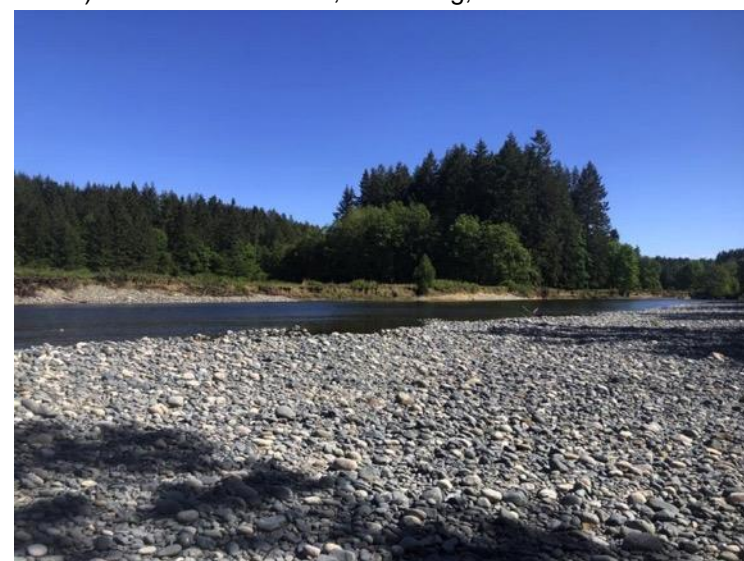
8.) Glide 3 (Placemark 23) near top of Reach 2, has 220m RB bank erosion

Reach 2 is the lowest non-tidal reach in the Nanaimo river. The location means it is habitat for all salmon species for migration, spawning and/or rearing. The protection of this habitat is vital. It is relatively un-developed by industrial and urban pressure. It has a wide floodplain which has not been dyked or channelized. In the left bank floodplain, the second generation of forest vegetation has been undisturbed in most areas. Most agricultural developments lie further out in the floodplain (i.e. Akenhead Creek) and are buffered by riparian vegetation. There is one streamside agriculture area in this reach (Figure 4, Placemark 23) and the lack of riparian protection has resulted in loss of pasture and river bank erosion.

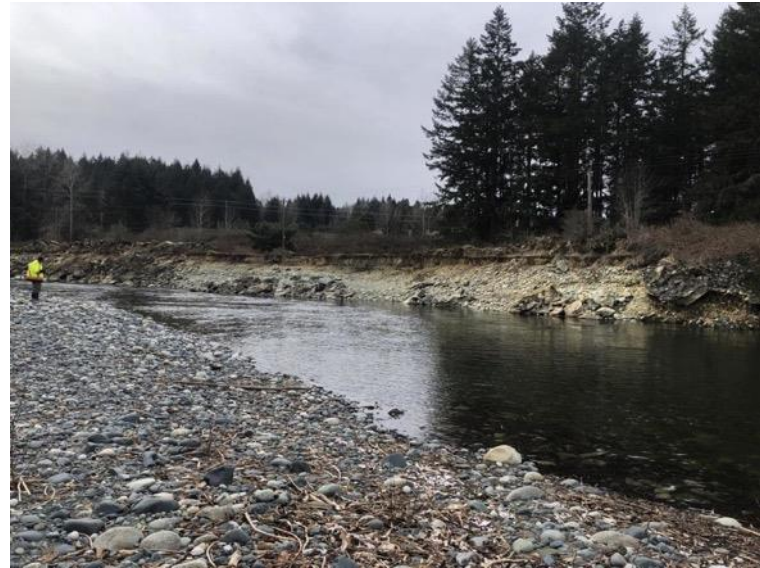
6.) Pool 2 – also showing LB erosion under trail/powerline

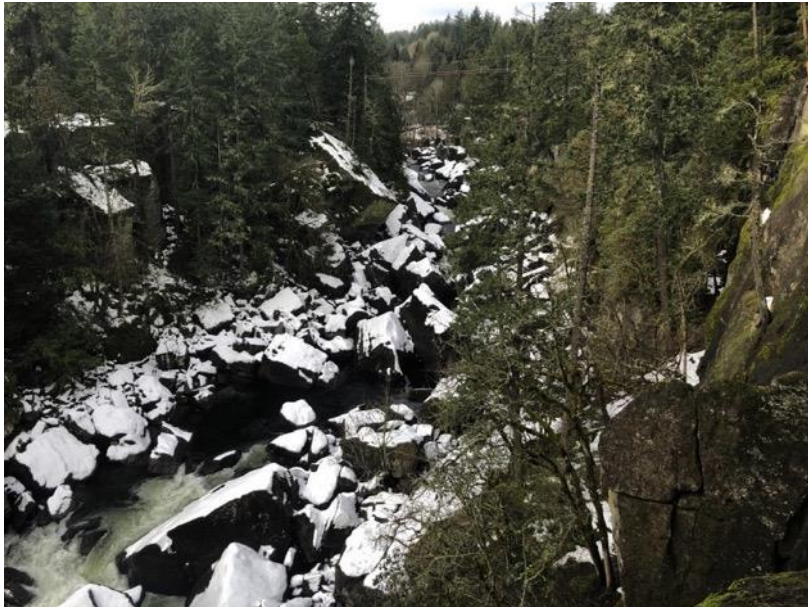
1.) R5. Bore Hole From Hydro Line looking upstream

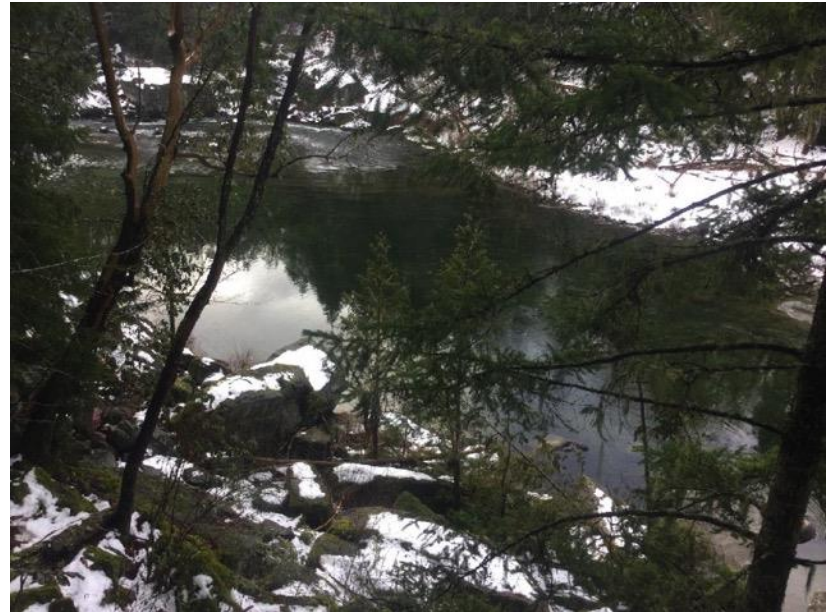
2.) R5 Pool 1 (below Hydro line) heading downstream – widest pool (73m) in R5

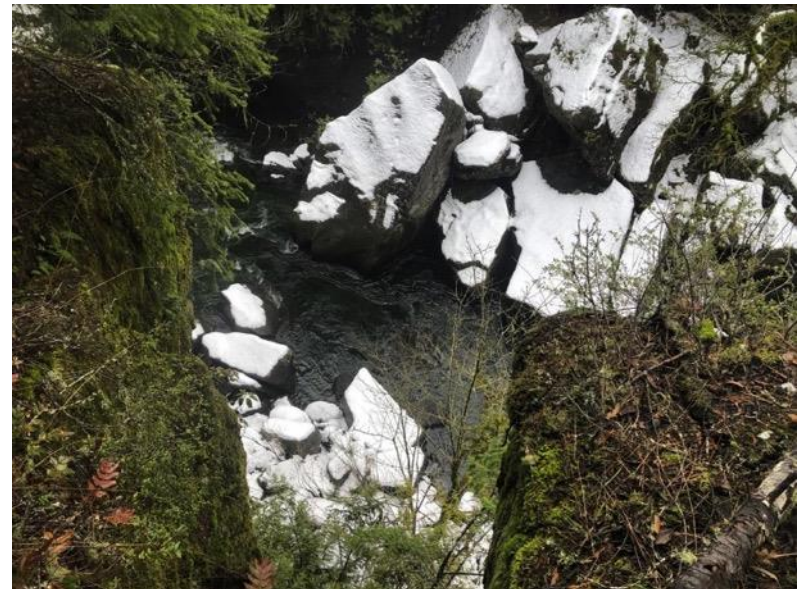
4.) R5 – Pool 2 more typical narrow (42m) pool in R5.

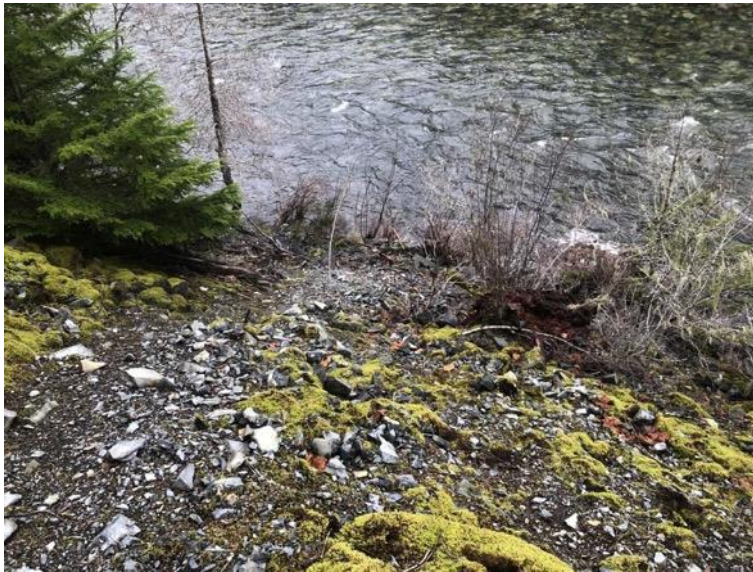
5.) R12- Slide track along rail grade needs planting

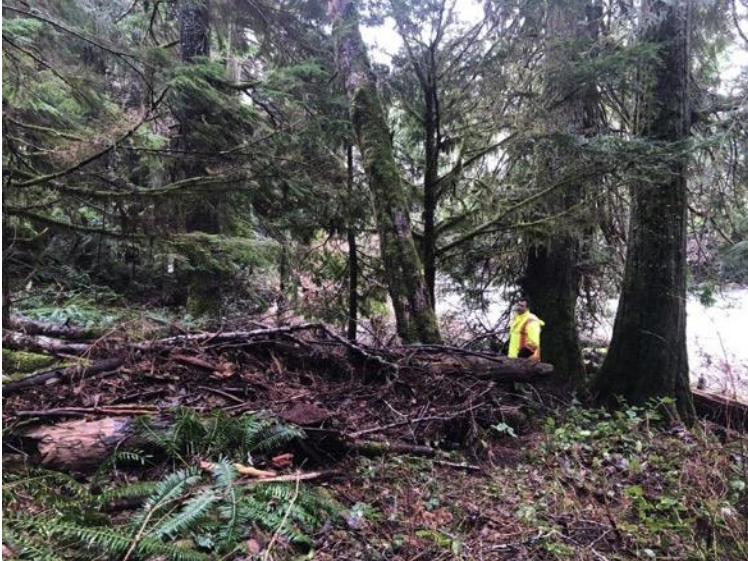
1.) R13- flood debris deposited high in riparian area

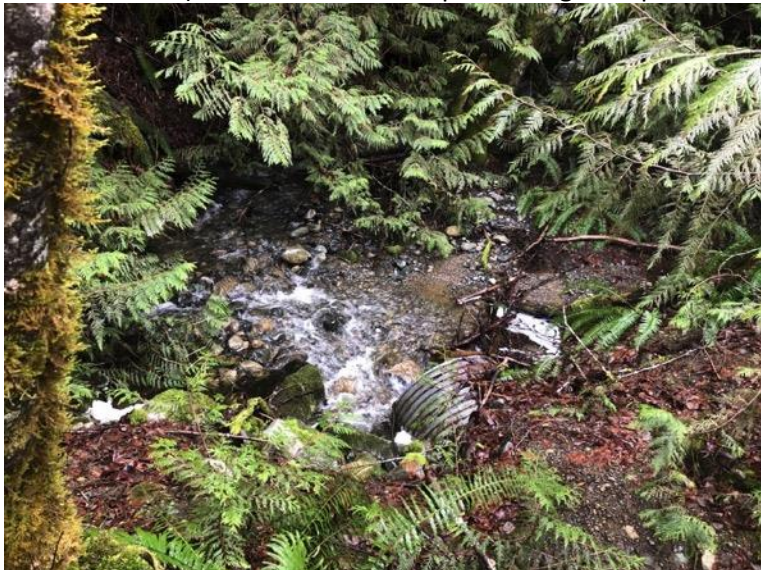
The habitat summary results in a Fair score. The Good rating for erosion is due to the fact the river bed is washed down to hard substrates. There are rail culvert washouts (Placemark 9 & 10) that are eroding off steep slopes into the river that need remediation. The Good rating for Obstructions such as log jams is because they must have been removed or historically washed away as none exist. Some residual log debris is observed in the narrow floodplain trapped amongst tree stems. The Alterations to the river are historic: the logging railway ceased operation approximately 60 years ago. The rail bed is in surprisingly good condition given there has been no sign of maintenance. Erosion was low for the overall length but two sites were observed along the rail grade. There is a plugged culvert at Placemark 9 has that needs cleaning. Downstream at Placemark 10 there is a bank failure approximately 30m wide eroding sand down to the river.

3.) R13 Placemark 9 culvert under rail grade

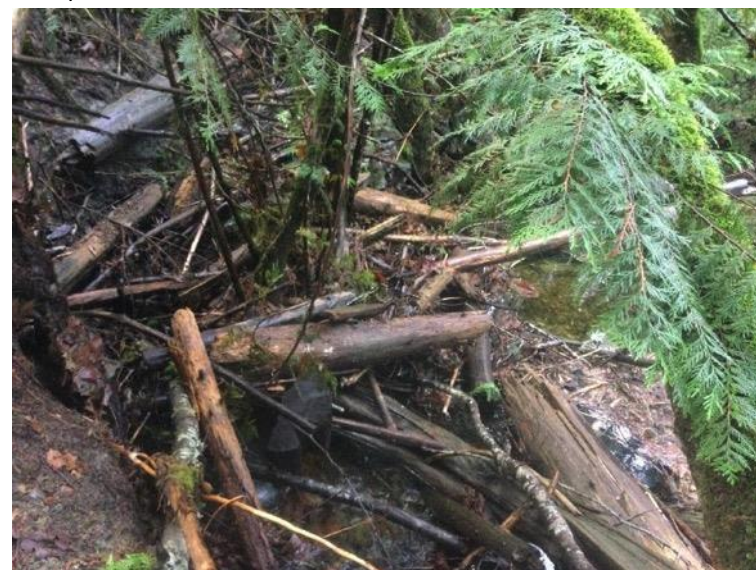
4.) R13 – Wolf Creek plugged culvert

- Erosion and Bank Stability scored Fair. There was 160m of bank erosion in this 2km reach (8%). The main type was trees falling in from undercut banks (i.e. Glide 2 Big Cedar) . The trees were lesser strength second growth (60-80 yrs) and it was more evident in areas where the channel had head cut. The old rail grade culverts are sources of sediment; there was a failure at Pool 3 with loss of fill. Wolf Creek culvert is a concern.

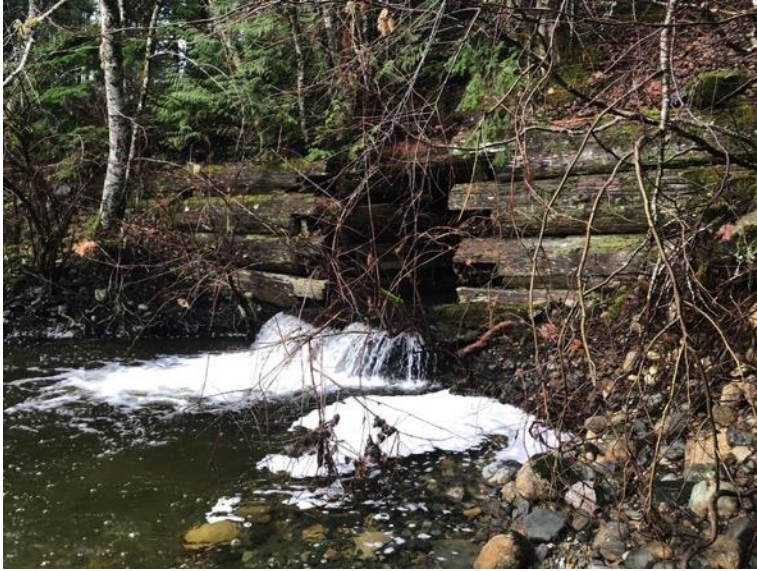
1.) Wolf Creek culvert

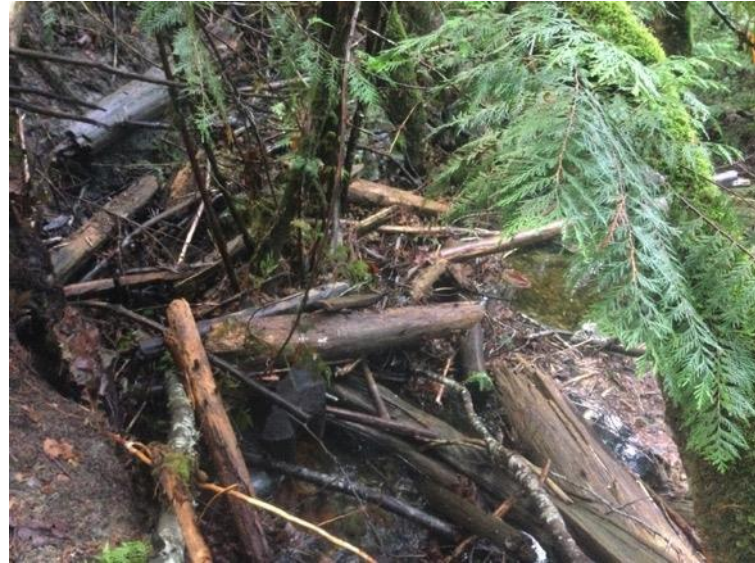
2.) Wolf Creek culvert log Jam

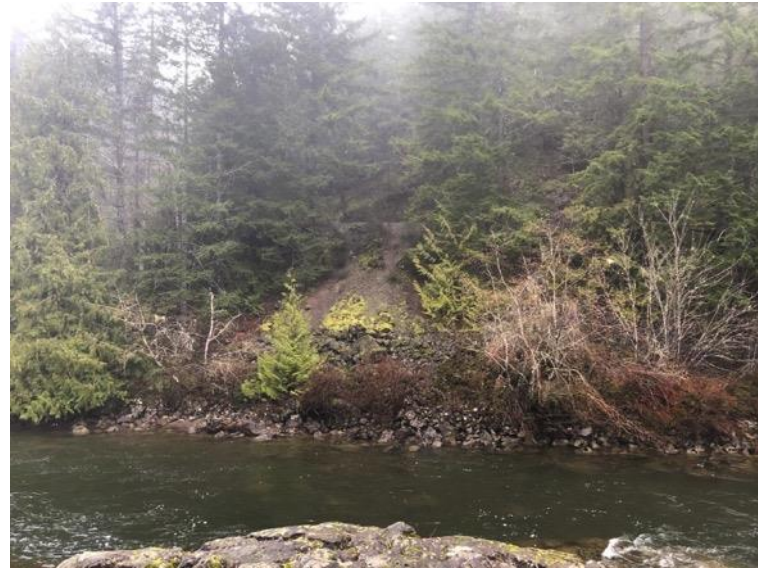
2.) Exposed slope – planting opportunity

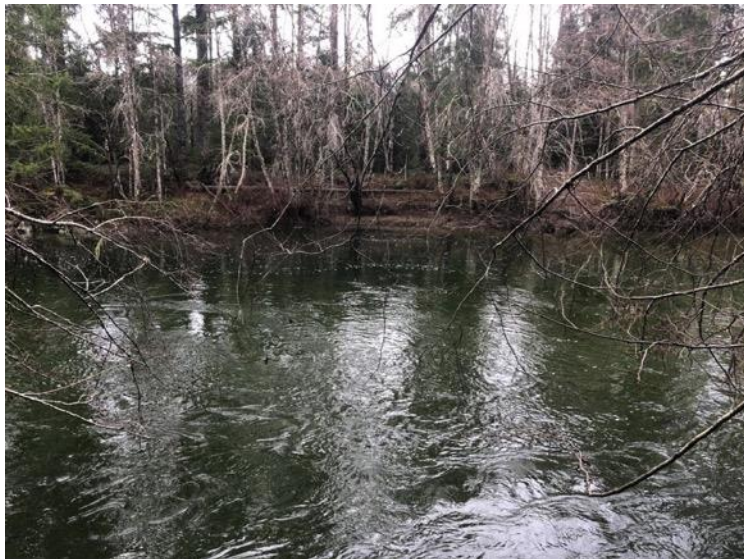
- LWD – the reach lacks LWD (0) due to historic logging effects. The lack of LWD results in a lack of cover for fish along the long glides. There is the opportunity to add LWD to the banks to protect eroding areas and create cover. Both banks are relatively low and accessible.
- Cover – Lack of cover throughout the reach was evident. The only cover was found in exposed Boulders not buried by sediments. Addition of cover that is flood proof is recommended and benefit juvenile fish greatly in this reach. Boulder habitat is evident in the reach but access to distribute boulders from bank areas is limited to the few roads near the banks.

3.) R18 Pool 1 – is 92m long and 3-4m deep, no LWD

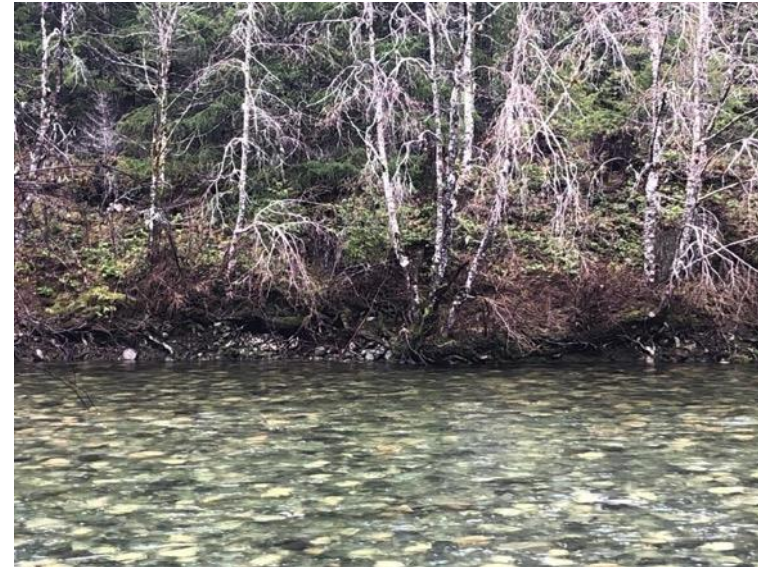
- Erosion – There are no large slides or long exposed bank erosion pockets. The banks are vegetated with second growth conifers, most of the Red Alder has died out. The trees are not mature size and prone to failure in floods; they are often pushed over by the river into the forested floodplain on the right bank, in many cases this forms a tight matrix of log debris among living trees that provides improved erosion protection. Assisting the trees in the battle with the river would include infill planting exposed areas with trees and shrubbery. There also may be some opportunity to cable the log matrices in place to improve stability in the treed floodplain. Note the floodplain is likely elevated in this aggraded reach due to sediment depositions.

4.) R18 – Glide 3 is 318m long, shallow no cover, small erosion pockets as trees fall in

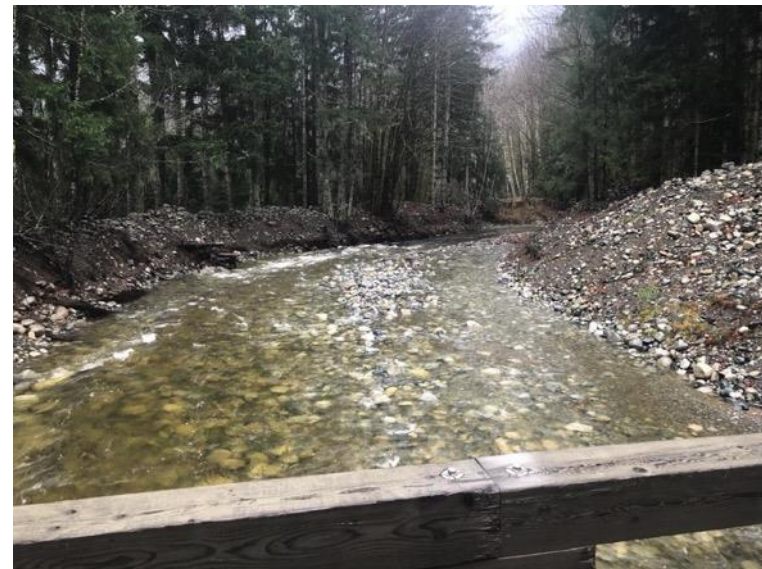
4.) R18 – Dash Creek sediment deposits at road crossing

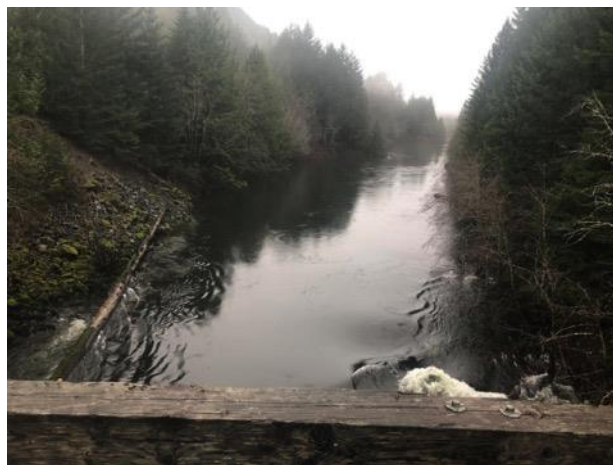
Alteration features in the river were relatively few but significant (Poor) in Reaches 3 and 16. Reach 3 has a 435m long alteration of the south bank from the concrete and rock Pulp Mill water intake infrastructure. This site has virtually no trees and no natural stream bank. Reach 16 above First Lake has a bridge footing and associated dredging and 80m of bank armoring.

Reach 16 has 80m armoured bank at bridge.
