**GEOLOGICAL SURVEY OF CANADA
OPEN FILE 8737**

**Photographs taken in the field by E.A. Hodgson
following the 1925 magnitude 6.2 Charlevoix,
Quebec, earthquake**

M. Lamontagne

2020

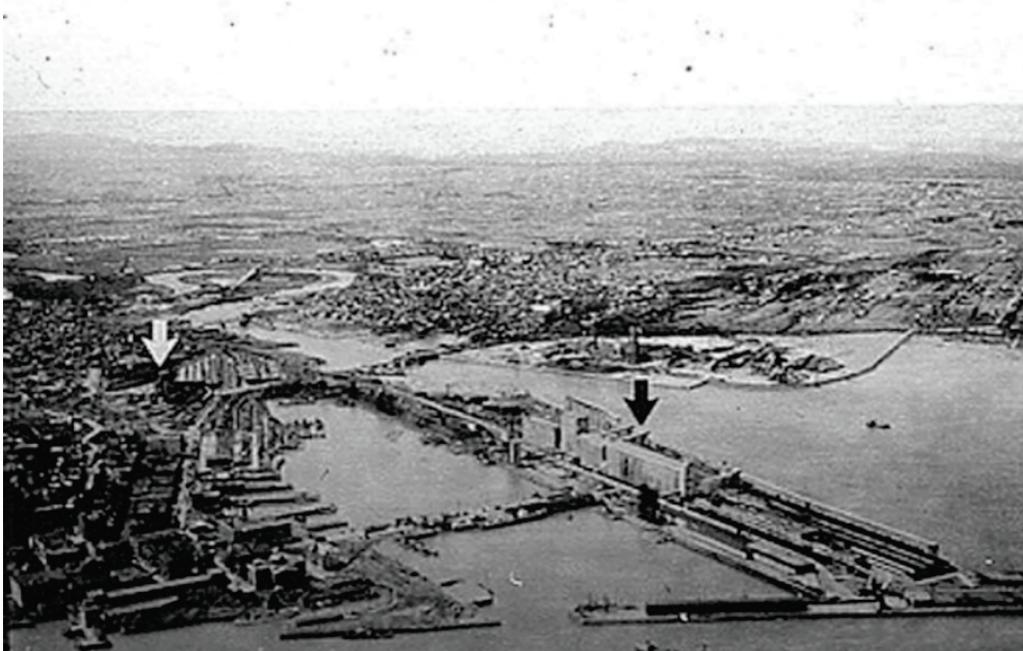
Figure 15: Quebec City : Position of grain elevators (black arrow) and of the Gare du Palais train station (white arrow) in Québec's lower town. This picture was taken in the late 1920s. (*NRCan photo: 2012-076*).
