Issue 2/2025

AVIATION SAFETY LETTER

TP 185E

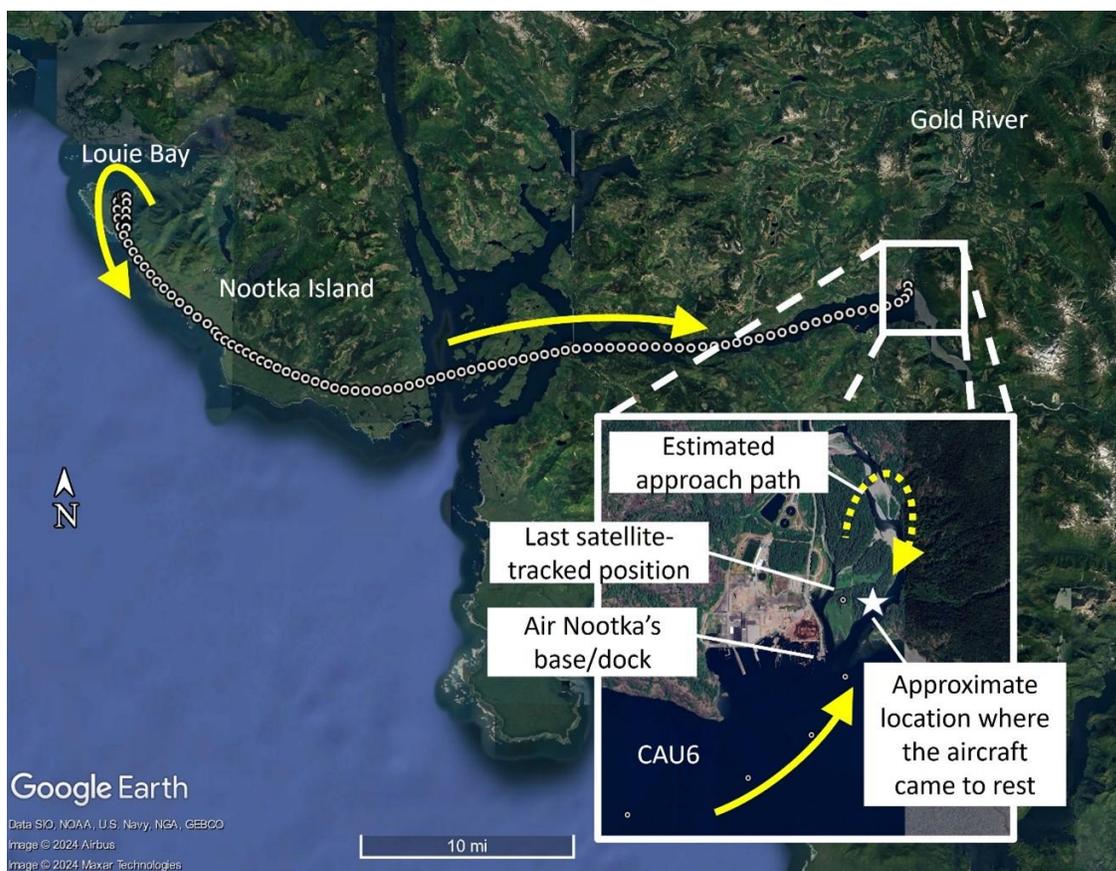
Figure 1: Recorded and estimated flight track of the occurrence aircraft
(Source: Google Earth and Spidertracks data, with TSB annotations)

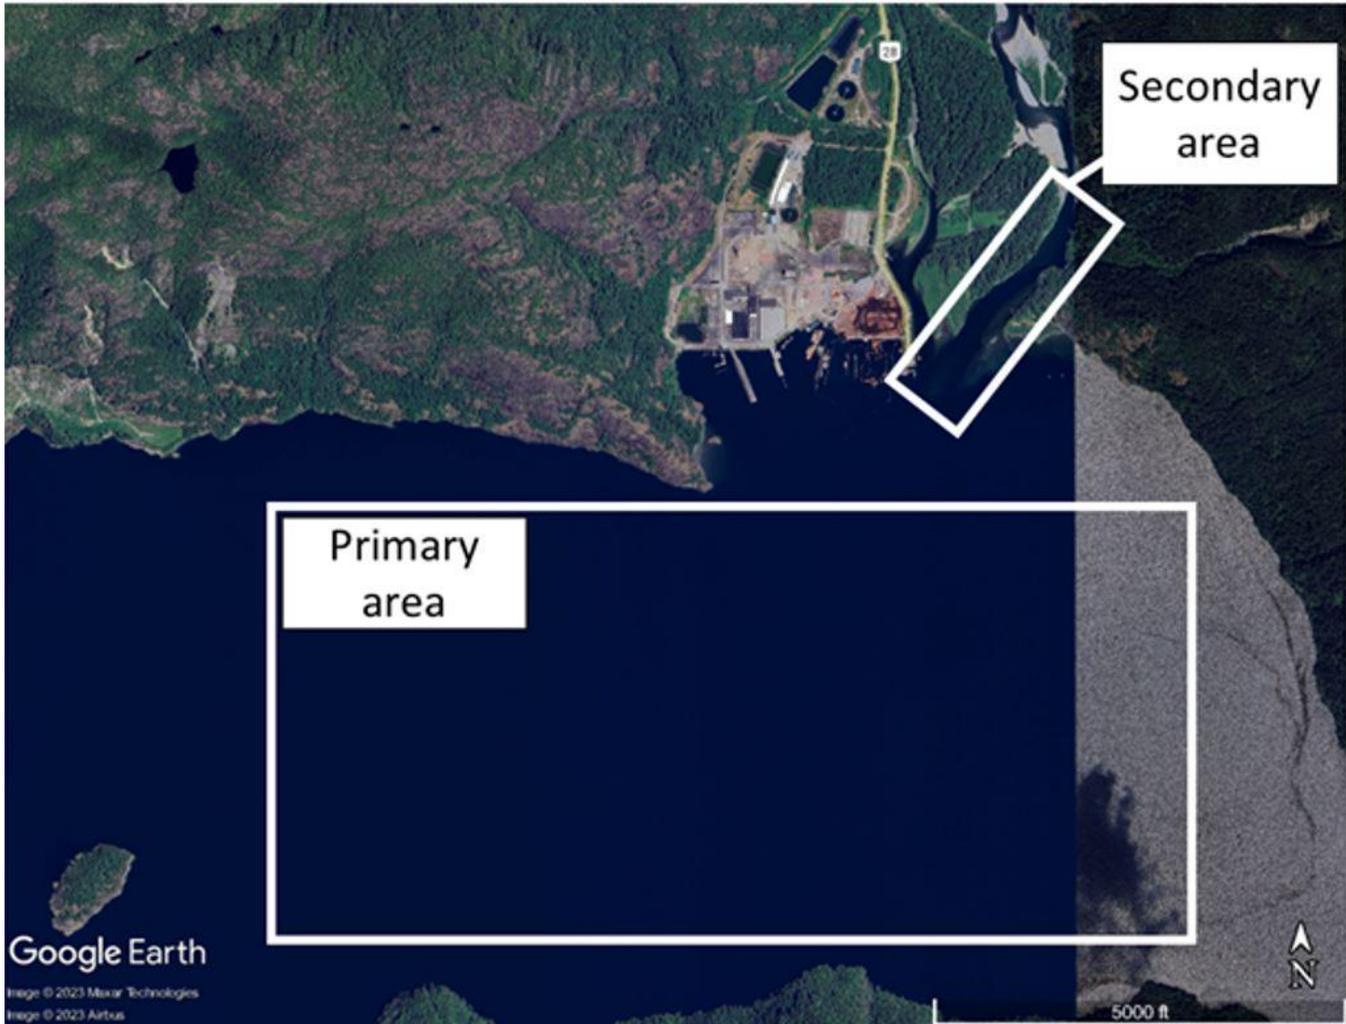
When the sea state is undesirable, the operator's recommendation for takeoff and landing is to use the southwest portion of the Gold River mouth (marked as the secondary area in Figure 2), which provides approximately 1 700 ft of surface. This secondary area may be shielded from the winds affecting the inlet, but the winds aloft in this area, as noted by the operator, have been observed to be unpredictable (Figure 2).

*Figure 2: Gold River Water Aerodrome operating areas
(Source: Google Earth, with TSB annotations based on operator description)*

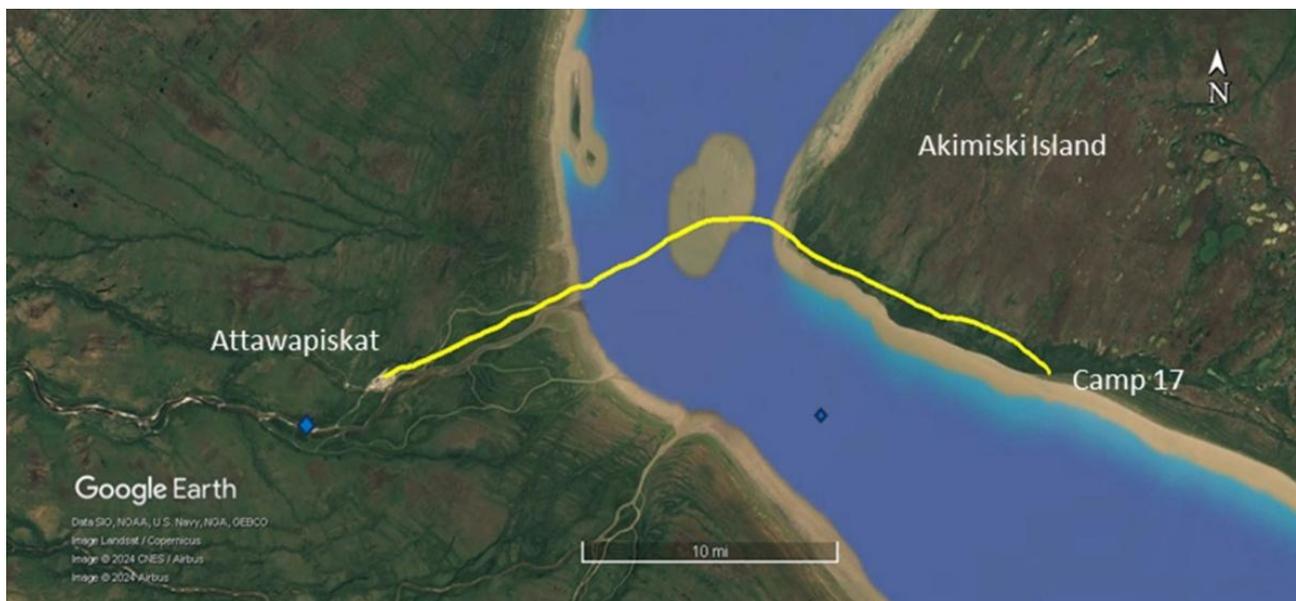
Figure 1: Occurrence flight path (Source: Google Earth, with TSB annotations)

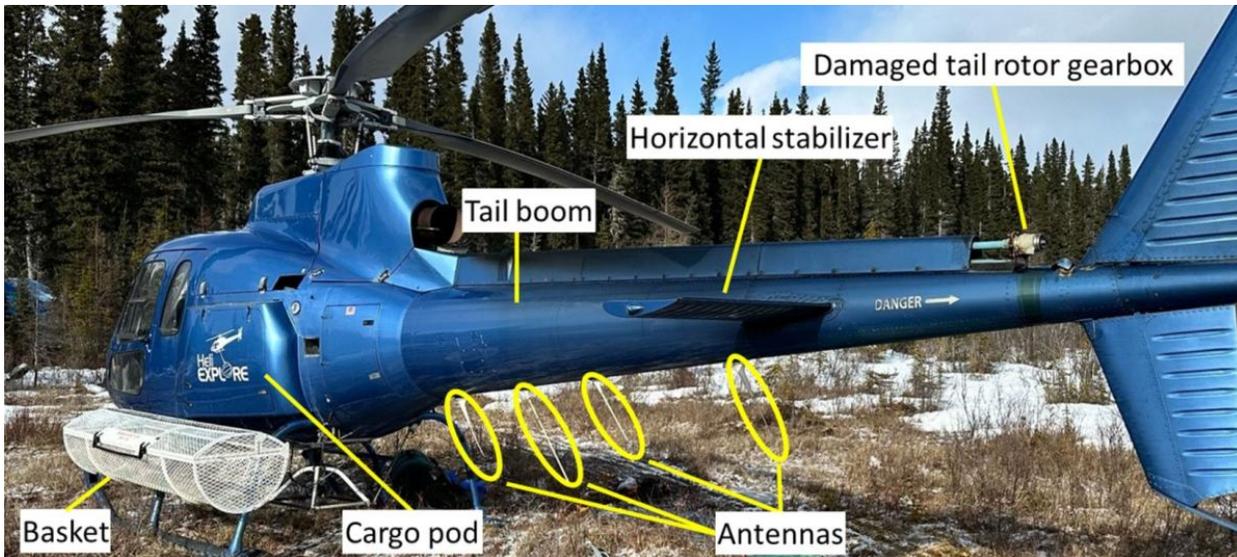
The snowmobile driver saw that the passenger was approaching the back of the helicopter and tried to warn him by yelling and gesturing for him to stay away from the back of the helicopter. The passenger continued along the left side of the tail boom toward the back of the helicopter, past four antennas mounted below the tail boom and past the left-side horizontal stabilizer (Figure 2). He then ducked under the tail boom, aft of the horizontal stabilizer, but forward of the tail's vertical fin. As he crossed to the right side, he was struck by the spinning tail rotor¹ and was fatally injured. The impact caused the tail rotor and most of the tail rotor gearbox to detach from the helicopter.

Figure 2: Occurrence helicopter (Source: Heli Explore Inc., with TSB annotations)

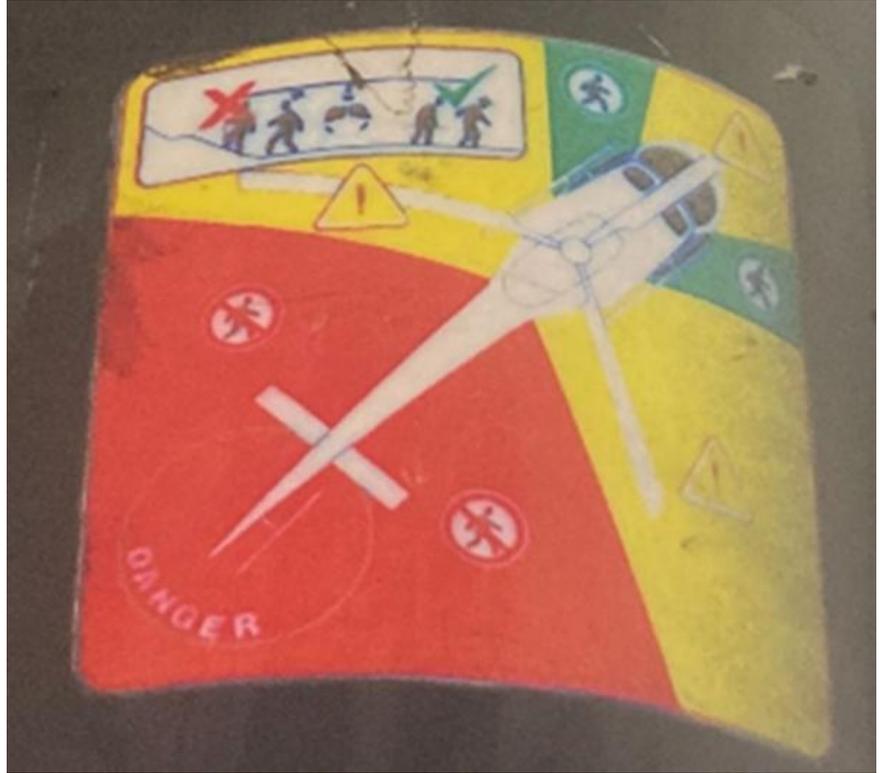
Figure 3: Occurrence helicopter's safety

An aircraft safety card is another way to inform passengers about the hazards and danger areas of a helicopter. A safety card identifies or depicts in graphic form emergency exits, proper use of safety belts, how to approach and leave the helicopter, and danger areas such as engine exhaust areas and main rotor and tail rotor arcs. The occurrence helicopter had this information in a safety card and on a placard (Figure 3) that was on the back of the front seats.

Pilots are reminded to ensure that all passengers and ground personnel are briefed on and understand the hazards of helicopter danger areas, especially the tail rotor, when moving about a helicopter with its engines running and rotors turning.
