INVESTIGATION OF TIE PLATE ICING/ICE JACKING for Transport Canada

P-22-011

October 24, 2022

Executive Summary

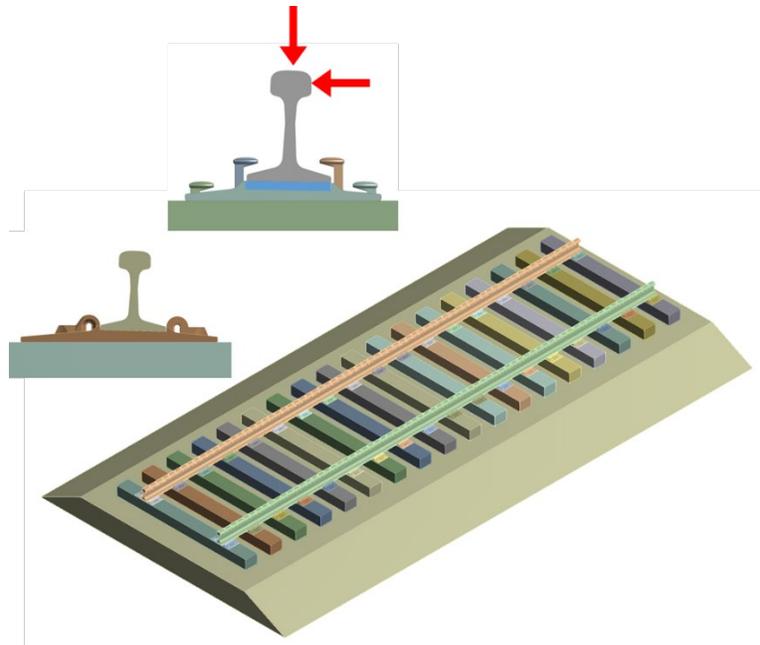
Figure 12. FE model for tie plate icing

A FE model has been established to further understand the tie plate icing issue. The model is capable of simulating a detailed rail-fastener-tie system with ballast support as shown in Figure 12, and it will mainly be used to evaluate the track gage strength when tie plate icing occurs. By simulating various track situations, some of which are not efficient and economical to obtain in the field, the model could provide a quick and useful understanding of how different variables
