National Energy Board

## Reasons for Decision

Review of Recommendation 5.9: Integrity of Existing Pipelines, of the National Energy Board Report MH-2-85 dated June 1986.

An Accident on 19 February 1985 Near Camrose, Alberta, on the Pipeline System of the Interprovincial Pipe Line Company Limited

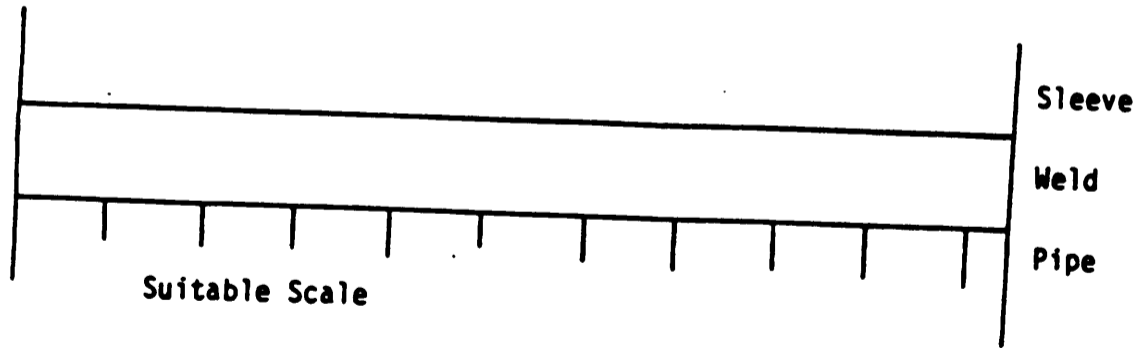
**Figure A3-7**  
**Display Schematic**
