HIGH-RISE APARTMENT REPAIR NEEDS
ASSESSMENT IN THE FORMER CITIES
OF TORONTO AND YORK

HIGH-RISE APARTMENT REPAIR NEEDS ASSESSMENT IN THE FORMER CITIES OF TORONTO AND YORK

CMHC
and
The Former Cities of Toronto and York

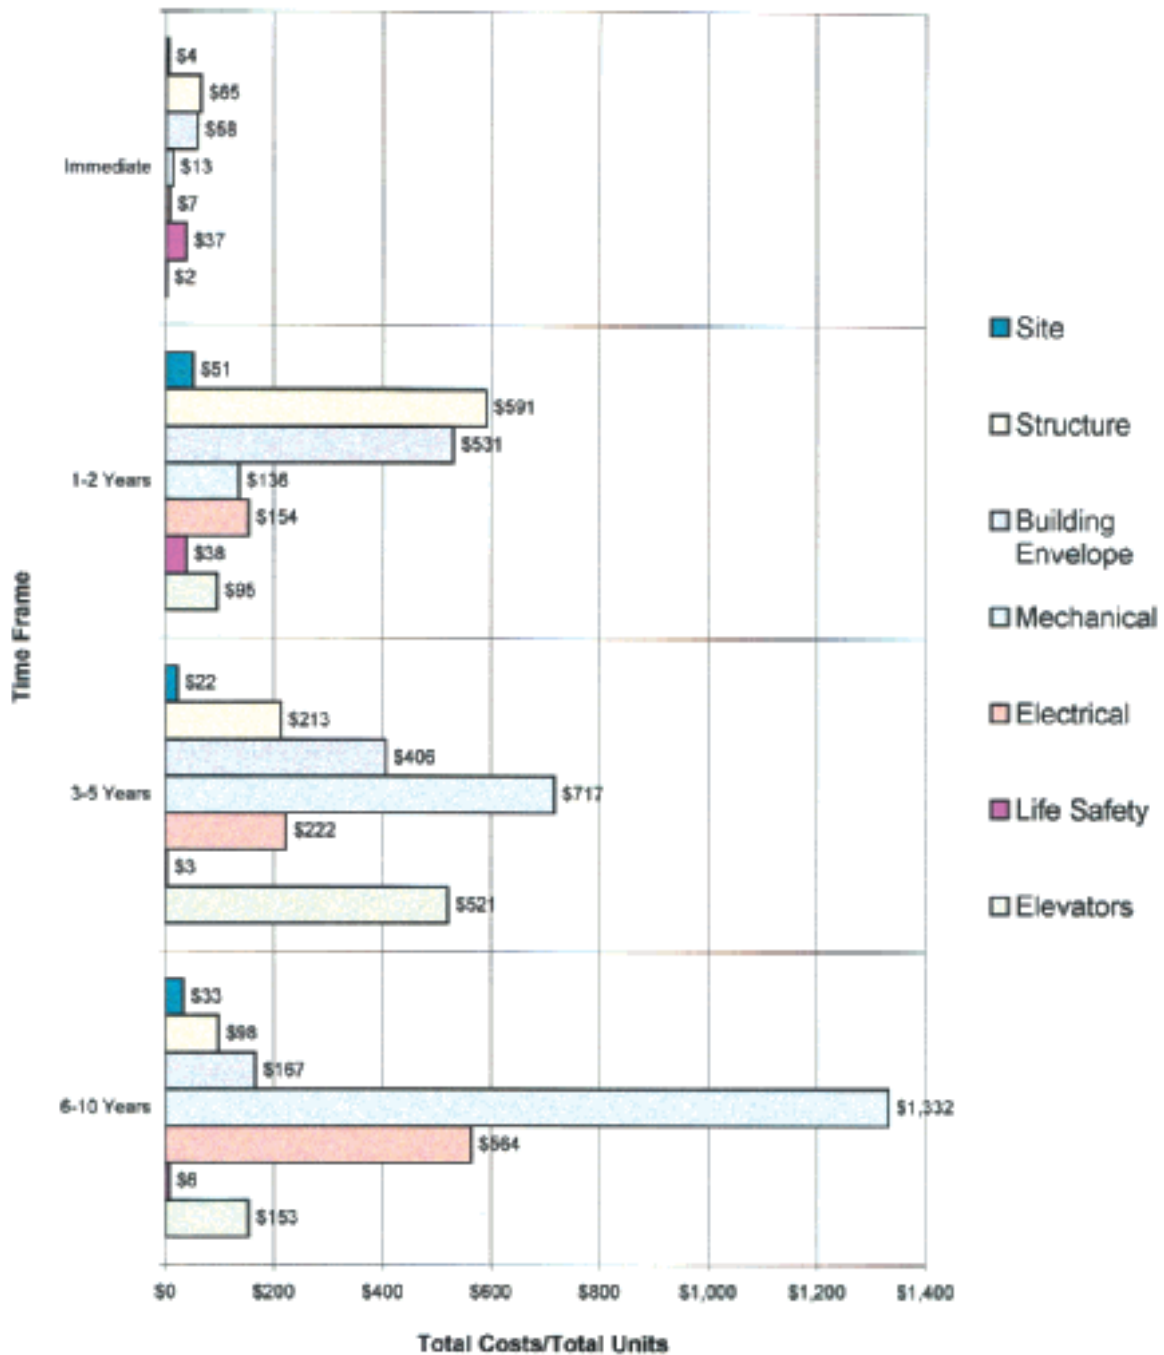
**Chart 1. Replacement Costs
by Time Frame and Building Component**

All costs are expressed in terms of dollars per apartment unit. The distribution of costs is shown on Chart 1: "Replacement Costs by Time Frame and Building Component" on the following page. As can be seen on the chart, the costs have been distributed over four time periods for the seven building systems.

The greatest cost in the Immediate period and the 1 to 2 year period applies to the Structure and Building Envelope. The greatest cost in the 3 to 5 year period and the 6 to 10 year period applies to the Mechanical and Electrical systems. Elevators produce high costs in 3 to 5 years. Life Safety system repairs are generally low cost as most have been done.

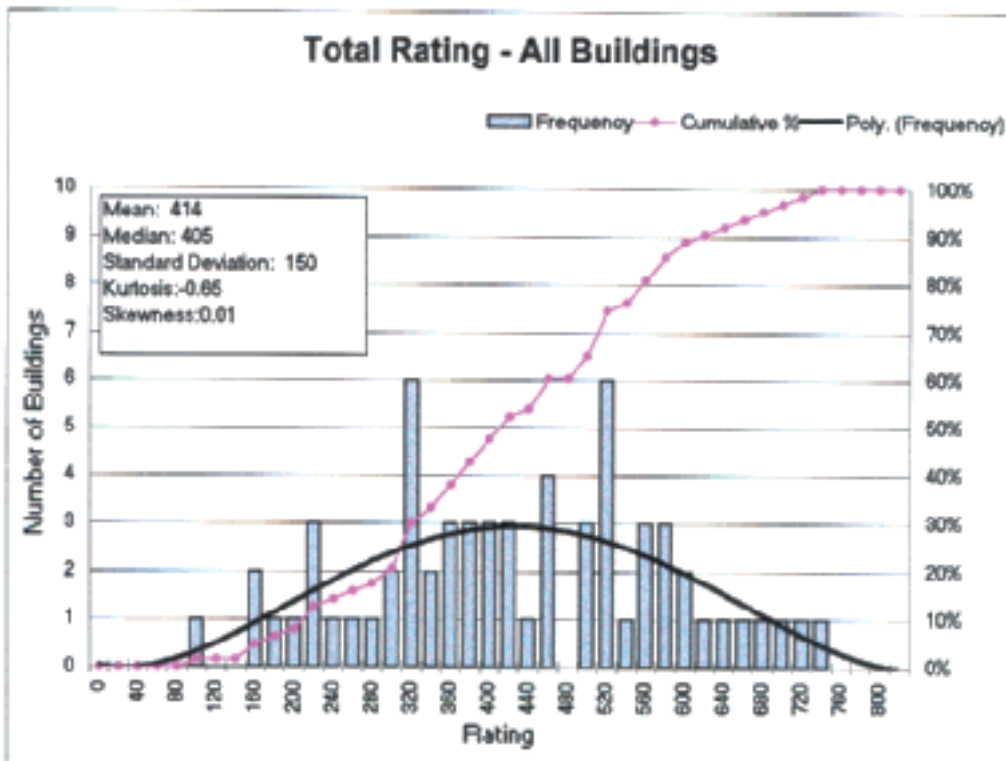
All Buildings Costs per Unit and Ratings

The shape of the cost/unit distribution for the sample is skewed to the right by the buildings that have the greatest cost per unit. Five of the seven buildings are pre-1960s buildings with only 40 or fewer units. Table F-1, included in Appendix F, tabulates the ratings and the per-unit costs for the highest cost buildings by each of the seven systems. The only incidences in which the maximum rating (most urgent repair need and greatest impact of failure) corresponds to the maximum cost per unit are Building 52, mechanical systems, and Building 32, life safety systems. In the case of Building 52, the building is over 40 years old, has 60 suites and requires \$10,500/unit in mechanical system replacements. In the case of Building 32, the building is over 60 years old, has 35 suites and needs a fire alarm system, a siamese connection and an emergency power system. A detailed description of the repair needs for the highest cost buildings is included in Appendix F.
