CMHC Dehumidifier Field Study

Final Report

Buchan, Lawton, Parent Ltd
5 – 5370 Canotek Road
Ottawa, Ontario K1J 9E6

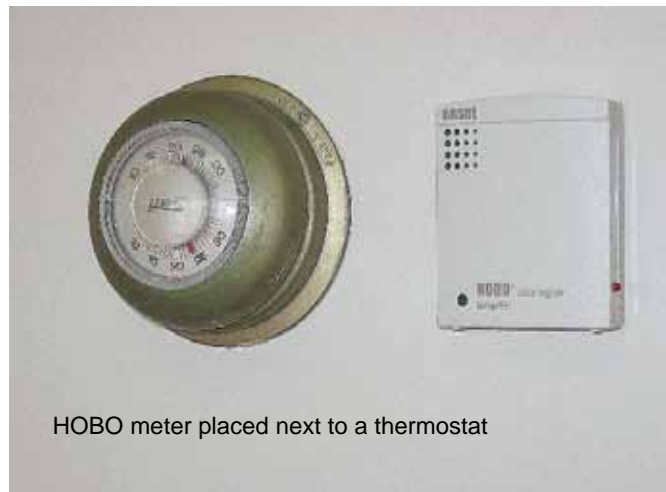
HOBO meter placed next to a thermostat

1. Locate the basement data logger close to the planned location for the dehumidifier (within five metres).
2. Avoid locating the data logger adjacent to any exterior walls or doors.
3. Locate the second data logger on the main floor avoiding the kitchen, bathrooms, a source of heat (such as a television or lamp), or an exterior wall or door.
(Participants were given the recommendation to locate the data logger beside the furnace thermostat or in a hallway.)
4. Place the data logger approximately 1.5 to 2 metres above the floor on a wall (or on an interior column in the basement) using the mounting kits included with the HOBO.

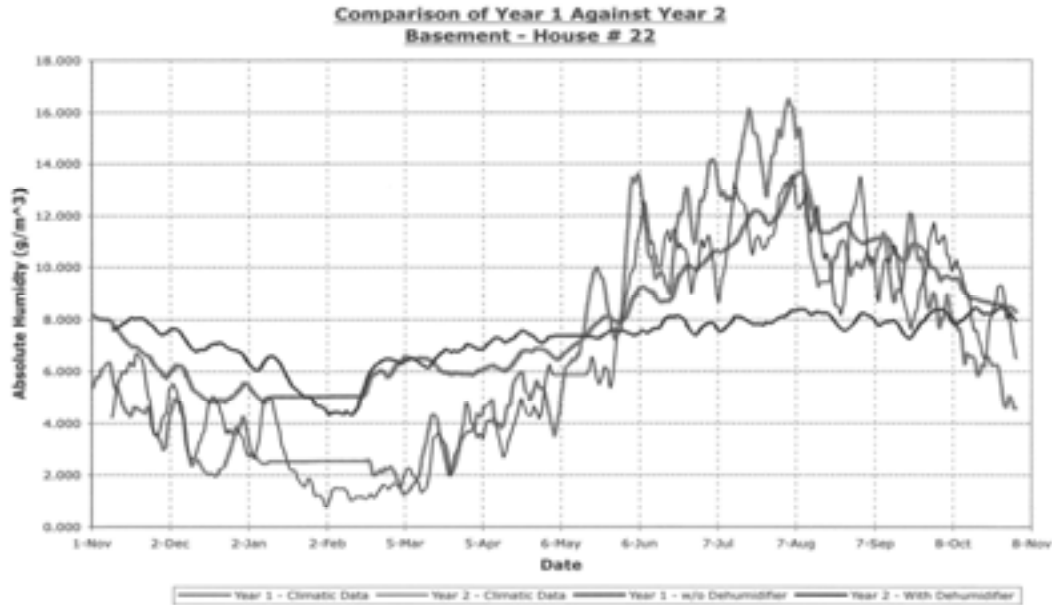
Figure 5.1 Comparison of Year 1 against Year 2 Indoor and Outdoor Absolute Humidities

Figure 5.1 compares the absolute humidities (moisture content) of the basement air in year 1 (without a dehumidifier) and year 2 (with a dehumidifier) of House #22. The climatic data retrieved from Environment Canada for the location of the subject house for both years, also shown in the figure, are superimposed. As was expected, the indoor absolute humidities during the winter months were higher than those of outdoor air. During the warm months, from May to the beginning of October, the indoor absolute humidities followed closely that of the outside air on Year 1, with a peak in early August. In Year 2, when the dehumidifier was running, the indoor absolute humidity remained nearly constant and lower than the outdoor absolute humidity during the warm months from May to October.

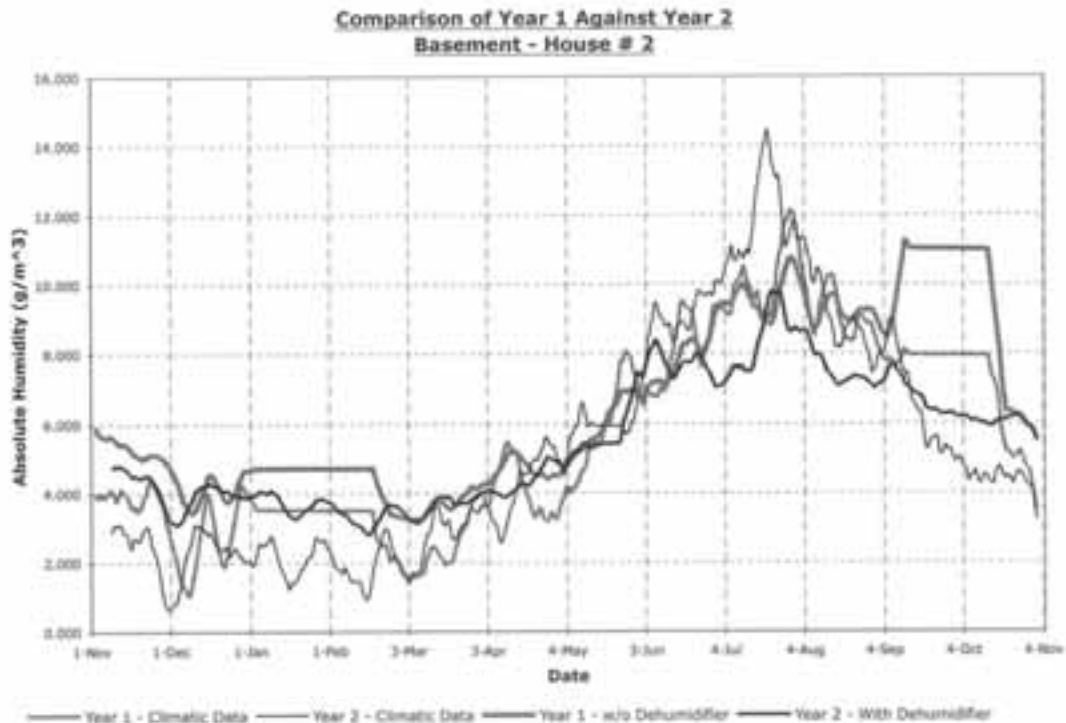
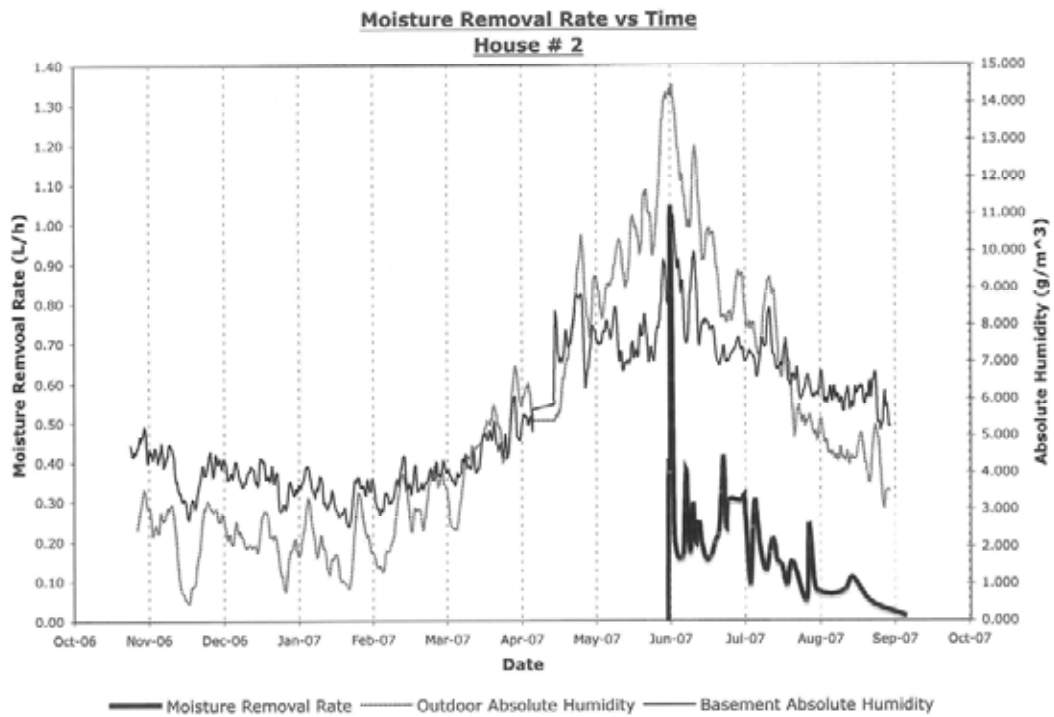
House #2, Sherwood Park, Alberta

Description	Household	Moisture Indicators	Observations
<ul style="list-style-type: none"> -Two storey detached -Built: 1991, 135 m² -Partially finished basement, full depth. -Insulated concrete and vapour barrier. -Pitched roof. Wood frame, R20 Fibreglass insulation -Double-glazed windows -Weeping tile, sump pump (covered), ground slopes away from home, and eavestroughs. -Force air gas furnace, and wood fireplace. 	<ul style="list-style-type: none"> -2 occupants -Temperature: 20°C day; 18°C night -Windows open for ventilation in summer, and sometimes open in spring and fall. Basement windows not opened. -Furnace fan only on when furnace is on 	<ul style="list-style-type: none"> -Bathrooms have fans -1 shower a day, 2 loads of laundry per week -Surrounding properties slope towards house; heavy rains cause sump to fill at regular intervals -No flooding problems -No leakage problems -Located in wet area -No humidifier used in the winter 	<ul style="list-style-type: none"> -Improvement in indoor vs. outdoor humidity levels in 2nd year when using the dehumidifier. -Despite increase in climatic moisture levels for second year, wood moisture content in wood appears to have decreased. -Peak Moisture removal rate approximately 1.1 L/h -Average removal rate approximately 0.15 L/h

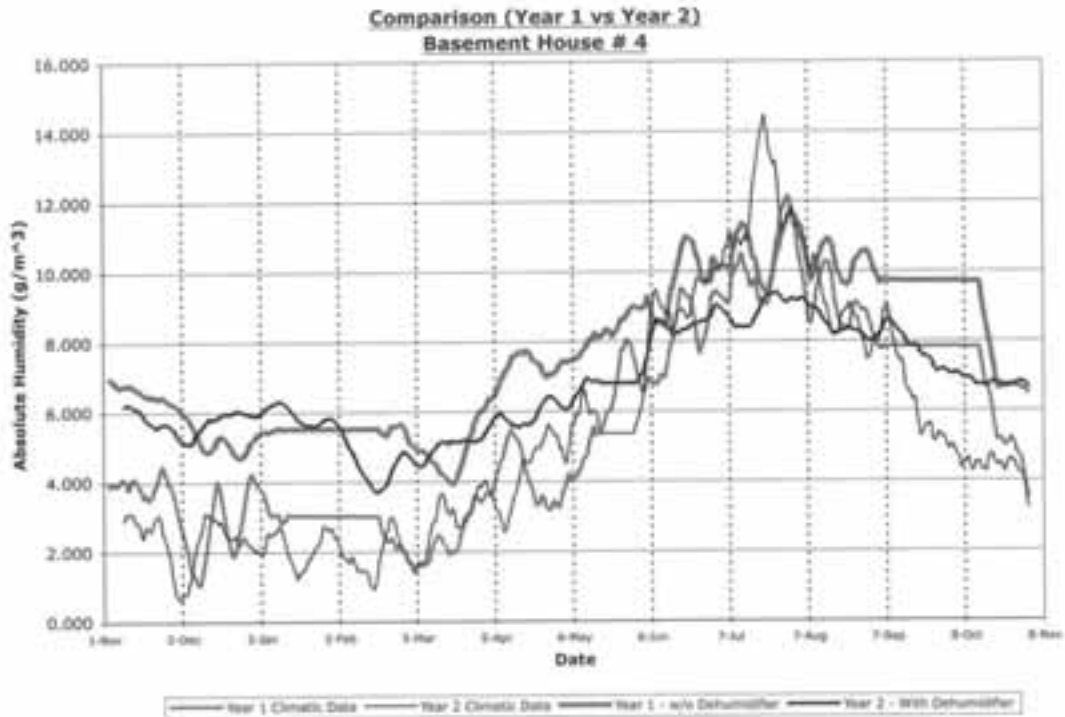
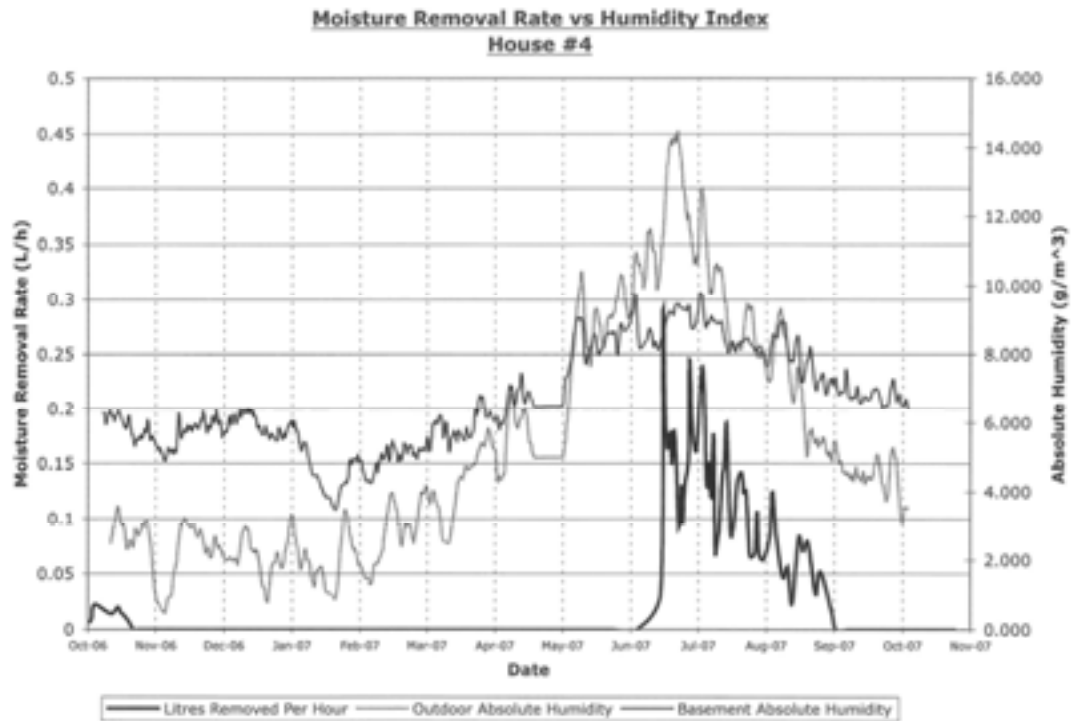
House #4, Sherwood Park, Alberta

Description	Household	Moisture Indicators	Observations
<ul style="list-style-type: none"> -Bungalow condominium -Built: 1998, 128 m² -Unfinished basement, full depth -Vapour barrier and concrete foundation -Pitched roof, with vented attic. Wood frame and fibreglass insulation -Double-glazed windows -Weeping tile, ground slopes away from home, sump pump (covered), and eavestroughs -Force air gas furnace with wood fireplace 	<ul style="list-style-type: none"> -2 occupants -Summer temperature: 19°C day; 15°C night -Winter temperature: 16°C day; 12°C night -Windows open for ventilation in summer -Basement windows not opened 	<ul style="list-style-type: none"> -Bathroom fans always used when showering -2 showers a day, 4 loads of laundry per week -Sump pump is loosely covered -Condensation on inside of window pane during winter months -No flooding problems -Leakage: Concrete foundation cracked, water penetrated, pooling in basement. (Fixed) -Humidifier used in winter 	<ul style="list-style-type: none"> -Drastic improvement in indoor vs. outdoor humidity levels in 2nd year when using the dehumidifier. -Moderate moisture removal rates. -Peak moisture removal rate approx. 0.3 L/h -Average moisture removal rate approx. 0.1 L/h -Observed minor improvements in wood moisture contents in 2nd year.

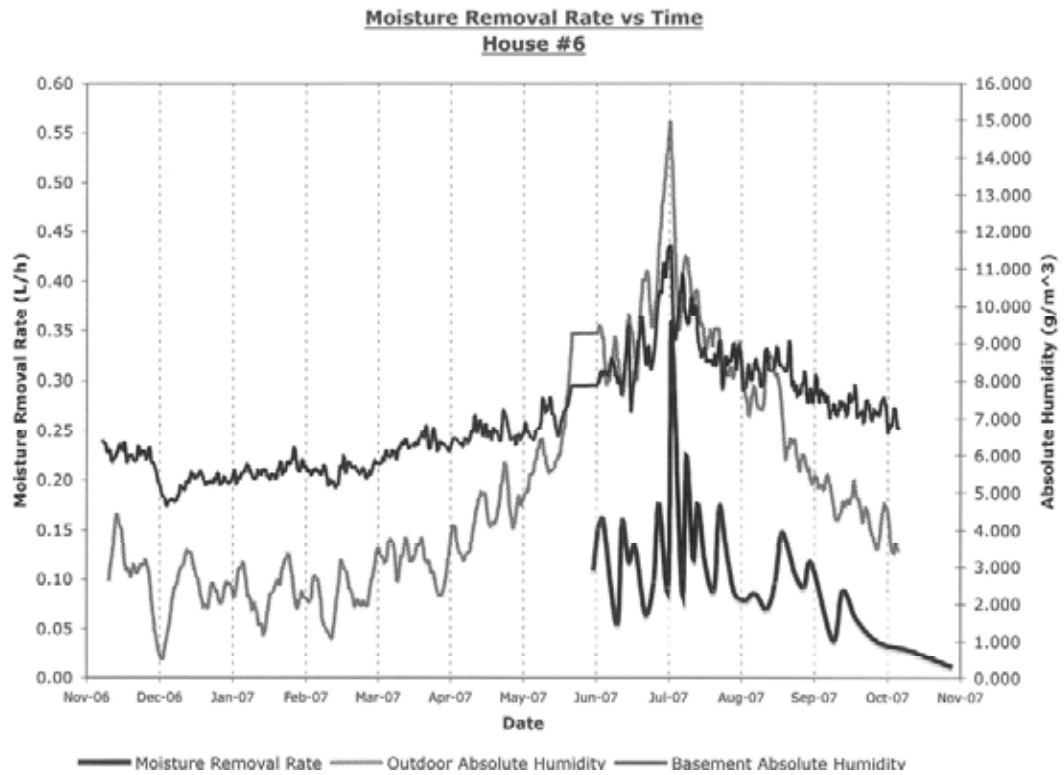
House #6, Calgary, Alberta

Description	Household	Moisture Indicators	Observations
<ul style="list-style-type: none"> -Detached single -Built: 1912, 88 m² -Finished basement, full depth, rubblestone walls -Insulated walls and vapour barrier, concrete foundation -Vented attic. Wood frame, 40% blown in, 60% Fibreglass insulation -Double-glazed windows -Eavestroughs -Forced air gas furnace with wood fireplace 	<ul style="list-style-type: none"> -1 occupant -Summer temperature: 23°C day; 18°C night -Winter temperature: 18°C day; 18°C night -Windows open for ventilation in spring, summer and fall. Basement windows open in July/August -Furnace fan only on when furnace is on -New wiring, plumbing, and windows installed in 1995. Washroom installed in basement in 2000 	<ul style="list-style-type: none"> -Primary bathroom without fan. Basement bathroom fan always used when showering -1 shower a day, 3 loads of laundry per week -No flooding problems -Leakage: Exterior tap pipe broke, large amounts of water in basement. Carpet dried and tap replaced. (Fixed, 2002) Record rainfall caused seepage through walls in cold room. (Fixed, 2005) -Humidifier used in winter 	<ul style="list-style-type: none"> -Fair reduction in indoor vs. outdoor humidity levels in 2nd year when using the dehumidifier -Seasonal fluctuations in indoor humidity level reduced. Humidity levels appear to be more constant. -Moderate moisture removal rates -Peak removal rate approx. 0.37 L/h -Average removal rate approx. 0.15 L/h -Insufficient information for wood moisture results

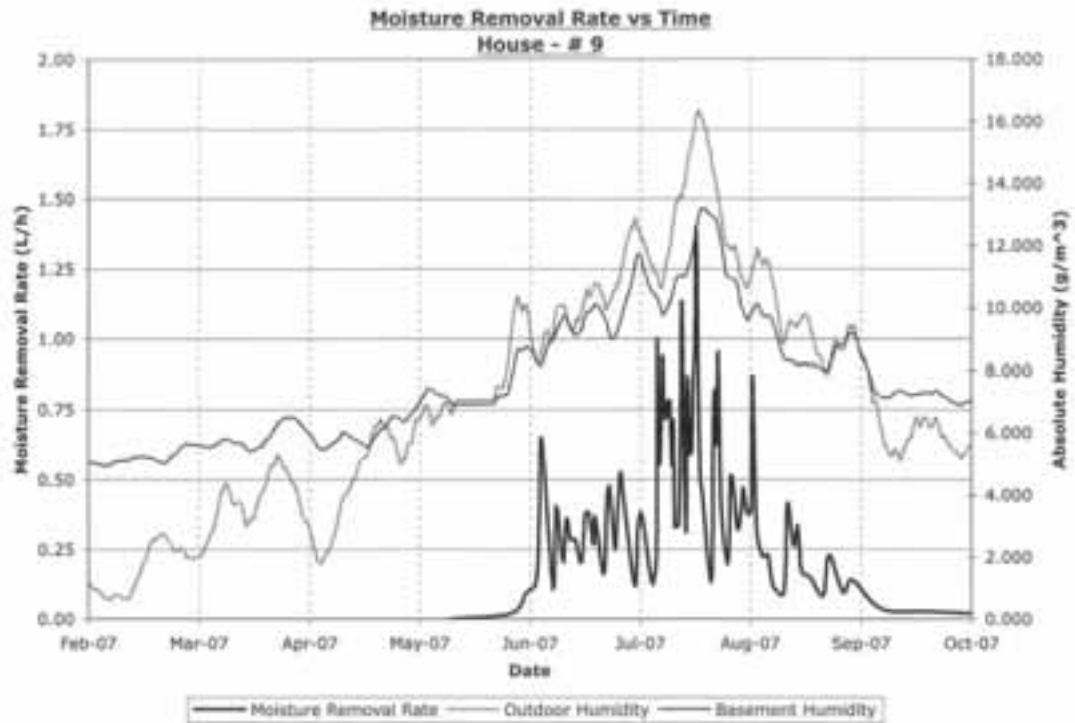
House #9, Grenfell, Saskatchewan

Description	Household	Moisture Indicators	Observations
<ul style="list-style-type: none"> -Detached bungalow -Built: 1984, 136 m² -Finished basement, full depth -P/T wood walls and foundation, on dirt/sand -Pitched roof. Wood frame. Unknown insulation type -Double-glazed energy efficient windows -Weeping tiles, sump pump (not covered) and eavestroughs -Forced air electric furnace 	<ul style="list-style-type: none"> -3 occupants -Summer temperature: 25°C day; 20°C night -Winter temperature: 19°C day; 17°C night -Windows open for ventilation in spring, summer, and fall, including basement window -Furnace fan running at all times in winter 	<ul style="list-style-type: none"> -Bathrooms have fans. Kitchen range only used if windows are closed -2.5 showers a day, 10 loads of laundry per week -Mold on exterior wall baseboard in basement bedroom (Fixed, 2005) -No flooding problems -Leakage: Service pipe broke inside house, 2" of water into basement, seeping through wood floor into crawl space (2003) -No humidifier in the winter 	<ul style="list-style-type: none"> -Fair reduction in indoor vs. outdoor humidity levels in 2nd year when using dehumidifier. -Excellent moisture removal rates -Peak moisture removal rate approx. 1.3 L/h -Average moisture removal rate approx. 0.5 L/h -Moisture removal corresponds closely with increase and decrease in outdoor humidity levels -Drastic reduction in Header at North wall. No significant reduction otherwise.

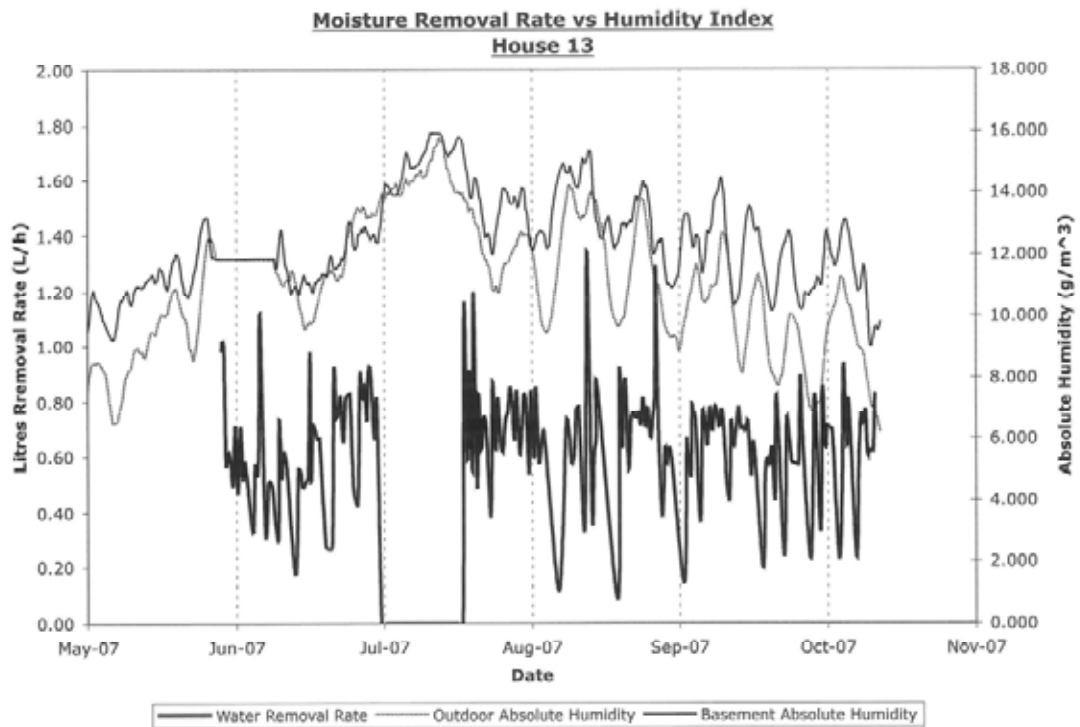
House #13, Yarmouth, Nova Scotia

Description	Household	Moisture Indicators	Observations
<ul style="list-style-type: none"> -Two storey detached -Built: 1919, 179 m² -Unfinished basement, full depth, with crawl space. -No listed barriers or insulation in concrete foundation. Crawl space rests on dirt/sand -Pitched roof with vented attic. Wood frame, unknown insulation type -Single pane windows on first floor, and double glazed on second -Weeping tiles, ground slopes away from home, and eavestroughs -Cast iron hydronic radiators with oil-fired boiler for heating 	<ul style="list-style-type: none"> -5 occupants -Summer temperature: 22°C day; 20°C night -Winter temperature: 20°C day; 18°C night -Windows open for ventilation in spring, summer, and fall. Basement windows not opened -No furnace fan 	<ul style="list-style-type: none"> -Primary bathroom has fan, secondary bathroom without a fan -4 showers a day, 7 loads of laundry per week, and no dishwasher -Located in wet area -Smells never linger -No flooding problems -Leakage: Occasional leak at bulkhead of exterior entrance into basement due to hydrostatic pressure. Concrete floor improperly poured. (Unresolved) -No humidifier in the winter 	<ul style="list-style-type: none"> -No significant improvement in indoor vs. outdoor humidity levels -Periods where indoor humidity levels exceed those of corresponding climatic levels. -Excellent moisture removal rates despite no significant reduction in indoor humidity levels. -Peak rate approx. 1.4 L/h -Avg. rate approx. 0.75 L/h -Moisture removal over 6-month period. -No significant change in wood moisture levels.

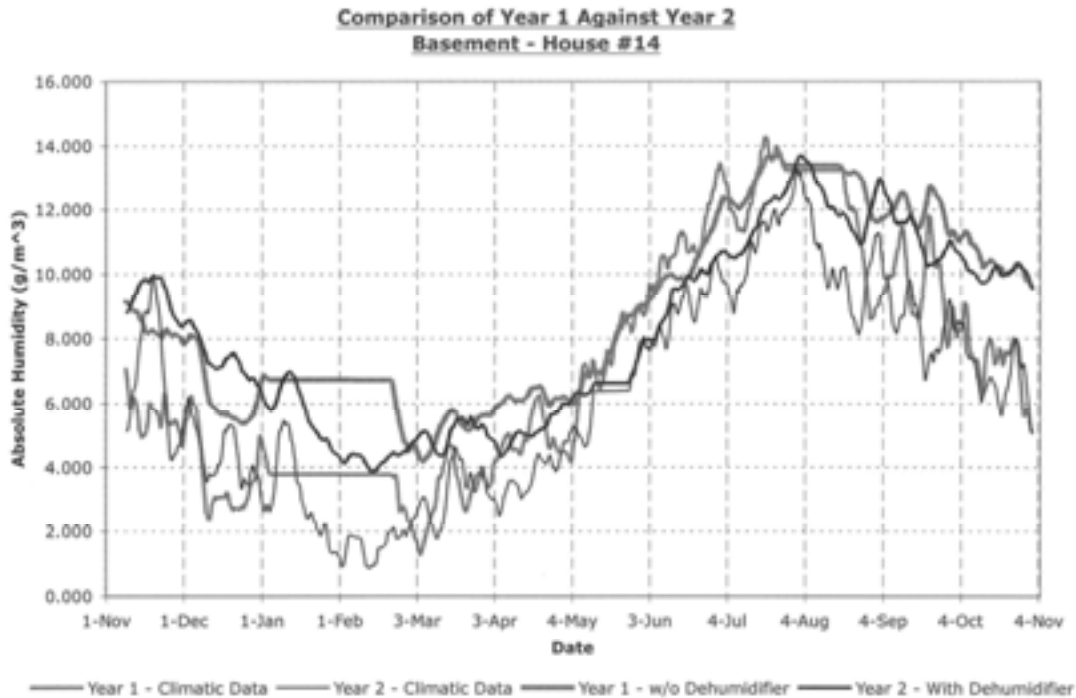
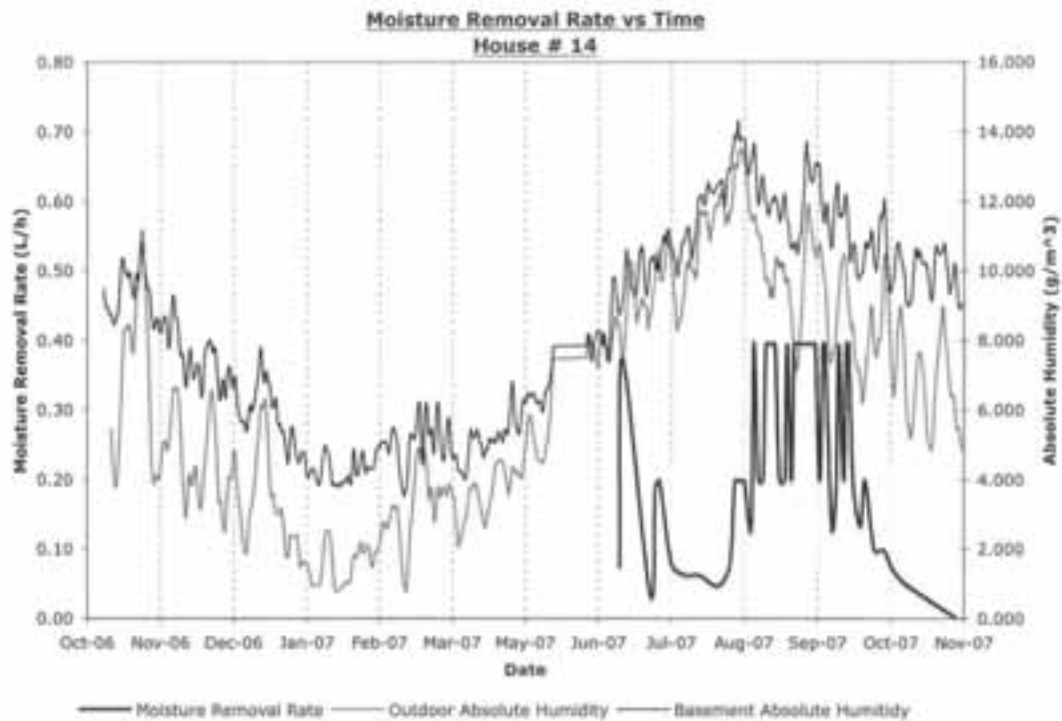
House #14, Corn Hill, New Brunswick

Description	Household	Moisture Indicators	Observations
<ul style="list-style-type: none"> -Two story detached -Built: half -1900, with extensive renovations, other half -1984, 102 m² -Unfinished basement, full depth -No listed barriers or insulation in concrete foundation -Vented attic. Wood frame, 40R fibreglass insulation -Half double-glazed windows, half double-glazed plus energy efficient -Weeping tiles, and eavestroughs -Forced air wood furnace 	<ul style="list-style-type: none"> -2 occupants -Temperature: 20°C day; 18°C night -Windows open for ventilation in summer. Opened occasionally in spring and fall. Seldom open in winter. Basement windows not opened -Furnace fan only when furnace is on -New windows and improved insulation (1985) 	<ul style="list-style-type: none"> -Bathrooms without fans. Kitchen without fume hood -2 showers a day, 6 loads of laundry per week, and 12 hours of cooking per week -Wood for furnace is stored indoors -No flooding problems -Leakage: Blocked drain pipe in basement (Fixed) -No humidifier in the winter 	<ul style="list-style-type: none"> - No significant improvement in indoor vs. outdoor humidity levels -Periods where indoor humidity levels exceed those of corresponding climatic levels. -Fair moisture removal rates. -Several peak moisture removal rates: 0.4 L/h -Avg. rate approx. 0.25 L/h -No observable reduction in wood moisture content. No data available at end of second year.

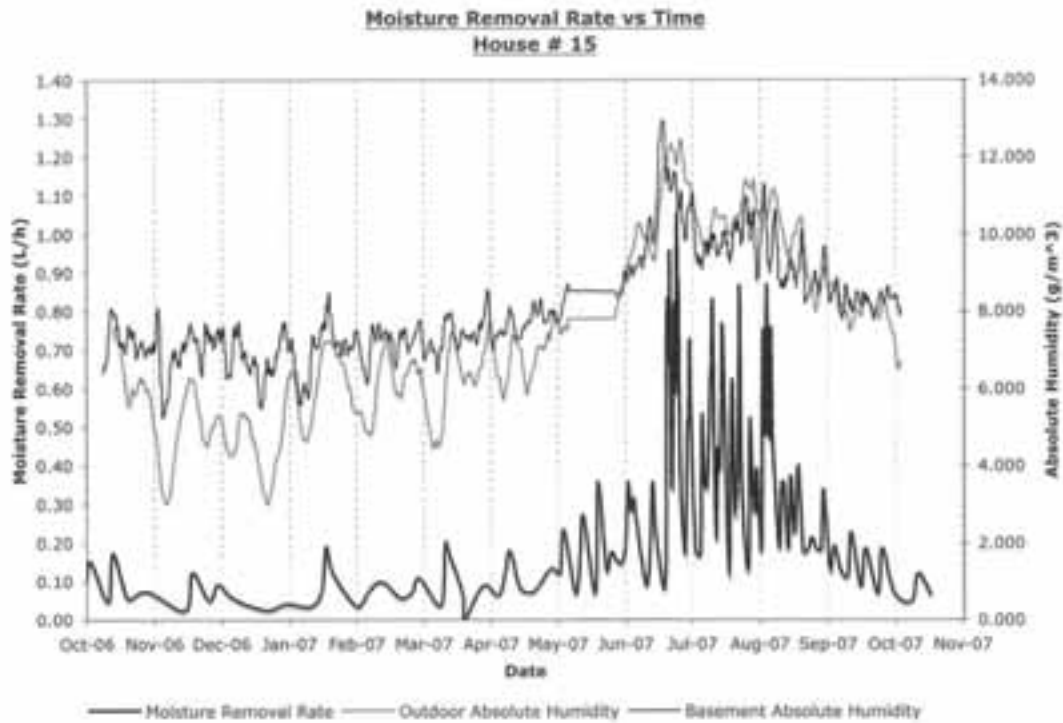
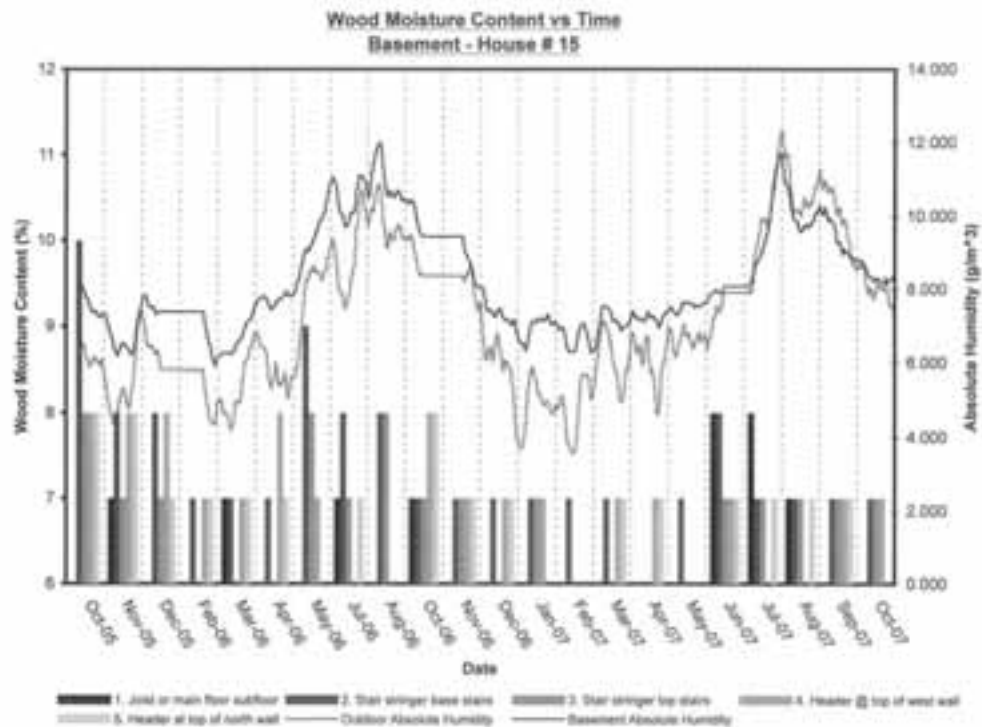
House #15, Campbell River, British Columbia

Description	Household	Moisture Indicators	Observations
<ul style="list-style-type: none"> -Detached single -Built: 1954, 186 m² -Finished basement, full depth -No listed barriers or insulation in concrete foundation -Flat roofed. Wood frame, 21R mineral wool insulation -Double-glazed, low E windows -Weeping tile drainage -Forced air, oil furnace, with fireplace 	<ul style="list-style-type: none"> -2 occupants -Summer temperature: 20°C day; 17°C night -Winter temperature: 21°C day; 16°C night -Windows generally not opened for ventilation. Basement windows opened occasionally in spring summer/fall -Furnace fan only on when furnace is on -Basement finished, increased insulation, and new bath upstairs (1998-2005) 	<ul style="list-style-type: none"> -Primary bathroom without a fan, secondary bathroom fan on moisture sensor -2 showers a day, 2 loads a week, 12 hours of cooking -Odours tend to linger after cooking -No flooding problems -Leakage: Roof around chimney leaks into upstairs kitchen. Flashing on chimney and tar roof both leak (Unresolved) -No humidifier in winter 	<ul style="list-style-type: none"> -No significant reduction in indoor vs. outdoor humidity levels in 2nd year. -Good moisture removal rates. -Moisture removal possible throughout full year. -Peak removal rate approx. 1.05 L/h -Avg. removal rate in summer approx. 0.55 L/h -Avg. removal rate during winter approx. 0.1 L/h -Minor decrease in wood moisture content in 2nd year

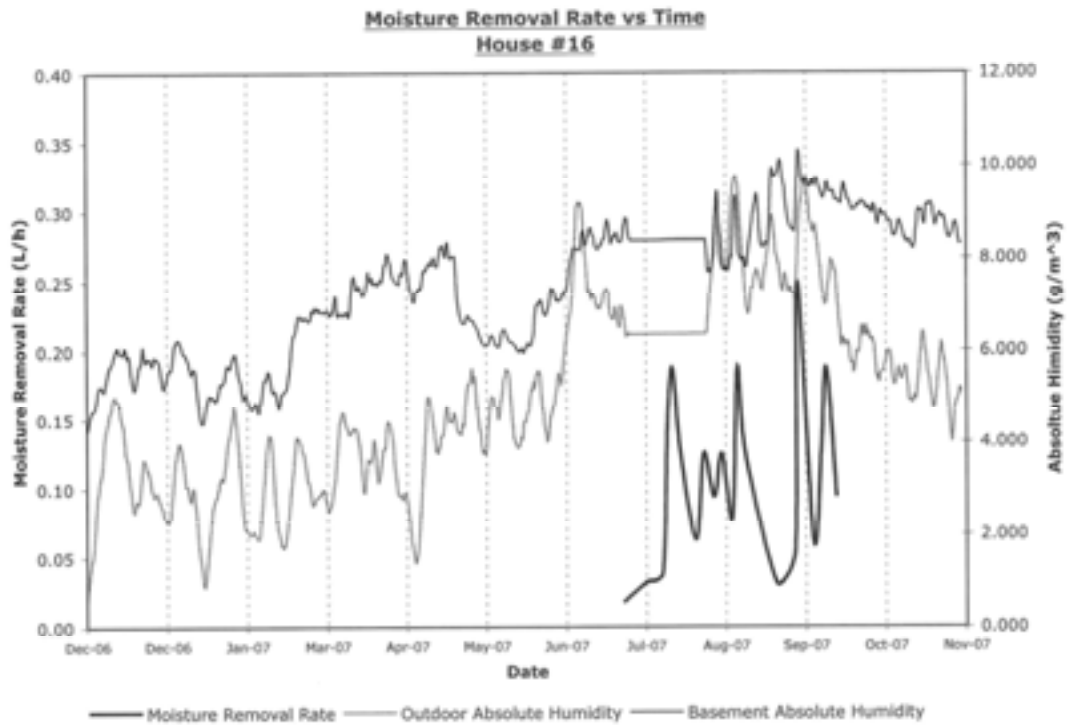
House #16, Prince George, British Columbia

Description	Household	Moisture Indicators	Observations
<ul style="list-style-type: none"> -1.5 storey detached -Built: 1979, 164 m² -Partially finished basement, full depth -No listed barriers or insulation in concrete foundation -Pitched roof with vented attic. Wood frame, 20R fibreglass insulation -Double-glazed windows -Eavestroughs and downspout drainage -Forced air gas furnace, with electric baseboards on top floor and gas fireplace in basement 	<ul style="list-style-type: none"> -2 occupants -Summer temperature: 20°C day; 18°C night -Winter temperature: 20°C day; 16°C night -Windows open for ventilation in summer. Basement windows not opened -Furnace fan on only when furnace is on 	<ul style="list-style-type: none"> -Bathrooms have fans running half the time. -1 shower a day, 1 load of laundry per week -No odour problems -Condensation appears on second story bedroom window, with a tendency to mold on walls on outside perimeter in winter -No flooding problems -Leakage: Copper pipe leak in basement bedroom closet (Repaired) -No humidifier in winter 	<ul style="list-style-type: none"> -No significant improvement in indoor vs. outdoor humidity levels in 2nd year when using the dehumidifier -Low moisture removal levels. -Moisture removal values only significant at peak humidity points -Peak removal rate approx. 0.25 L/h -Average removal rate approx. 0.13 L/h -Insufficient information for wood moisture results

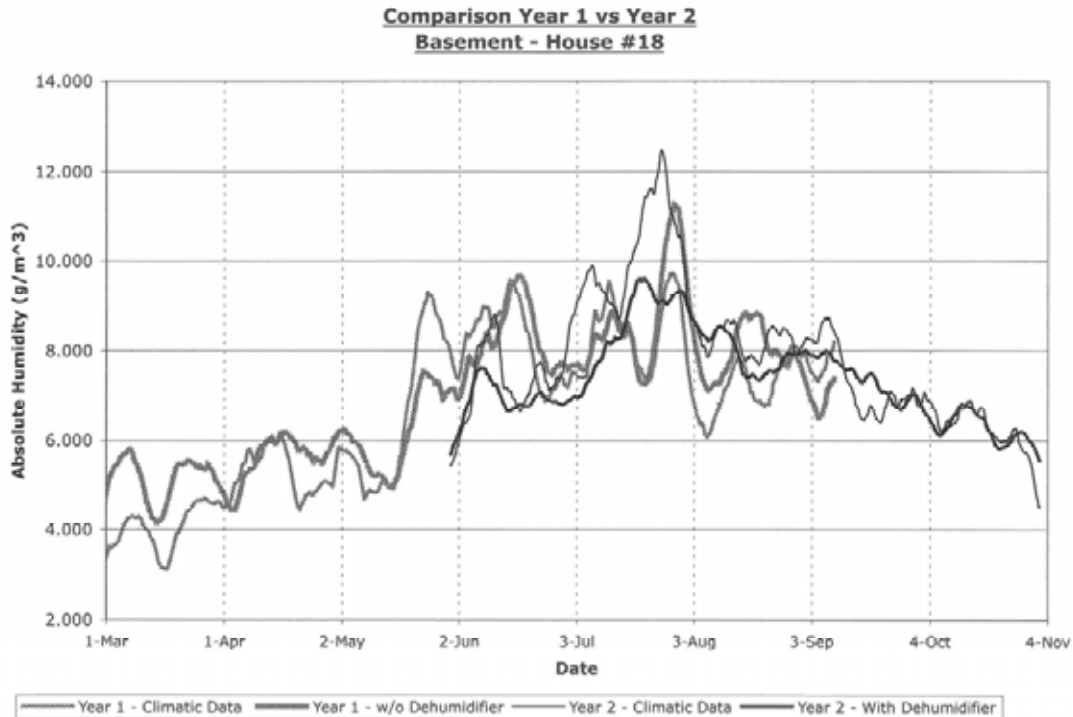
House #18, Lytton, British Columbia

Description	Household	Moisture Indicators	Observations
<ul style="list-style-type: none"> -Detached Bungalow -Built: 1974, 186 m² -Unfinished basement, full depth walk out. -Concrete foundation with drainage membrane -Pitched roof with vented attic. Wood frame, 12R paperback insulation -Double-glazed windows -Weeping tiles, and downspouts -Electric baseboard heating, with woodstove 	<ul style="list-style-type: none"> -2 occupants -Summer temperature: 29°C day; 18°C night -Winter temperature: 15°C day; 15°C night -Windows open for ventilation in spring, summer, and fall. Basement windows only open in summer -No furnace fan 	<ul style="list-style-type: none"> -Bathrooms without fans. Kitchen without fume hood -Take baths instead of showers, 2 loads of laundry per week, and 7 hours of cooking -Musty smell in basement -Located in wet area -No flooding problems -Leakage: Roof had several leaks, causing moldy smell. (Roof replaced, 2005) -No humidifier in winter 	<ul style="list-style-type: none"> -Significant improvement in indoor vs. outdoor humidity levels in 2nd year when using the dehumidifier. -Moisture removal values only significant at peak humidity points -Peak removal rate approx. 0.26 L/h -Average removal rate approx. 0.05 L/h -No observable change in wood moisture content levels from year 1 to year 2.

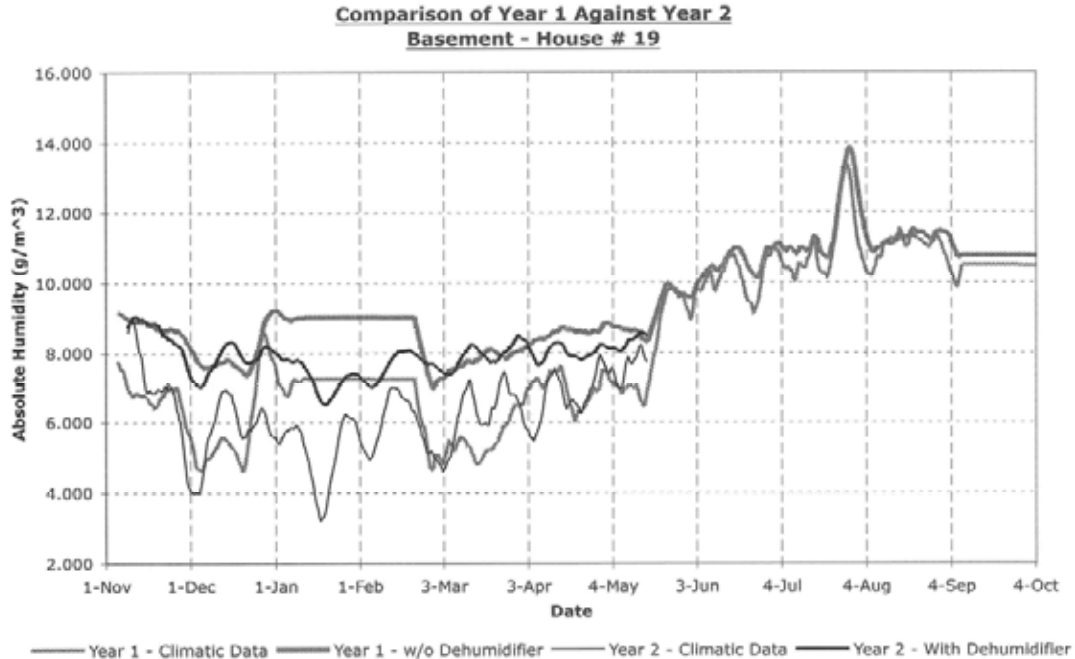
House #19, Burnaby, British Columbia

Description	Household	Moisture Indicators	Observations
<ul style="list-style-type: none"> -Two storey detached -Built: 1994, 242 m² -Finished basement plus crawl space. -Concrete foundation with drainage membrane in walls and vapour barrier in floor -Pitched roof with vented attic. Wood frames, fibreglass insulation -Double glazed, energy efficient windows -Eavestroughs drainage -Forced air natural gas furnace with gas fireplace and electric baseboard heating 	<ul style="list-style-type: none"> -3 occupants -Summer temperature: 25°C day; 20°C night -Winter temperature: 21°C day; 18°C night -Windows open for ventilation in summer, including basement windows -Furnace fan running at all times in winter 	<ul style="list-style-type: none"> -Bathroom fans on timers -2 showers a day, 6 loads of laundry per week -Wet hockey equipment dried inside -Basement bath smells musty -No flooding problems -No leaking problems -No humidifier in winter 	<ul style="list-style-type: none"> -Insufficient information during summer months. -Moisture removal possible throughout full year. -Peak moisture removal rate approx. 0.5 L/h -Average moisture removal rate approx. 0.16 L/h -Insufficient information for wood moisture results

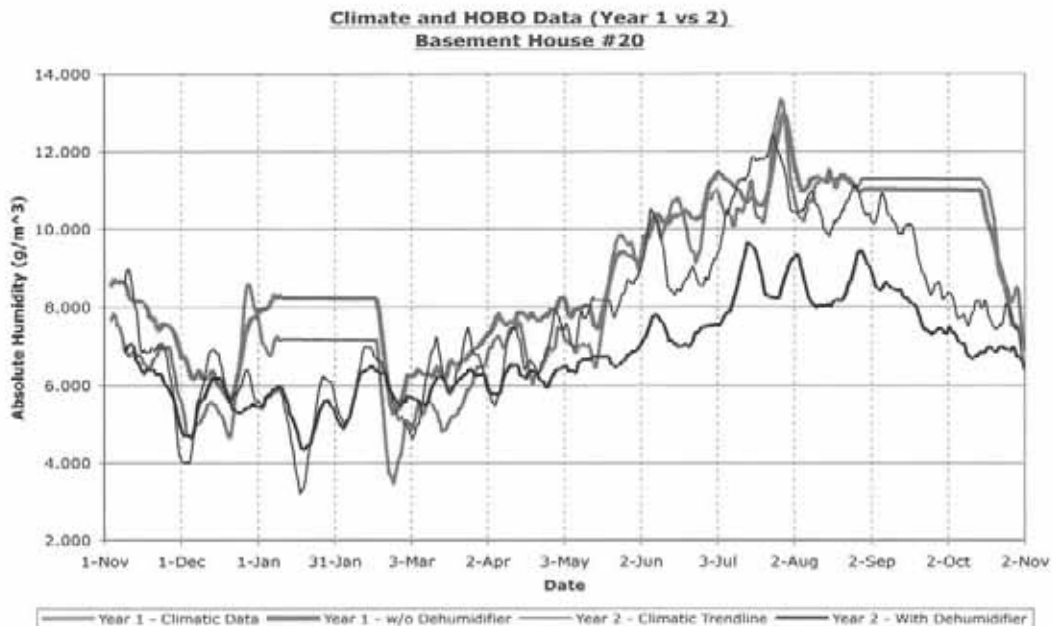
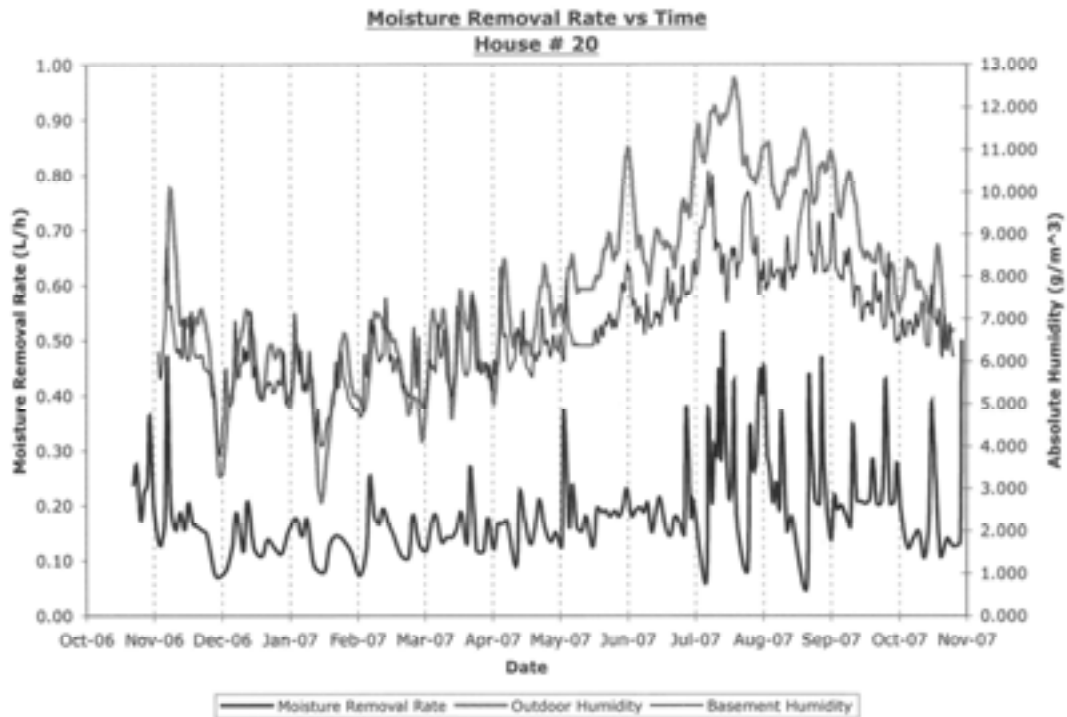
House #20, Burnaby, British Columbia

Description	Household	Moisture Indicators	Observations
<ul style="list-style-type: none"> -Detached single -Built: 1982, 242 m² -Finished basement, partially below ground -P/T wood walls with concrete floor foundation -Vented attic. Wood frame, pink foam insulation -Double-glazed windows (65%), double-glazed energy efficient windows (35%) -Sump pump (covered) -Gas furnace, with baseboard heating and wood fireplace -No heating in basement 	<ul style="list-style-type: none"> -5 occupants -Summer temperature: 25°C day; 15°C night -Winter temperature: 20°C day; 15°C night -Windows open for ventilation in summer, including basement windows -Furnace fan only on when furnace is on -New windows (2001) 	<ul style="list-style-type: none"> -Bathroom fans on timers -2 showers a day, 2 loads of laundry per week, and 7 hours of cooking. -Laundry is hung to dry indoors -Plenty of indoor vegetation -Odours occasionally linger -Located in wet area -Flooding: Sump pump backed up causing extensive flooding in basement. Walls repainted and carpet replace (Fixed, 2002) -No leakage problems -No humidifier in winter 	<ul style="list-style-type: none"> -Drastic reduction in indoor vs. outdoor humidity levels in 2nd year when using dehumidifier -Moisture removal possible throughout full year. -Moisture removal rate fairly constant throughout full year -Peak removal rate approx. 0.5 L/h -Average removal rate approx. 0.2 L/h -Noticeable reduction in wood moisture content from year 1 to year 2

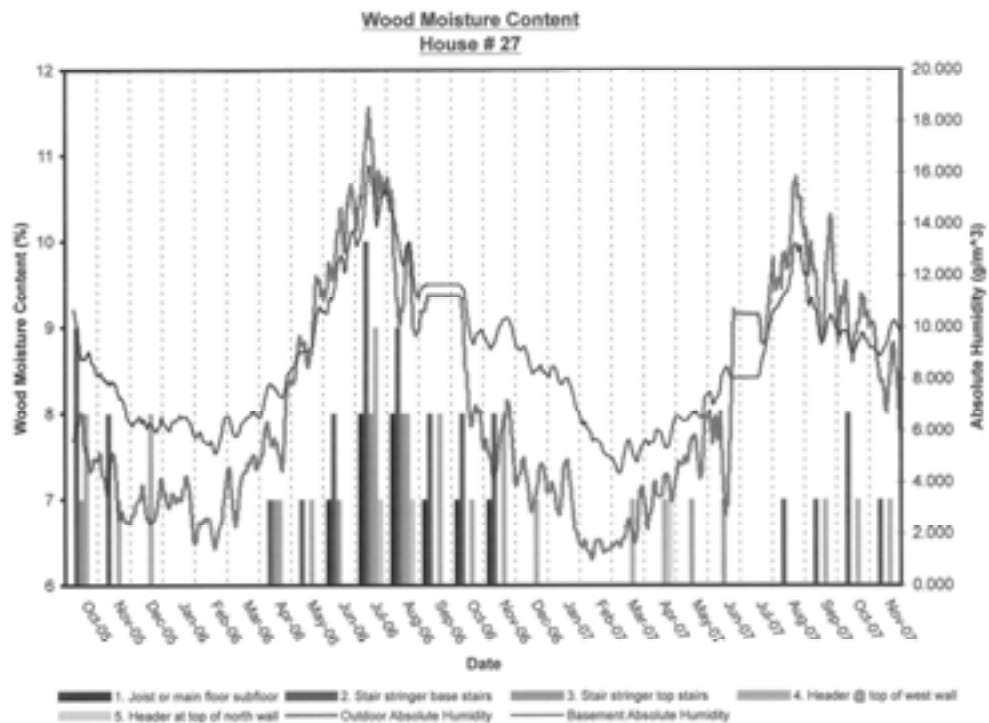
House #27, Bécancour, Québec

Description	Household	Moisture Indicators	Observations
<ul style="list-style-type: none"> -Two storey detached -Built: 1987, 149 m² -Mostly finished basement, partially above ground -Concrete foundation with insulated walls and vapour barrier -Vented attic. R40 in roof, R26 in walls, and R20 in basement -Double-glazed windows -Weeping tiles, ground slopes away from house and eavestroughs -HRV system installed -Forced air wood burning furnace. Electrical heating as secondary source 	<ul style="list-style-type: none"> -2 occupants -Temperature: 22°C day; 22°C night -Windows open for ventilation in summer, including basement windows -Furnace fan running all year 	<ul style="list-style-type: none"> -Bathrooms without fans -1 showers a day, 7 loads of laundry per week, and 4 hours of cooking per week -HRV running 10% of the time -Occasional condensation around windows and linen closet (Unresolved) -Occasional musty zoned (Fixed) -Clothes are hung inside -No flooding problems -No leakage problems -No humidifier in winter 	<ul style="list-style-type: none"> -No significant improvement in indoor vs. outdoor humidity levels in 2nd year when using the dehumidifier -Insufficient moisture removal rate readings -Excellent moisture removal reading in fall of 2006 -Peak removal rate approx 0.7 L/h -Avg. fall removal rate approx 0.4 L/h -Excellent reduction in wood moisture levels from year 1 to year 2
