TP 185E
Issue 3/2012

AVIATION SAFETY LETTER

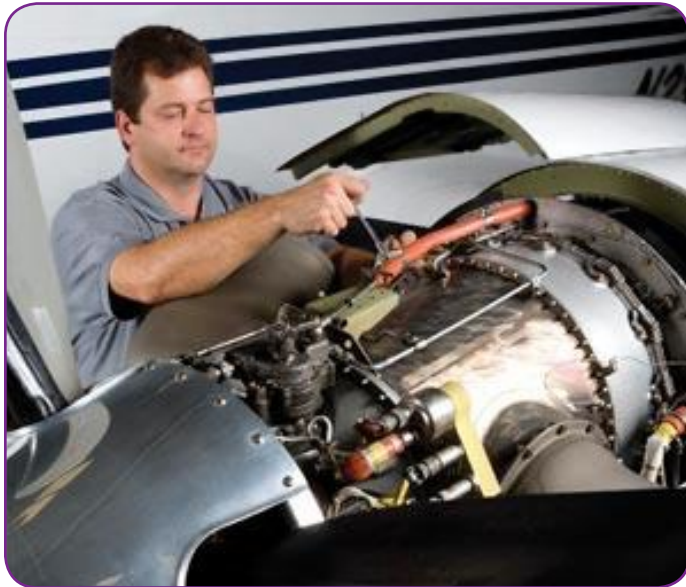
Before you start working on a turbine, put together a plan of attack with the right tools and manuals.
(Photo: Dallas Airmotive)

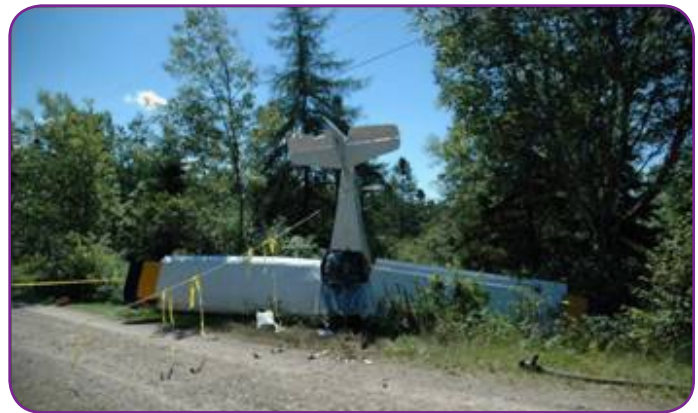
Aircraft impact orientation

and was transported to hospital. The aircraft came to rest directly along the extended centreline of Runway 20 of the private airstrip, about 275 ft beyond the departure end. The aircraft was destroyed and there was no fire.

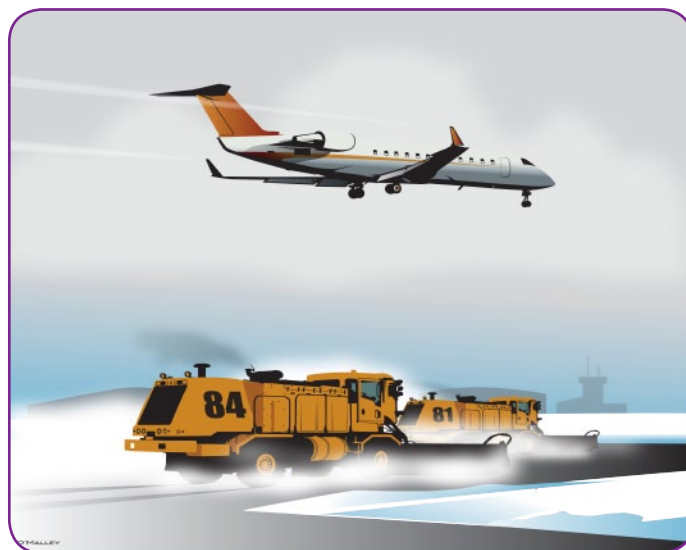
Artist's impression of risk of collision event, as the CL-600 overflew the two snow sweepers on final approach

The crew acknowledged the request. The aircraft landed approximately nine minutes later, at 13:50 Pacific Standard Time (PST), after flying over two runway snow sweepers operating on the portion of the runway located before the displaced threshold for Runway 31L. A position report was not provided to Whitehorse tower at 10 mi. final and no landing clearance was issued. The weather report issued 10 minutes after landing reported the ceiling as vertical visibility 600 ft, visibility of $\frac{3}{4}$ SM in light snow and drifting snow with a runway visual range (RVR) of 4 500 ft.

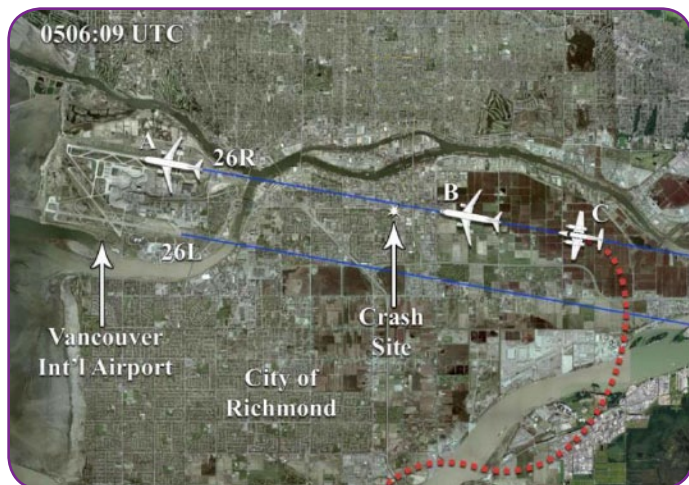
At 22:06:09, the Chieftain intercepts the localizer 1.5 NM behind the Airbus, approximately 2.6 NM from the crash site.

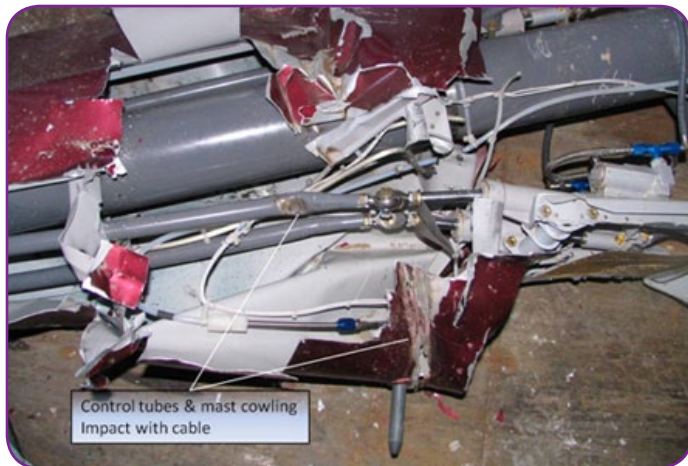
Cable marking on control tubes

On November 12, 2009, a privately owned and operated Robinson R44 II Raven helicopter took off for a VFR flight from a work site at Baie-Trinité, to Baie-Comeau, Que. At 12:49 Eastern Standard Time (EST), the helicopter struck a ground wire atop a power line crossing the Franquelin River and crashed on the river bank below. The pilot sustained fatal injuries and the two passengers on board were seriously injured. A pedestrian discovered the wreckage at approximately 14:10 and advised the authorities.

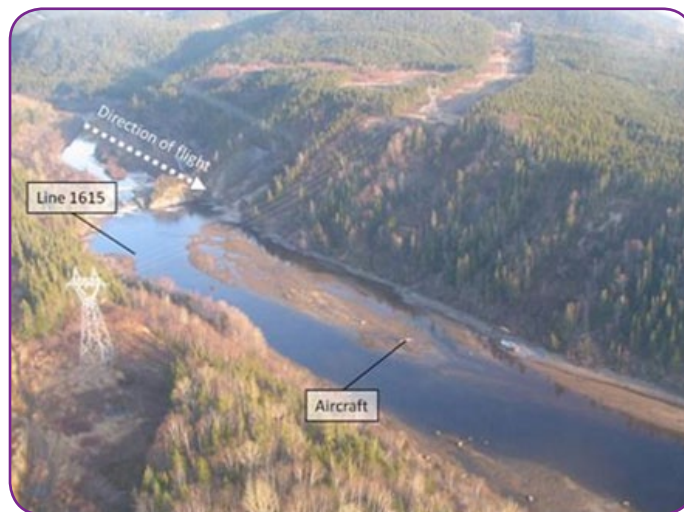
Aerial view of accident site
