ISSUE 2 2007

Flight Comment

The Next Leap Ahead

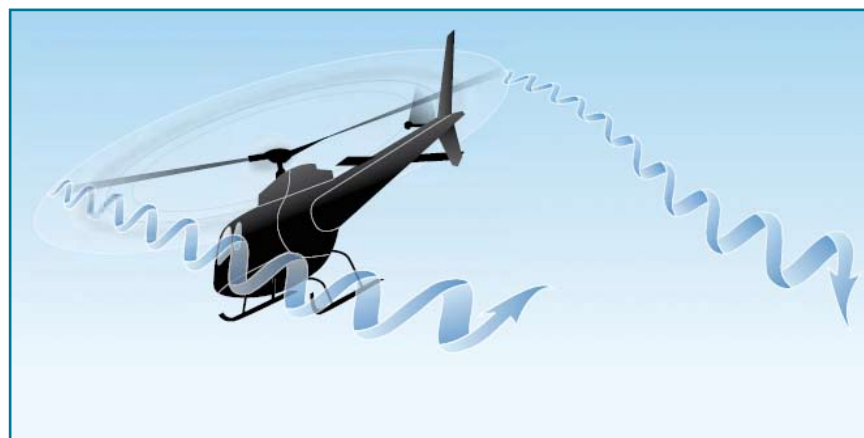
Figure 4: Simplified wake vortices generated from a helicopter in forward flight.

- During forward flight, a helicopter generates a pair of spiralling wake vortices from the rotor blades (Figure 4). Wake turbulence also occurs in the rotating air beneath the helicopter. In this situation the wake vortices are similar to those of larger fixed-wing aircraft. It is, therefore, recommended that small aircraft exercise caution when in the vicinity of a helicopter in forward flight.

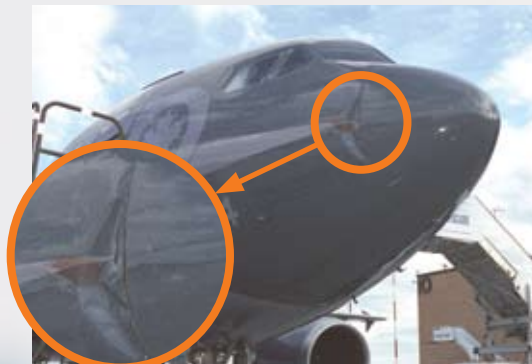
September 2003 – A CC150 Polaris struck a Canada goose at 200 feet AGL.

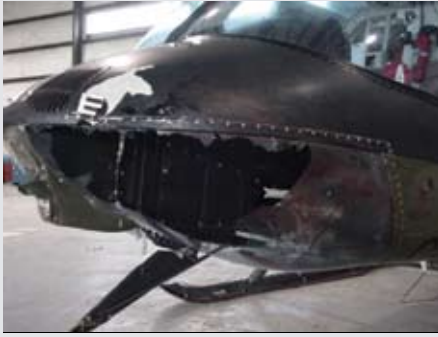
October 2006 – A CH139 Jet Ranger was struck by a 3 pound mallard while flying at night on a simulated IFR approach. There were no injuries, but it did result in \$20,000 worth of damage.

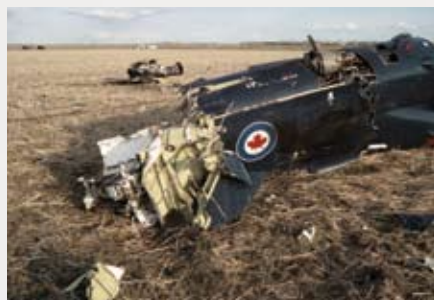
May 2004 – A CT155 Hawk ingested a 280 gram gull during a closed pattern.

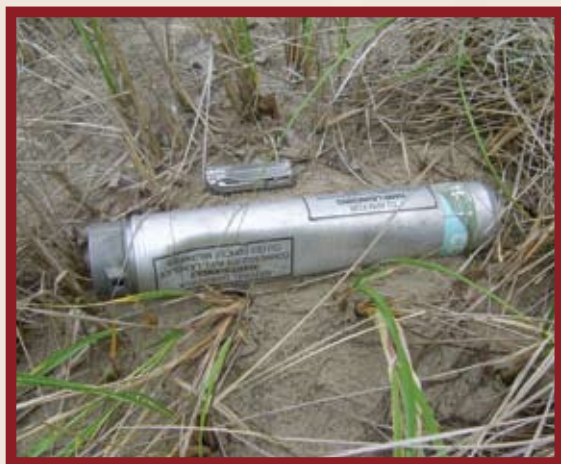
Partially consumed C2A1 Marker Location Marine (MLM). This buoyant smoke and flame-producing device is used by ships and aircraft as a positional marker on the water surface. A small number of MLMs do not completely burn off and remain afloat.

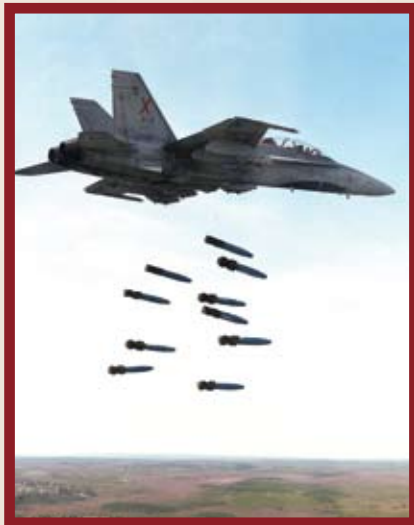
CF18 releasing 10 Mark 82 bombs, Cold Lake / Prim Lake (1990s)

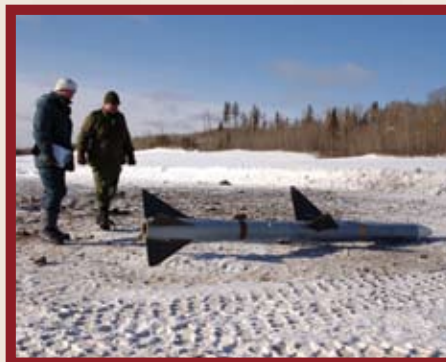
Dismantling/destruction of CF18 missile, Cold Lake (2003)

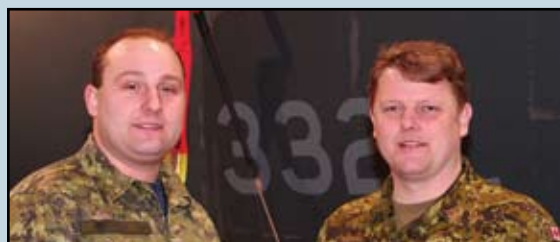
Despite the fact that there was no evidence of any other leak, Cpls Dye and Malboeuf noted the fuel transfer rate was slower than normal during the de-fuel operation. Upon carrying out a thorough inspection of the work area they discovered a very small amount of contamination on the bottom of the fuel tank and determined that the valve had failed due to a piece of foreign material (FOD) being ingested and lodged in the gate mechanism. Not satisfied with the slow fuel transfer rate, they investigated further on their own accord focusing their attention on the fuel pump and surge box area at the aft end of the fuel tank. Upon opening the number one fuel pump access panels they discovered the pump screens were completely clogged with debris. They then proceeded to check the remainder of the main fuel tanks and found all four-fuel pump screens were clogged with FOD. The aircraft was immediately quarantined pending

Their initiative and attention to detail while inspecting this hidden area is commendable. Research revealed this aircraft had recently undergone extensive contractor fuel tank repairs during the past 18 months and had less than 10 flying hours since the last repair. The fuel pumps, filters and associated FOD were subsequently forwarded to the Quality Engineer Test Establishment (QETE) for further analysis.

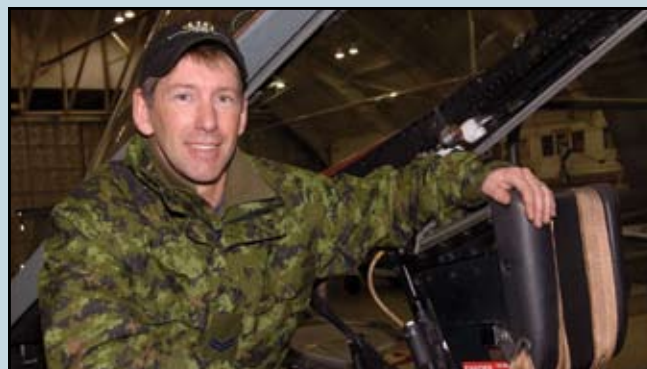
On 9 December 2005, Corporal Maher was tasked with replacing the shielded mild detonating cord (SMDC) ejection-system explosives set in the cockpit of *Hornet* CF188926. After removing the rear ejection seat, he noticed that the small clevis pin securing the left-hand trombone tube on the ejection seat was protruding. Cpl Maher chose to investigate further and determined that a cotter pin was missing and the adjacent clevis pin was no longer secure. He immediately declared the ejection seat unserviceable and ensured the problem was rectified.

If an ejection had been initiated with the cotter pin missing it is very likely that the clevis pin would have fallen out. This, in turn, would have caused a breakdown in the ejection sequence with almost certain fatal results for the pilot or passenger occupying the seat.

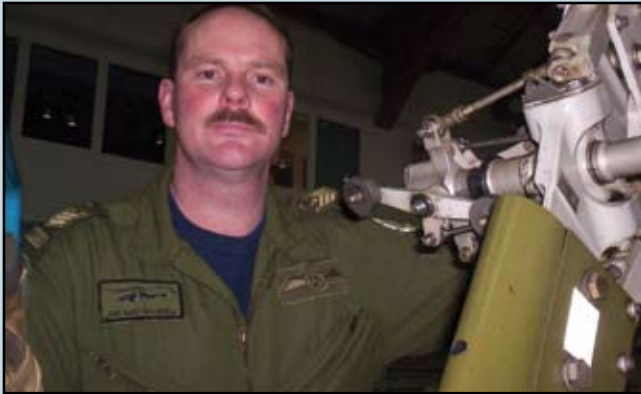
On 22 March 2007, 417 Squadron was preparing to operate a mission with a CH146 *Griffon* that was borrowed from the Aerospace Engineering Test Establishment. During the required pre-flight inspection, Sgt MacDougall noticed that the tail rotor fixed link inboard bolts had been installed backwards. Upon further inspection, he detected that these bolts

were contacting the tail rotor hub and had already scraped off adjacent paint.

The resultant flight safety investigation established that the bolts had been installed on 13 October 2006, and the aircraft had flown 99.6 hours prior to the incident. In spite of numerous tail rotor inspections by technicians and Flight Engineers that preceded this incident, the incorrect installation of the tail rotor fixed link inboard bolts had gone unnoticed.

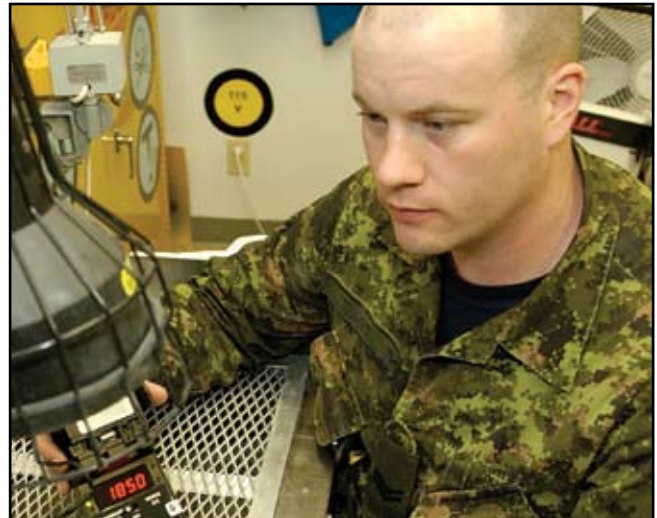
Unsatisfied with these findings, he notified his supervisor and suggested that a NDT procedure be carried out to eliminate any chance of damage in this suspect area. A subsequent eddy current inspection was carried out and revealed multiple cracks totalling 14 inches in length on the frame. The "dog house" forms a critical part of the structure that maintains three hydraulic reservoirs. Numerous other technicians had frequented this area during the associated maintenance on the engine and main gearbox, but this defect had gone undetected.

On 15 December 2006, Cpl Talbot was tasked to carry out a liquid penetrant (LPI) examination of the main gearbox (MGB) mounts on *Sea King* helicopter CH124433. While waiting for the penetrant dwell time on the MGB mounts, he noticed a very slight linear discoloration of the metal in a separate area known as the "dog house". Although not in close proximity to the principle area of inspection, Cpl Talbot observed that this discoloration was unusual. Suspecting that this may be a crack, he sought the appropriate permission through 443 Maritime Helicopter Squadron maintenance organization to further investigate his visual observation. He proceeded to clean the suspect area, and found that there was no immediate evidence of damage.

It was a combination of Cpl Talbot's keen observation and attention to detail that drew him to this area and locate the defect. Had this fault gone undetected, the cracks would have progressed to the point of failure of the frame and loss of the reservoirs. The three hydraulic reservoirs are required to maintain controlled flight of the aircraft and their loss could have potentially lead to the catastrophic failure of flight components as well as the loss of both the aircraft and crew.
