ISSUE 3 2007

Flight Comment

Tampering with Torque (page 6)

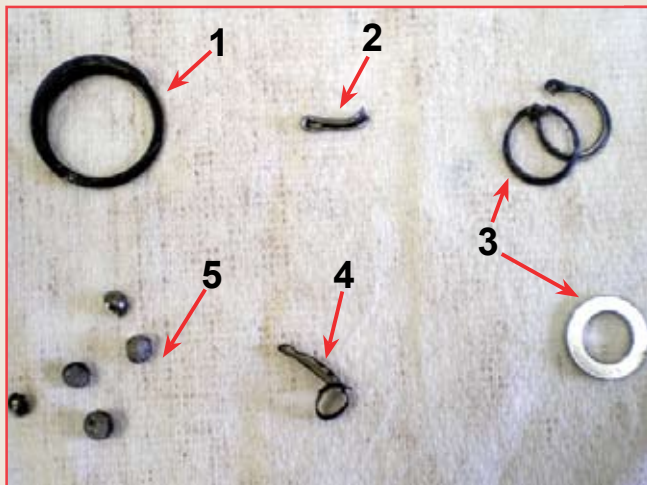
Figure 2: A sampling of the unsafe items found that revealed obvious tampering:

1. Ratchet seal, soldered, in place of the Cerro safe seal
2. Cotter pin found in load spring
3. Circlips and aircraft washers used as spacers
4. Metal shaving found inside torque wrench
5. Broken ball bearings in lock mechanism

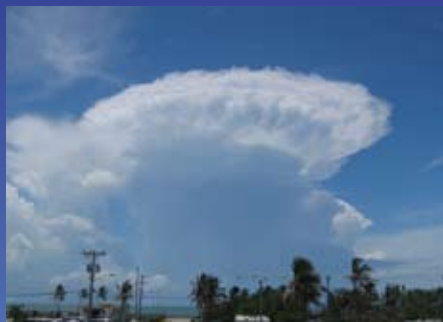
CUMULONIMBUS (CB)

Heavy, dense cloud. Lightning, thunder and hail occur and there may be moderate to heavy showers of rain, snow or hail. Turbulence may be severe both in and below cloud, very violent on entering or leaving. Risk of icing; clear ice likely above the freezing level.

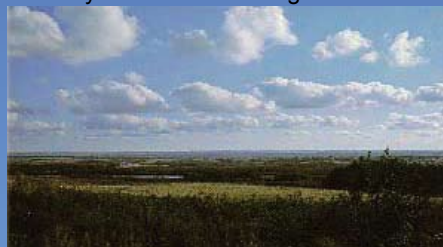
CUMULUS (CU)

Generally dense with sharp outlines and uniform bases. Light to moderate turbulence in fine weather. Large cumulus may generate moderate to severe turbulence both in and below cloud; strong turbulence on entering or leaving. Rain or snow may occur. Risk of icing; clear ice just above freezing height.

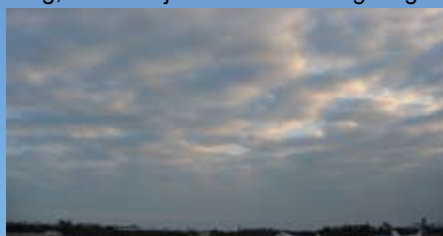
STRATOCUMULUS (SC)

Grey or whitish patch or sheet of cloud. Very light rain, drizzle or snow may occur. There may be light to moderate turbulence beneath and in cloud, and when passing through inversion at cloud top. Smooth above. Occasional rime icing if the freezing height is low enough. A change in air density through the inversion causes changes in aircraft performance.

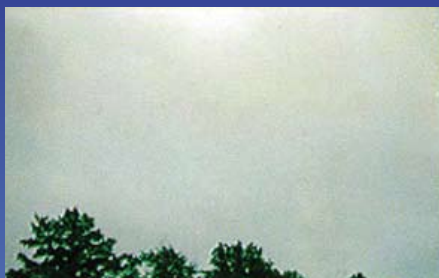
STRATUS (ST)

Generally a grey cloud layer with fairly uniform base, which may precipitate as drizzle. Light turbulence. There may be an inversion as with stratocumulus. Usually no icing. At takeoff you need to attain a good speed early in the climb and exercise care in descent.

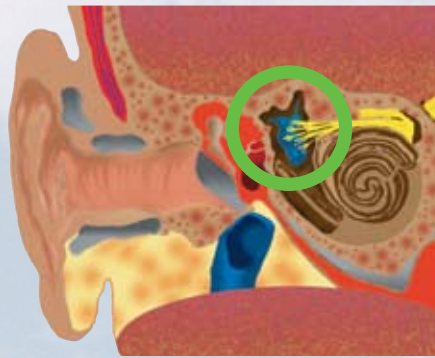
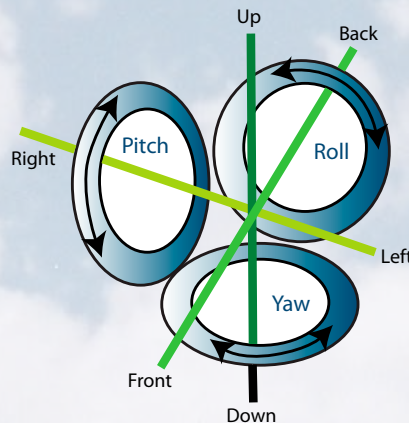
Each of the three canals in the inner ear is aligned along a different axis of rotation and contains a small tuft of sensory hairs (above circled). Orientation illusions can occur when these hairs are affected by acceleration.

Spatial illusions and disorientation are created when the fluid of the inner ear responds to acceleration, deceleration, pitch, roll and yaw.

Forces on the ear: Each of the three canals in the inner ear is aligned along a different axis of rotation and contains a small tuft of sensory hairs (circled above). Orientation illusions can occur when these hairs are affected by acceleration.

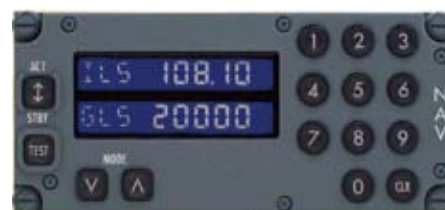
Figure 1: Gables G7501-01 GLS-capable navigation control panel (image courtesy of Boeing)

Landing System, providing both lateral and vertical guidance down to CAT III minimums. Recently, three ICP School staff had the opportunity to fly GLS approaches in a Boeing 737-800 Next Generation aircraft simulator (see in *Figure 1* for the navigation control panel used). It was very similar to ILS to both set up and fly.

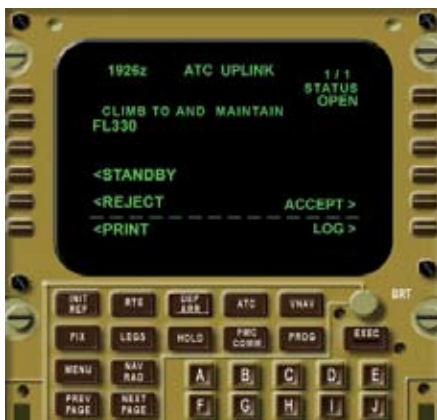
CPDLC stands for controller-pilot data link communications. This system is intended to allow the communication of routine ATC instructions through data link vice voice radio. Many airlines and corporate operators are already receiving their initial IFR clearances through data link. The picture in *Figure 2* shows a Boeing 747 flight management system (FMS) CPDLC page with a clearance from ATC to “climb and maintain flight level 330.” Note some of the options available for the crew depending on which button they select: standby, reject or accept.

Figure 2: Boeing 747 FMS CPDLC page (image courtesy of Boeing)

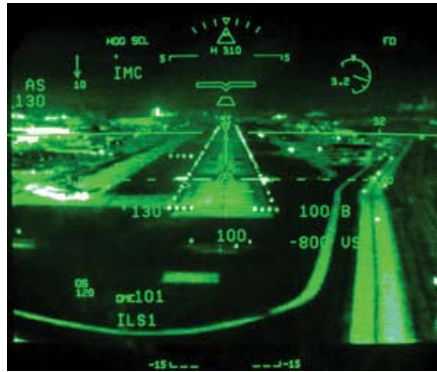
Figure 3: EVS night view

night vision goggles (NVGs) in that it is intended to provide a means to see through darkness and, unlike NVGs, through cloud as well. *Figure 3* is a night approach as seen with EVS through a head-up display (HUD).

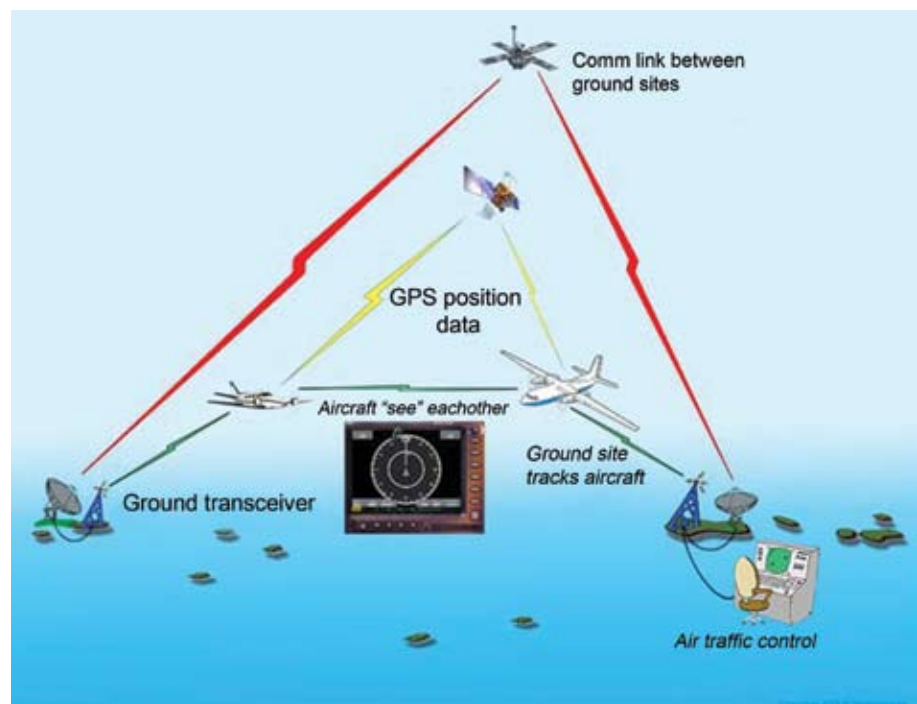
ADS-B is the acronym for Automatic Dependent Surveillance-Broadcast. This system is designed to provide surveillance capability both between aircraft and ATC. The way it works is relatively simple. Aircraft use GNSS to derive their position. That position information plus other data is then transmitted via datalink to other appropriately equipped aircraft or ATC facilities. *Figure 4* outlines the basic ADS-B architecture.

Figure 4: Basic ADS-B architecture (image courtesy of ADS-B)

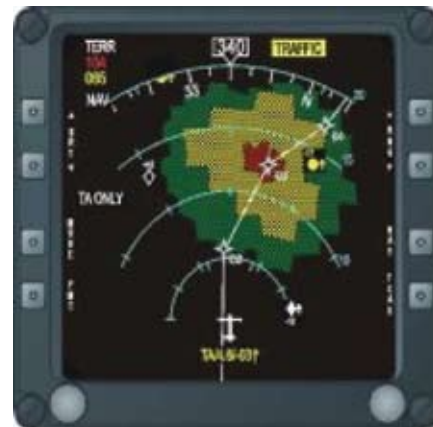
TAWS is the acronym for terrain awareness and warning system. This is the modern version of the ground proximity and warning system (GPWS). *Figure 6* shows a typical TAWS display. If you stay on the track depicted you will crash into a mountain peak!

Figure 6: TAWS display

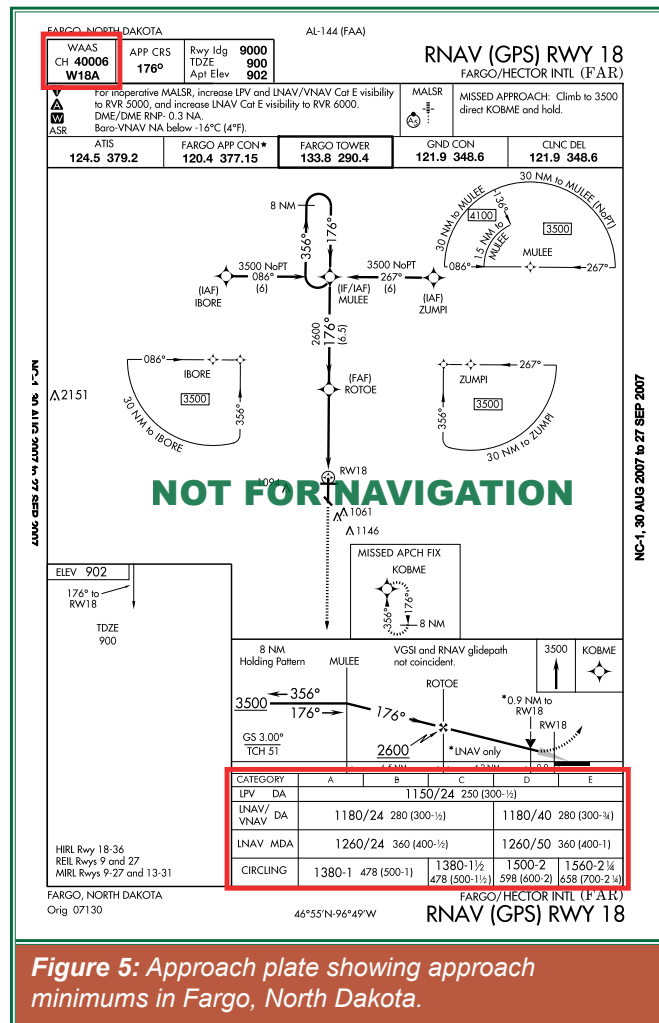
Figure 5: Approach plate showing approach minimums in Fargo, North Dakota.

nearing ILS standards. A sample approach plate is shown in *Figure 5*.

RNAV stands for lateral navigation. RNAV approaches are space-based non-precision approaches. These approaches require GPS avionics. The approach plate in *Figure 5* has RNAV minimums. ♦

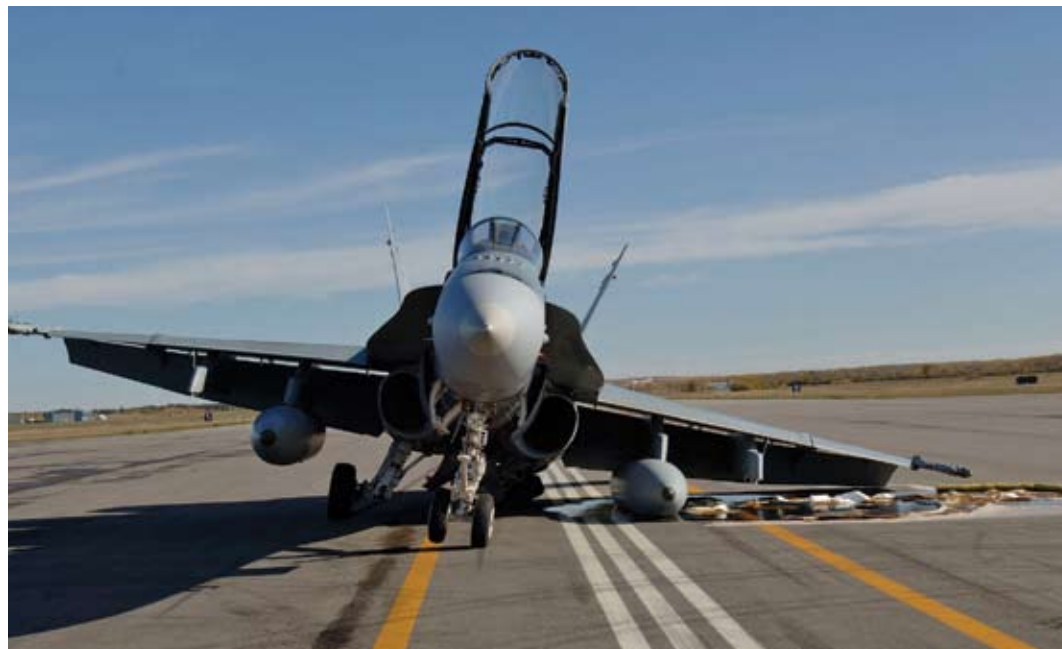
Several preventive measures were taken, including special inspections on all CF188 landing gear to inspect and correct the tolerances, rigging and general condition. The Canadian Forces Technical Orders (CFTO's) were amended to better address landing gear maintenance. As well, pilots were briefed on the occurrence and the enforcement of training requirements was stressed.

Other preventive measures were recommended including additional revisions to the CFTO's, maintenance requirements and other airworthiness aspects of the landing gear. Additional training for pilots was also recommended, as well as a revision of the landing techniques currently used on the CF188 fleet. ♦

The aircraft suffered “D” category damage to the left main landing gear (MLG) assembly, the left MLG doors, the left MLG rim and tire and the left external fuel tank.

approximately 1200 feet per minute and a landing G between 2.4 and 3.0 with significant left drift and the left wing low. This resulted in a very large strain being imparted on the left landing gear. The investigation also revealed that the left and right MLG were out of rig in a number of key areas that are known to contribute to MLG collapse and/or planing mechanism failure.

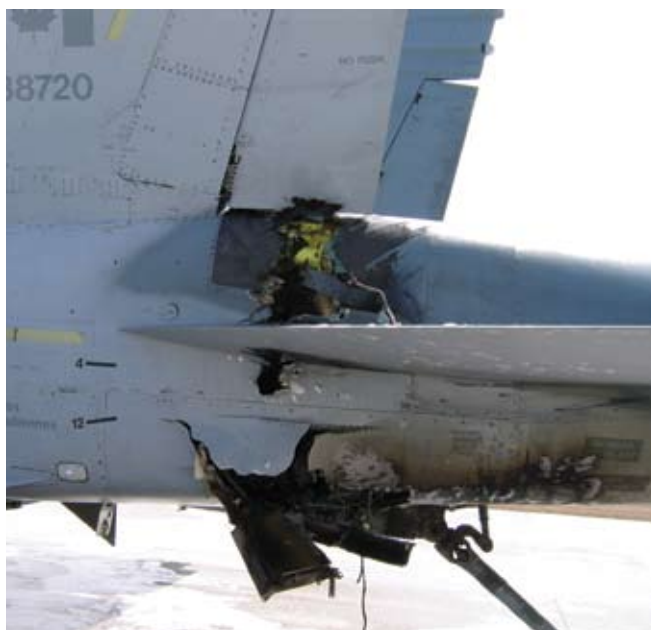
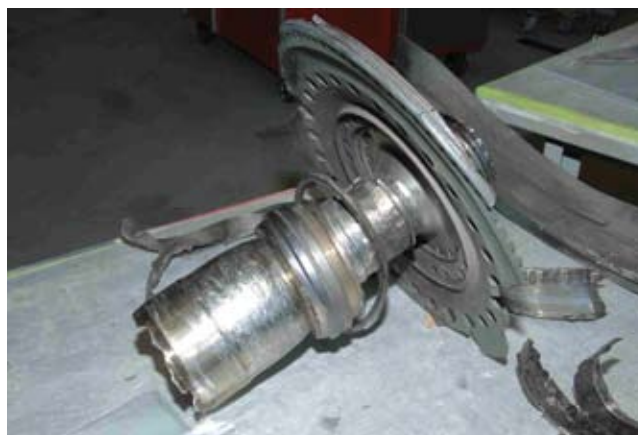
Investigation revealed that the left-hand engine had suffered a catastrophic failure of the low-pressure turbine disk. The engine was found to be separated into two sections. Only a small portion of the low-pressure turbine (LPT) disk was recovered.

The inspection of the engine also revealed that the actuating ring attachment plate for the inlet guide vanes was missing 2 bolts and nuts at the 9 o'clock position with 4 inlet guide vane arms not connected to the actuating split ring. As a result of this finding, the F404 engine technical authority immediately directed field units' engine bays to conduct a sampling inspection to confirm the presence of all attachment hardware for the high-pressure compressor (HPC) variable guide vanes actuating split rings. All HPC modules were found with the appropriate hardware.

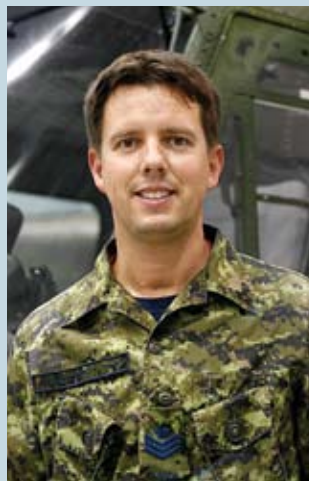
When the gearbox was uninstalled and thoroughly examined, it was observed that the mounting holes were severely elongated. The hole measurements indicated that two of the four were beyond the allowable limit, although the condition of the gearbox shims was normal.

Sgt Rancourt repeated the gearbox installation procedure in order to find out what went wrong. He had to put one more washer under each bolt head, as authorized by the Canadian Forces Technical

Order (CFTO), so the assembly would not move after applying initial torque. Adding extra washers made the assembly very secure after final torque was applied. It is clear that an additional washer under each bolt head would have been needed on the initial installation. Unfortunately, this fault allowed the gearbox to move, which caused the

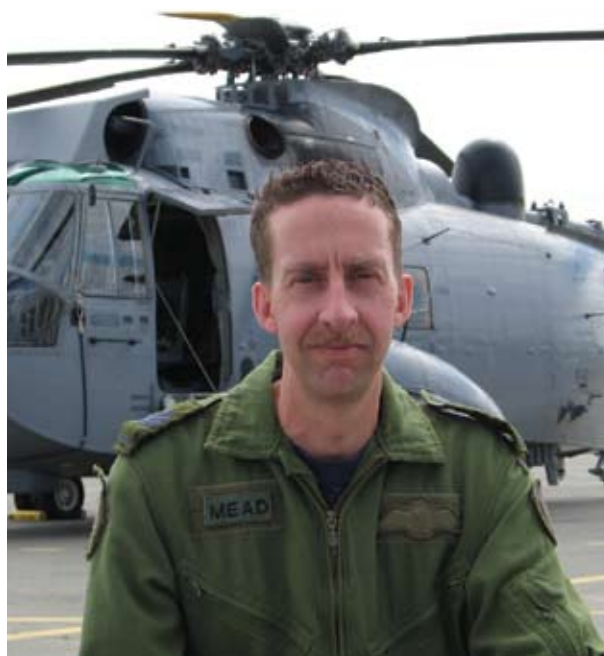
The investigation revealed that the bolts were installed opposite to the direction of rotation contrary to the Canadian Forces Technical Order (CFTO). If the nuts had loosened, the centrifugal force may have expelled the bolts causing a catastrophic tail rotor failure and the possible loss of the helicopter and crew.

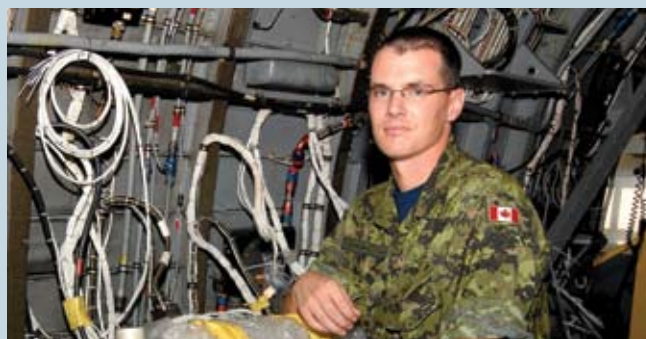
During this process, Pte Rossignol was tasked to support wire bundles to lessen the tension on a clamp that required removal. At this point Pte Rossignol who wanted to be actively involved in the de-snagging process, took the initiative to inspect the wire bundle and discovered a charred wire. He immediately informed his supervisor who investigated further and found that a number of wires were affected including one that had completely burned through.

The nature of this un-serviceability was such that, had it gone undetected, it could easily have led to an electrical fire. The energized damaged wire was exposed to the atmosphere in an area that is not visible during any regular servicing checks.
