National
Defence

ISSUE 1, 2008

Flight Comment

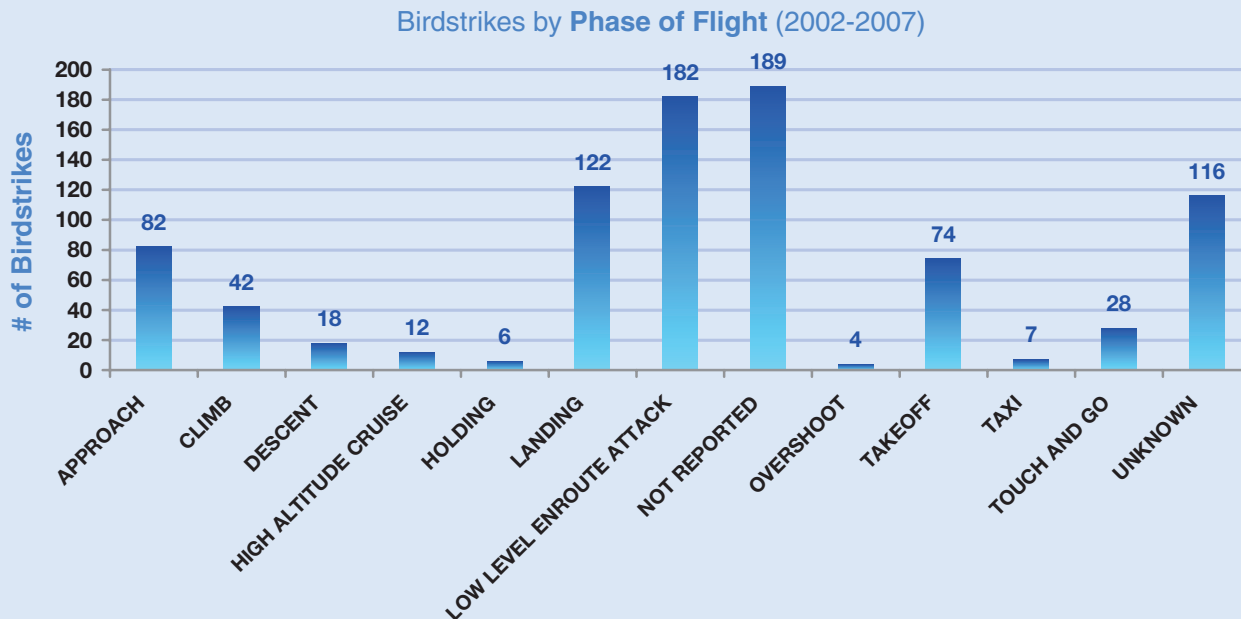
Figure 2, CF birdstrike distribution by phase of flight, 2002 - 2007

Phase of flight

Refer to figure 2 for the distribution of birdstrikes in the CF per phase of flight for the reported period.

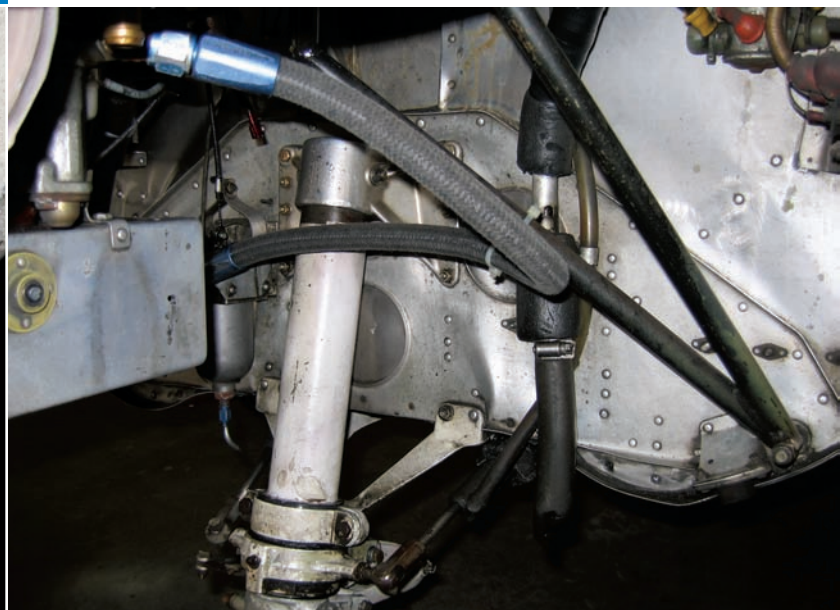
TYPE: Cessna 172M (C-GFVE)
LOCATION: Waterville Airport, NS
DATE: 13 July 2007

The accident occurred during a student solo flight being conducted as part of the Air Cadet Power Scholarship program. The student pilot was on a second solo flight and was conducting circuits to practice landings and touch-and-go's. On the sixth landing attempt the pilot did not flare and the aircraft landed nose-wheel first in a nose down attitude. The aircraft bounced back into the air and then came down in a nose-low attitude, causing the propeller to make contact with the runway, and the aircraft bounced into the air again. The pilot's instructor, observing from a nearby building, used the radio to direct the student to overshoot. The aircraft bounced twice more on the main landing gear before becoming airborne. The pilot completed an uneventful circuit and landing. The student pilot then taxied to the ramp, shutdown and exited the aircraft, apparently unaware that the aircraft had been damaged.

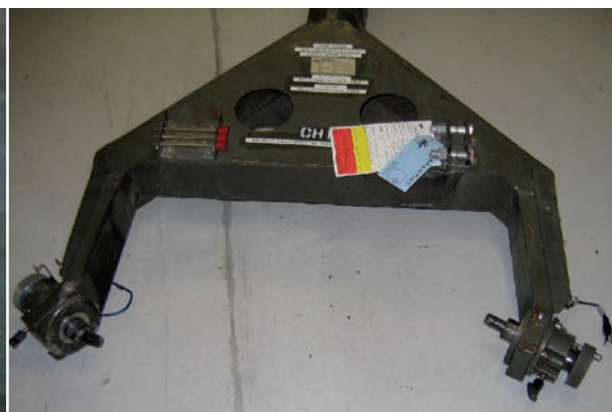
Tow Bar Adapters

Left

**NLG
Axle**

Initial assessment identified that the damage was limited to the right-hand wheel assembly and the left-hand tow bar adapter. It was also found that the mechanism allowing the nose-wheel to turn freely (or castor-latch) was not disengaged prior to the towing evolution. The castor-latch was disengaged and the aircraft was towed back in the hangar. A second damage assessment revealed serious damage. Specifically, the assessment identified damage to the right-hand wheel, both tow bar adapters, the axle, and the landing gear itself.

The investigation revealed that the safety feature of the tow bar did not preclude damage to the landing gear. A review of the technical publications revealed that there are no torque values for the tow bar safety bolt and shear bolts. The analysis of the occurrence suggests that the torque value of the safety bolt, in all probability, delayed the shearing of the shear bolts.

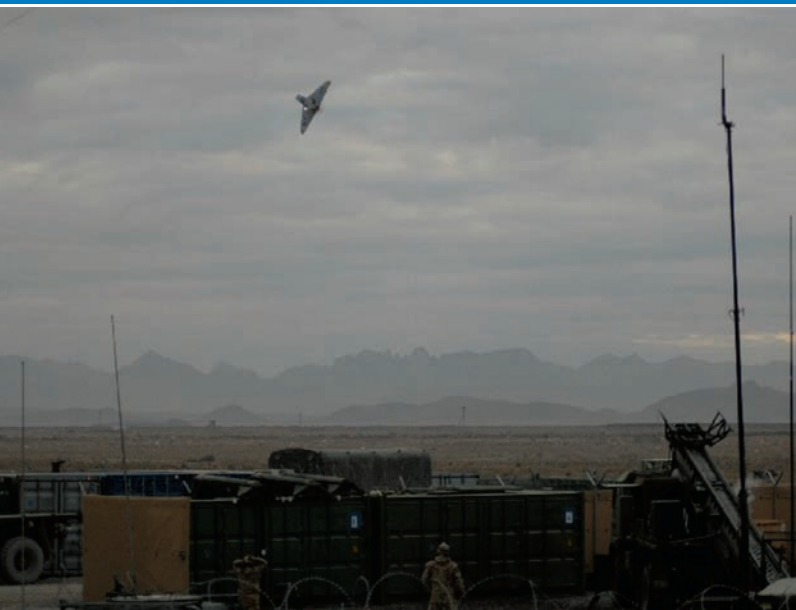
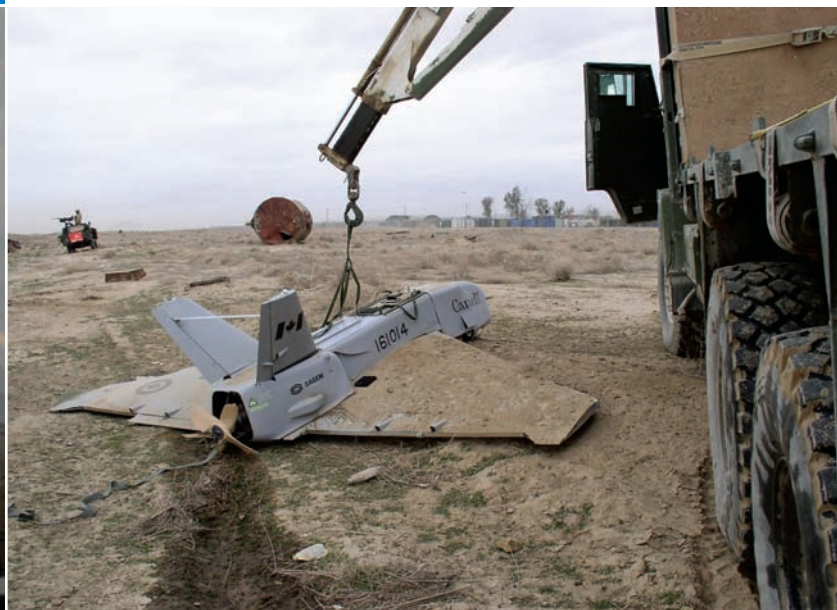
TYPE: CU161 Sperwer (161014)
LOCATION: Kandahar, Afghanistan
DATE: 24 January 2007

The accident occurred during an uninhabited air vehicle (UAV) mission conducted at the Kandahar Airfield (KAF) in support of Op ARCHER. Immediately following launch, the air vehicle (AV) entered an uncommanded steep left turn, descended and crashed approximately 250 metres from the launcher. There were no injuries and the AV was destroyed.

The AV's attitude and navigation functions are controlled by a hybrid navigation system (HNS). The HNS senses the AV's pitch, yaw and roll and provides an input signal to the mission control unit (MCU). The MCU in turn processes the signal and provides an output signal to the AV's control surfaces for steering and navigation. The AV must be launched with the HNS in alignment mode; otherwise, the AV will not have the requisite attitude and navigation functionality for controlled flight. The investigation concluded that the AV was launched with the HNS in standby mode. Consequently, the AV's flight control surfaces were essentially frozen which caused the AV to crash.
