National
Defence

ISSUE 2, 2008

Flight Comment

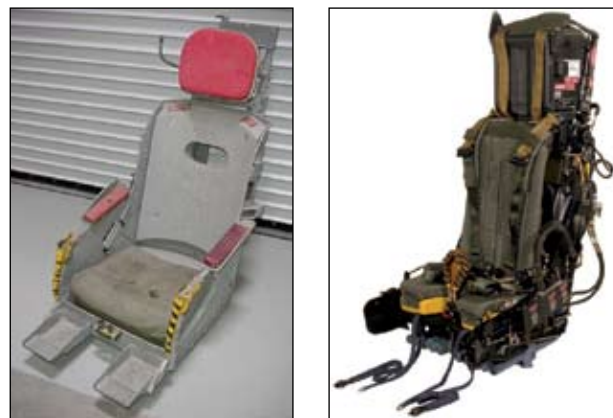
Figure 1. F86 Sabre (left) versus CF188 NACES (right)

Just to give you an example, the venerable F86 Sabre's ejection seat (figure 1, left) was of little use below 1000 feet above ground, and did little else than push the seat and pilot out of the aircraft with a catapult. The pilot had to manually eject the canopy and manually lock his harness prior to ejection. He also had to remember to bring his feet back and place them on the seat's footrests, and brace his arms on the armrests. Post ejection, he had to unstrap himself manually from the harness and quick away from the seat, and had to manually open the main parachute, which was directly attached to the pilot, and had to be carried in and out of the aircraft for each flight. Talk about a busy egress drill! Needless to say, the confidence in such a system was limited at best.

Now, compare this to the Mk 14 NACES seat (figure 1, right), which is scheduled to upgrade the CF188 Hornet escape system next year. The NACES uses a

digital electronic sequencer along with airspeed sensors and electrically-fired systems on the seat to allow for five separate modes of operation depending on the sensed conditions at ejection. The pilot's legs are automatically reeled in and held in place, and the seat harness automatically retracts and locks the pilot firmly in place. The seat is pushed out of the aircraft via a multi-stage catapult system, followed by a powerful underseat rocket. Immediately upon leaving the aircraft, the seat deploys a rocket propelled multi-point attachment drogue chute which slows the seat down prior to the main parachute deployment and keeps it stabilized in the airflow (see figure 1a, next page). Needless to say, the main parachute (also rocket-deployed) opens automatically, along with seat-man separation. The NACES' ejection envelope goes from zero airspeed and zero altitude, all the way to 600 knots and 50,000 feet.

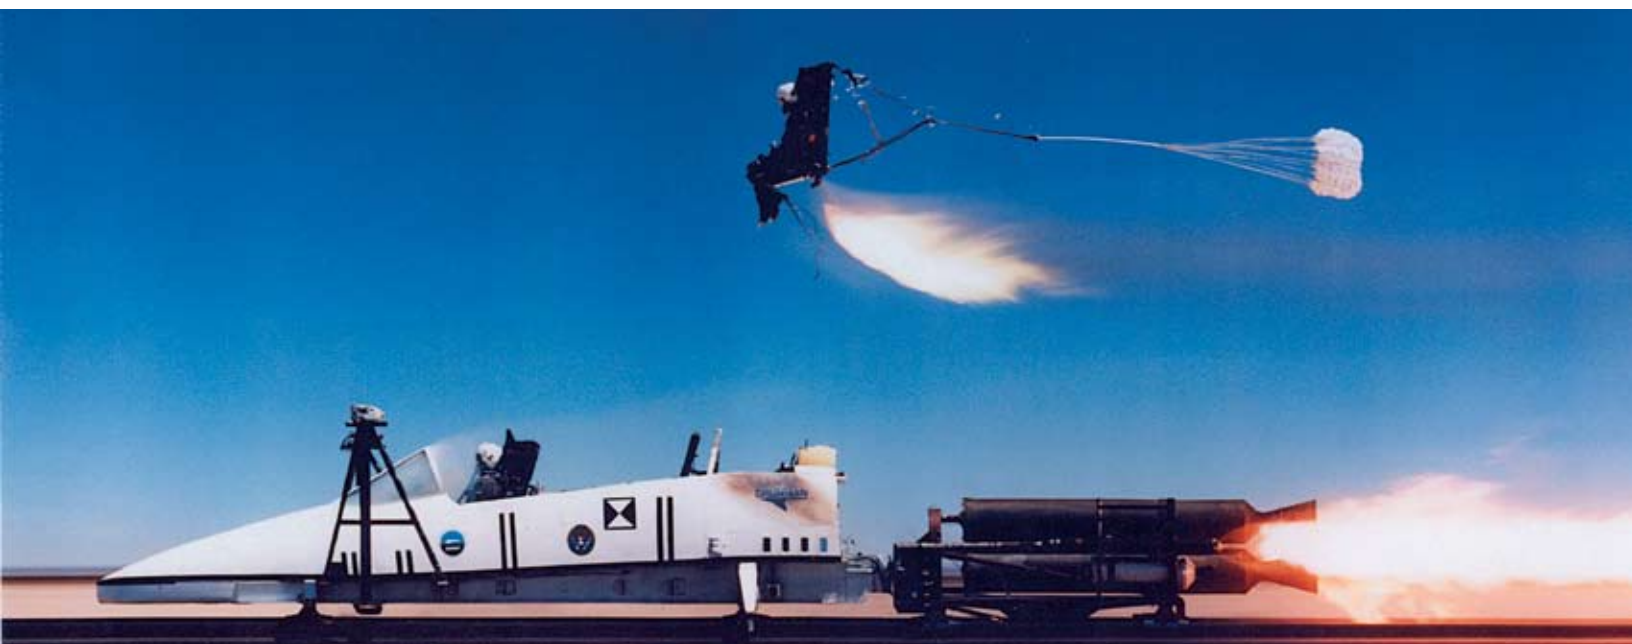
Figure 1a. NACES ejection test showing the multi-point attachment drogue chute

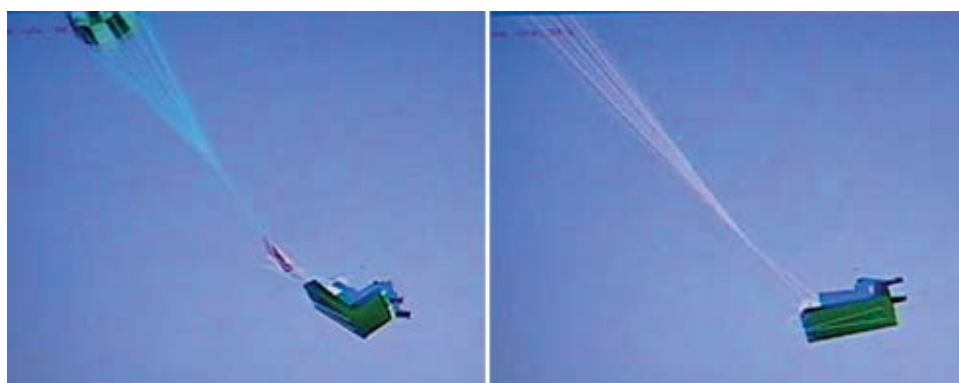
Figure 2. Extraction of main parachute by drogue chute; approximation of misalignment of seat/pilot with main chute axis on inflation

The SJU 9/10 seat (otherwise known as Martin-Baker Mk 10L) which was used in this ejection uses a single point drogue chute for initial seat aerodynamic stabilization, deceleration and to extract the main parachute from the headbox. However, at low altitudes (below 7500' ASL), this drogue chute will only be in action for about 1 second prior to extracting the main parachute. Thus, during a low level, high speed ejection, a large deceleration force will be imparted to the pilot during the main parachute opening phase. In this case, it was estimated at approximately 25 G's. This large force was applied sideways because the seat was not properly aligned with the airflow at the time of main parachute opening (see figure 2).

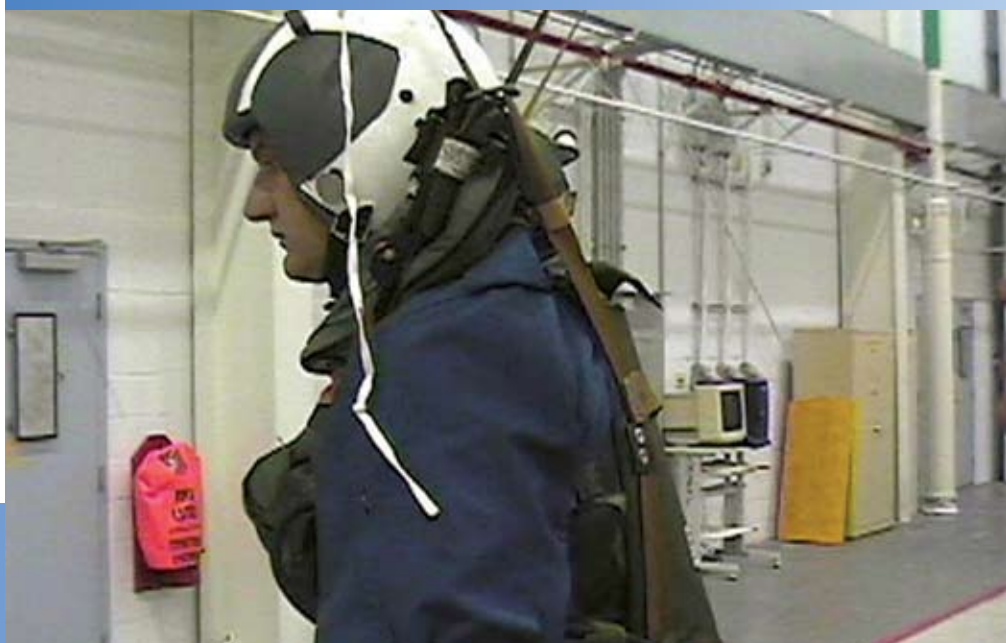
Figure 3. Suspension test showing excessive triangular void above the shoulders

This accident again highlighted the importance of following the proper strap-in procedure as per the AOI's. The IP had, here again, an excessive triangular void due to an improperly tightened harness, which

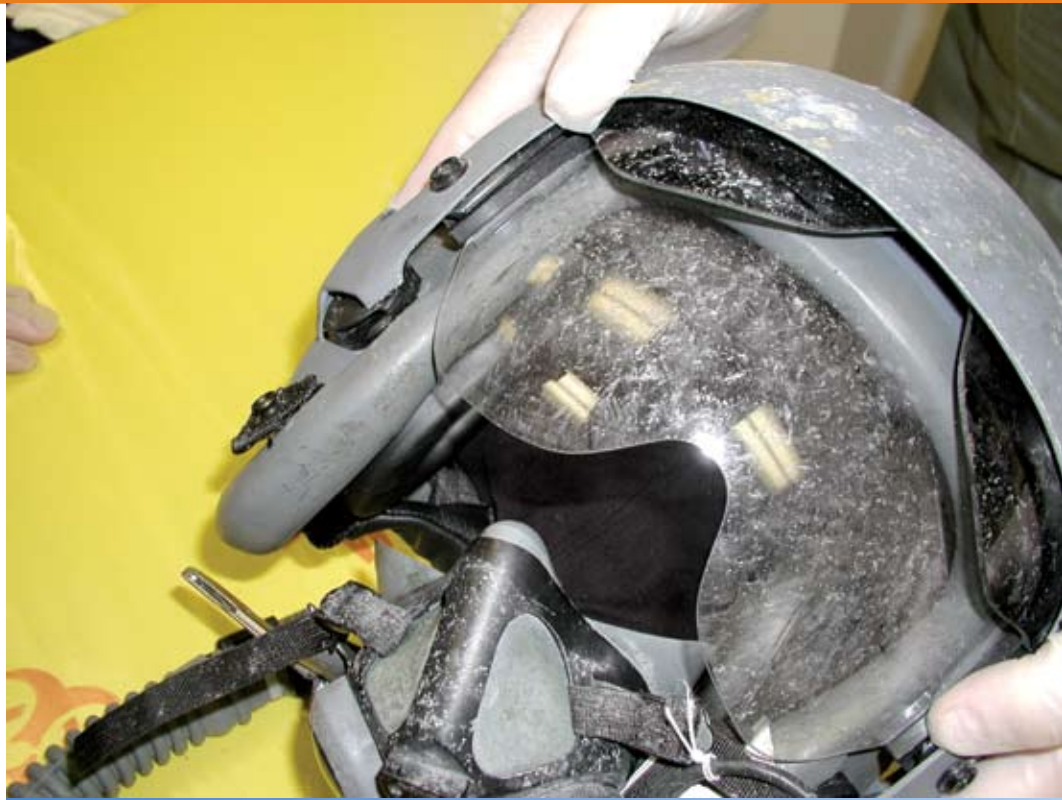
Figure 4. Helmet, visor and mask damage due to MDC and canopy material

Both pilots suffered burns from contact with molten MDC material during the ejection. Both helmets and visors showed signs of pitting, scratches and residue deposits (figure 4). As well, the blast cover of one Beaufort Mk30LC LPSV was perforated rendering the floatation bladder, stored within the carrier, unserviceable. The investigation

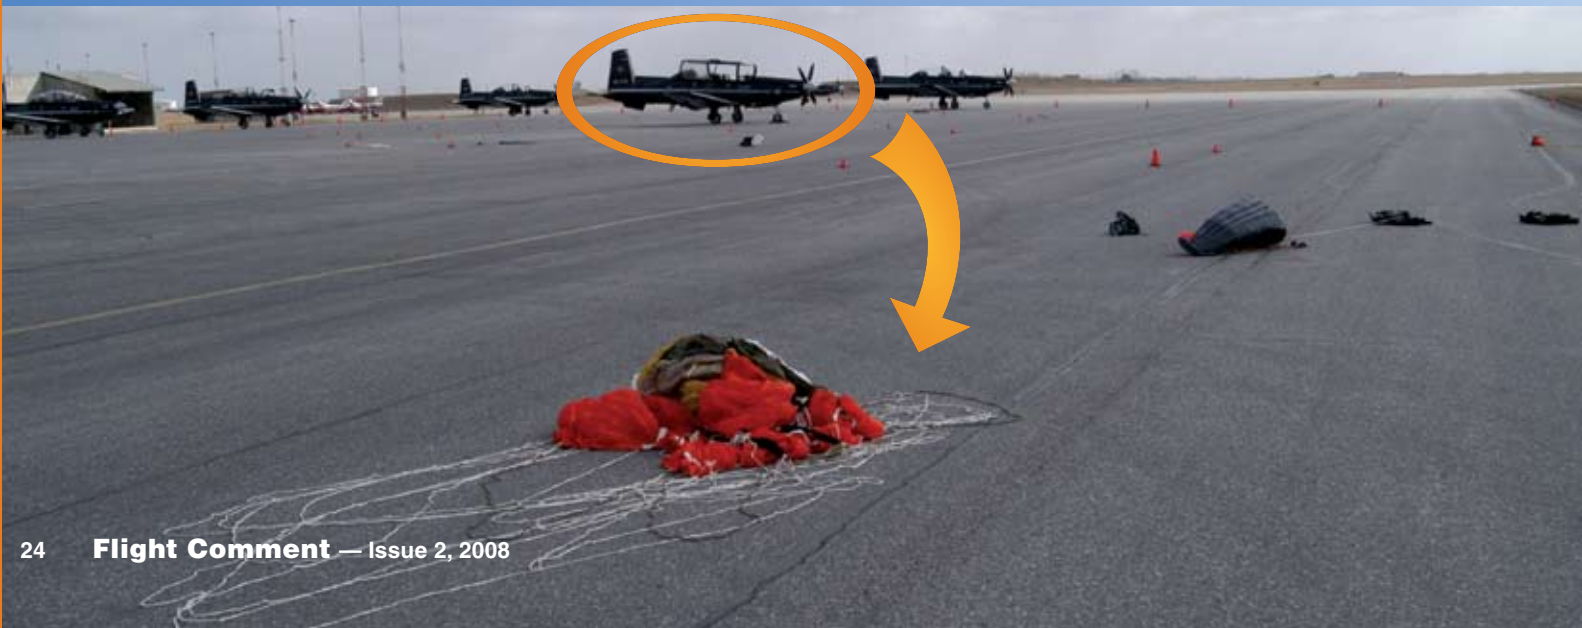
CT156 Harvard, 156112, April 4th, 2007

- A survey of CT156 aircraft in Moose Jaw revealed several differing lengths of communications lines on oxygen hoses.
- One of the two seat initiator cartridges did not fire, resulting in the non-activation of the harness powered retraction unit (HPRU), which forcefully restrains the pilot in the seat

and helps in adopting the proper posture. This was likely due to an improper stowing of the leg restraint lines by the pilot under the seat.

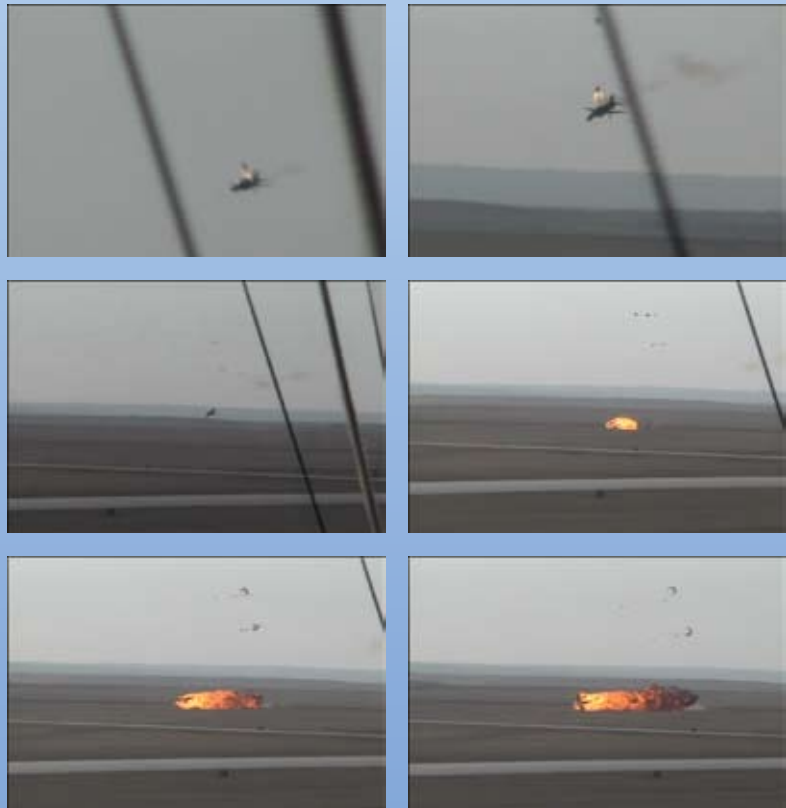
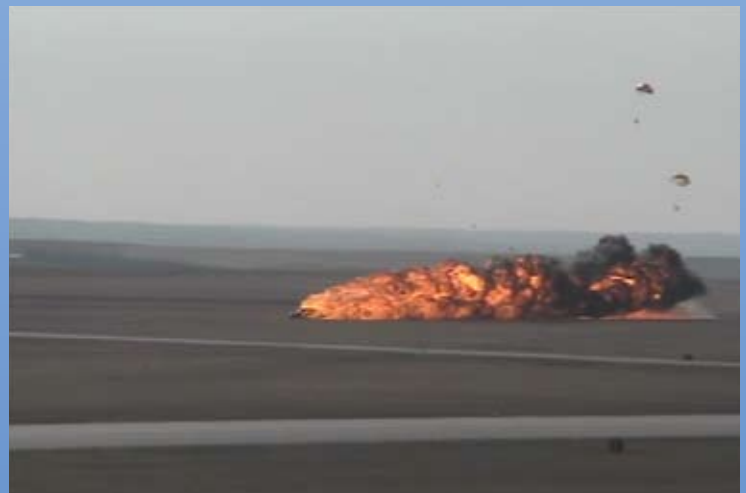
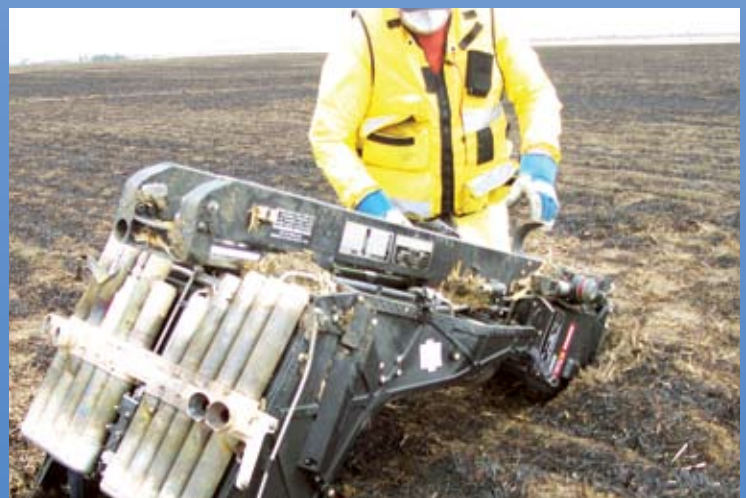
CT155 Hawk, 155215, April 18th, 2008

- Both IP and SP suffered serious injuries. The IP's injuries are consistent with loads imparted during the catapult phase, where contact with the aircraft canopy plexiglas, prior to it being ballistically removed, likely contributed to the injuries. The SP's injuries are consistent with loads experienced during the ejection and landing phase sequence. Based on these injuries, both ejections were classified as unsuccessful/survivable.

- The IP's helmet and mask showed significant damage, and parts of his visor were recovered with the aircraft canopy debris.
- The IP did not attempt to steer his parachute or release the Personal Survival Pack (PSP), and landed with the PSP under the right side of his body. The student did not attempt to steer his parachute but did repeatedly attempt to deploy his PSP, unsuccessfully. He landed while still trying to deploy it.
