Transport  
Canada

TP 185E  
Issue 2/2008

# AVIATION SAFETY LETTER

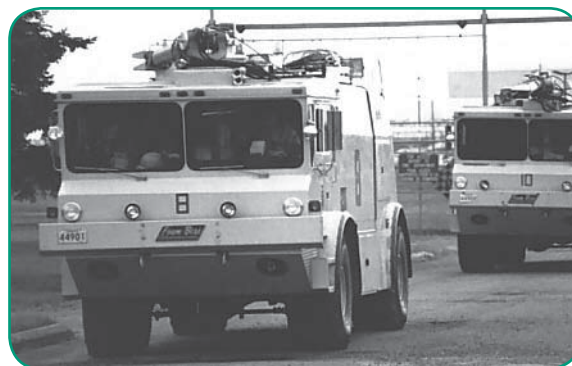
*Emergency vehicles responding to an aircraft emergency*

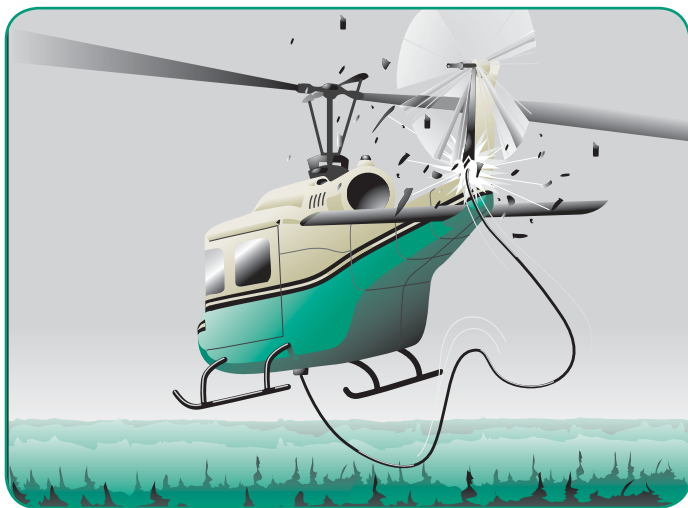
*Artist's impression of catastrophic contact between a light sling load and the tail rotor assembly*

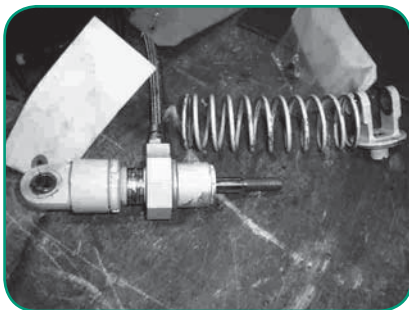
Up-lock actuator, part number 215750098

The Transport Canada routine follow-up included checking the SDR national database. Including the most recent submission, only three SDRs regarding this part have been filed. The first two were in the early months of 2000. The relatively small number of reports in the database raises several questions. Is the type certificate holder aware of the actual rate of defects found in this part, and the average time in service? Are they aware of the different NDT processes being used in the field, and why they are used? The SDR reporting process would allow them to assess what is happening, evaluate the data, and take appropriate action, if necessary. Are all the operators of this aircraft type in Canada aware of the additional information? Unless another operator happened to inform them in some way, it is not likely. Is there a way a new or foreign operator can obtain this information in a readily-accessible fashion? Again, unless another operator happened to inform them in some way, it is not likely.

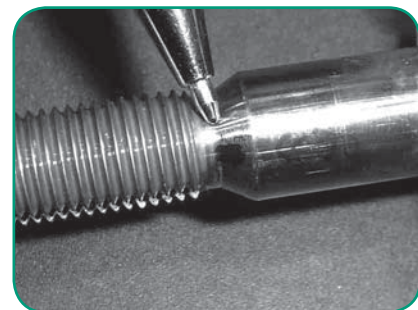
Shaft, part number 33130131, with a defect shown

of their aircraft will experience an unexpected failure of the up-lock actuator shaft. If the failure occurs, in this case, during a high force-loaded part of the flight, such as takeoff, landing or while scooping water, the result may be catastrophic. If everyone shares information using the available process, which is the SDR database, then

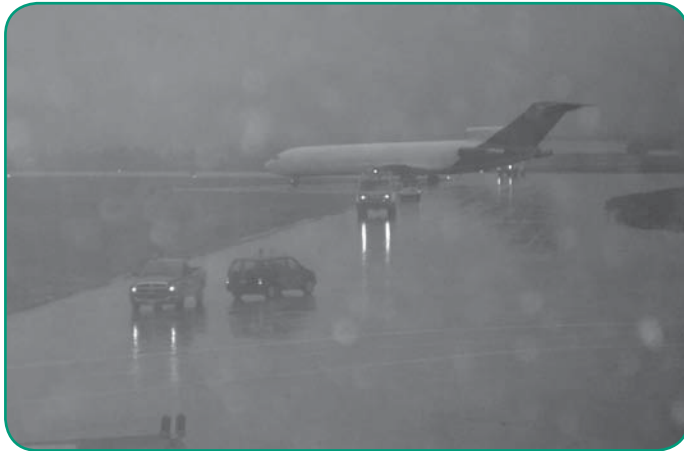
*Aircraft moments after runway excursion*

On August 31, 2004, a Boeing 727-200 cargo aircraft was on a scheduled cargo flight from Toronto, Ont., to Halifax, N.S., with stops at Montréal, Que., and Moncton, N.B. The aircraft landed on Runway 29 at Moncton at about 12:22 Atlantic Daylight Time (ADT). After touchdown, the aircraft hydroplaned and departed the runway at the Taxiway Charlie intersection. It crossed the taxiway and came to rest on an abandoned runway threshold, a short distance from the taxiway. Damage was limited to tread damage to the four main landing gear tires, and destruction of a taxiway light. There were no injuries.

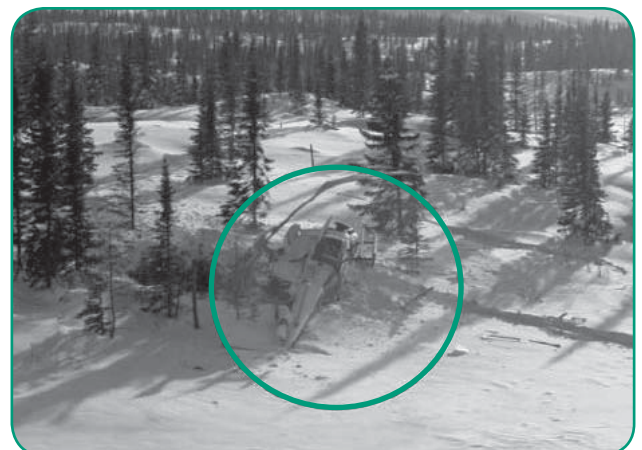
*View of wreckage and accident site*

On January 24, 2005, at approximately 15:00 Eastern Standard Time (EST), the pilot of an Aérospatiale AS 350 BA helicopter, with four hunters and one guide on board, was conducting an approach to an unserviced landing area on the edge of a lake, located in the James Bay area, 60 NM from La Grande-4, Que. At the end of the approach, the helicopter began to hover, and then started to descend into whiteout and loose snow conditions. The downdraught of the main rotor lifted the snow, causing a total loss of visual reference. After the left ski touched the snow-covered surface, the helicopter rolled onto its left side into snow that was several feet deep. During the rollover, the rotor blades struck the ground and the gearbox partly separated from the fasteners. Some blades penetrated the cockpit, fatally injuring the guide and the pilot, who was wearing a helmet. The four passengers sitting in the rear seats were not wearing seat belts, and received minor injuries. Two of the passengers were ejected from the aircraft, and ended up approximately 10 ft from the wreckage; the two others remained in the cabin. The survivors were evacuated by two other helicopters at approximately 16:30 EST.

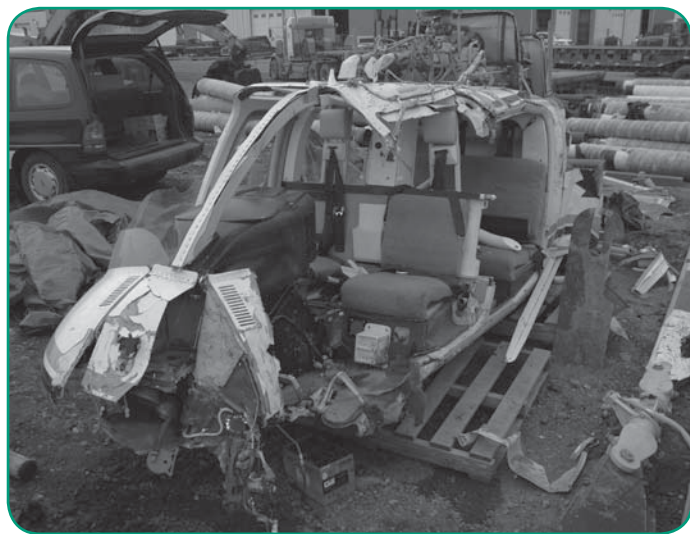
Forward left view of main rotor strike damage to cockpit

7. The main rotor penetrated the left-side cockpit and cabin, contributing to the severity of the injuries to the passengers.
8. It is probable that the passenger in the rear left seat was not wearing the available shoulder harness; this likely increased the severity of his injuries.
