Transport  
Canada

TP 185E  
Issue 3/2008

# AVIATION SAFETY LETTER

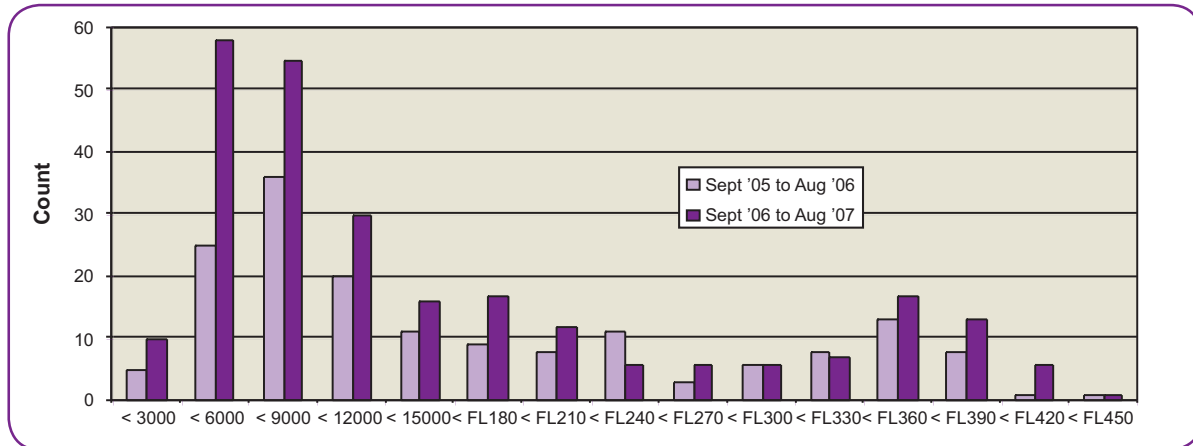
Altitude deviations<sup>1</sup> are serious events which, if undetected, can lead to losses of separation and the potential for collision with both aircraft and terrain. Figure 1 shows the altitudes where deviations were reported through NAV CANADA's aviation occurrence reporting (AOR) system for the last two years for which complete data is available. The figure is broken down by altitude and shows, not surprisingly, that most altitude deviations take place in the lower altitudes, where aircraft are involved in making step climbs and descents.

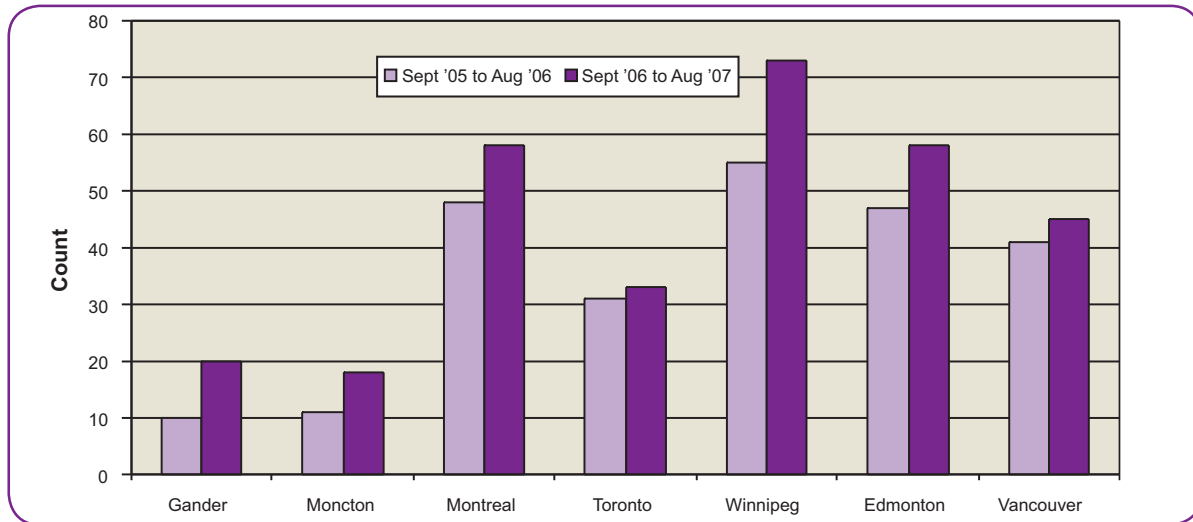
Figure 2 shows the number of altitude deviations reported over the last two years, broken down by flight information region (FIR), and demonstrates that this issue is pertinent across Canada.

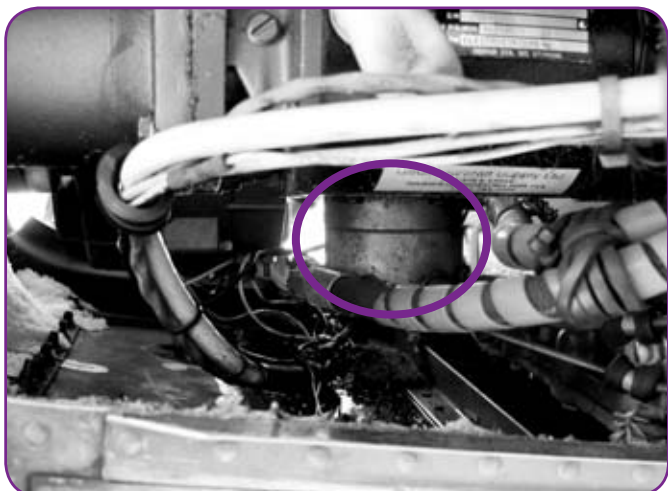
Figure 1: Fuel distributor valve installation in the lower front engine area

with no fuel supply to the forward cylinder nozzles; the right engine had a complete blockage with no fuel supply to any of the cylinder nozzles. The blockage was determined to be within the fuel distributor valve(s) because fuel pressure was present upstream of the valves. The right engine fuel distributor valve was removed and examined. There was ice found adhering to the internal main metering well surface. Ice formed from super-cooled water droplets was also found adhering to the servo bleed screen, fully covering and blocking the return-to-tank bleed orifice.

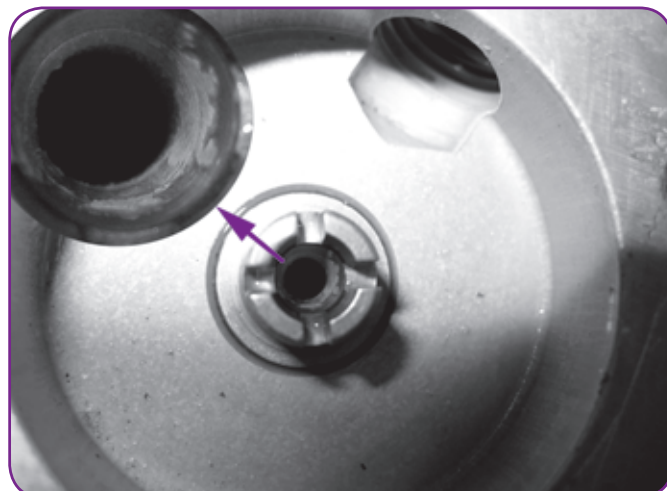
Figure 2: Ice on main metering well

The precipitated moisture in the form of super-cooled water droplets emerged from the pump and was carried through the fuel injection metering unit to the fuel distributor valve. A significant reduction in flow velocity occurred at the bottom of the distributor valve plunger well. This, combined with a reduced fuel distributor valve surface temperature (due to the cooling air blast against the forward face of the valve), promoted the formation of ice crystals. These ice crystals continued to capture the super-cooled water droplets until the ice build-up blocked the forward fuel injection lines, causing a reduction in engine power. In extreme cases, all the nozzle ports could become blocked, causing a complete loss of engine power. Small ice formations were also observed at the bottom and side surfaces of the fuel distributor plunger (main metering) well. When melted, the ice accumulation represented less

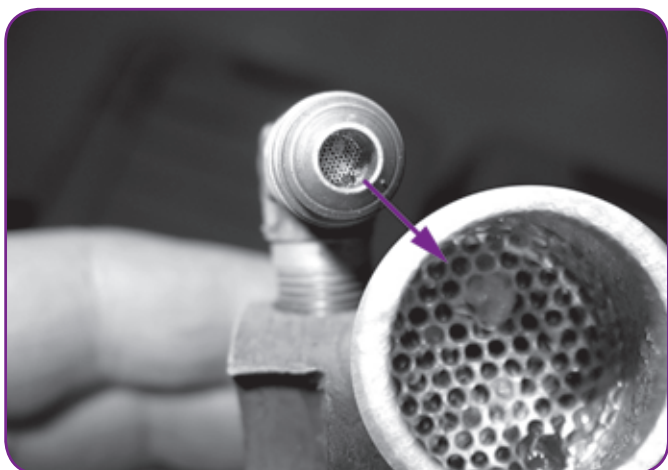
Figure 3: Super-cooled droplet ice-formation on the servo bleed screen

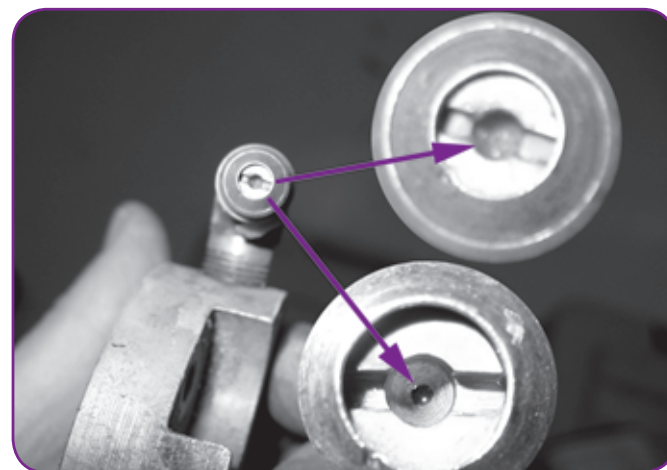
Figure 4: Return-to-tank bleed orifice (shown frozen and thawed for comparison)

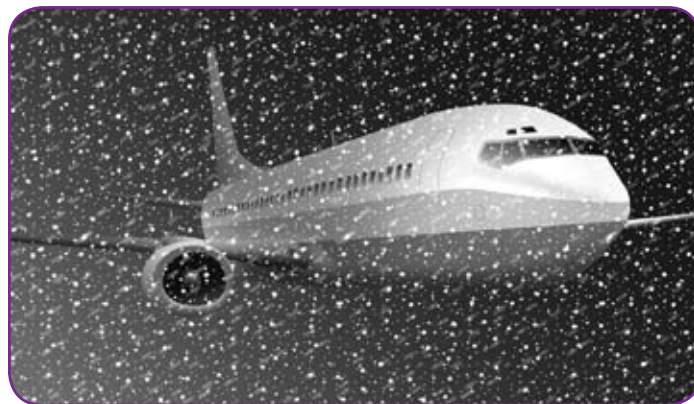
*The ice crystal or mixed phase icing threat to engines is a major concern since engines are relied upon to continue to operate in any kind of icing conditions.*

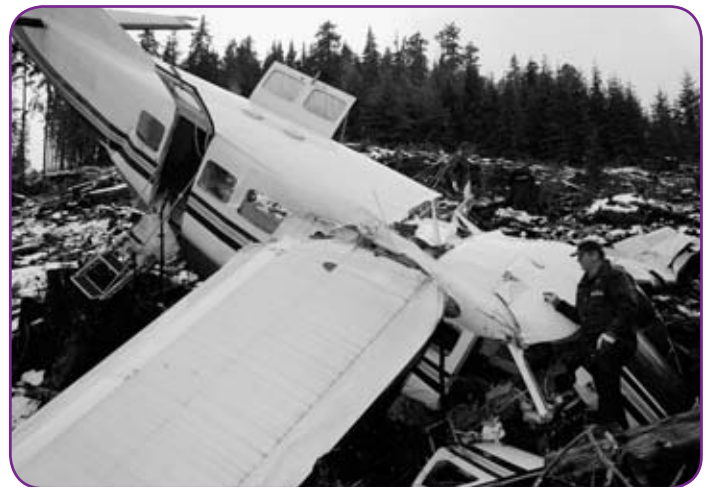
On January 21, 2006, a Cessna 208B aircraft was en route at 9 000 ft above sea level (ASL), from Tofino, B.C., to the Vancouver International Airport, B.C., when the engine failed. The pilot began a glide in the direction of the Port Alberni Regional Airport, B.C., before attempting an emergency landing on a logging road. The aircraft struck trees during a steep right-hand turn and crashed. The accident occurred at about 14:20 Pacific Standard Time (PST), approximately 11 NM south-southeast of the Port Alberni Regional Airport. Five passengers survived with serious injuries; the pilot and the other two passengers were fatally injured.

1. The engine lost power when a compressor turbine blade failed as a result of the overstress extension of a fatigue-generated crack. The fracture initiated at a metallurgical anomaly in the parent blade material and progressed, eventually resulting in blade failure due to overstress rupture.
2. The combination of aircraft position at the time of the engine failure, the lack of equipment enabling the pilot to locate and identify high terrain, and the resultant manoeuvring required to avoid entering instrument flight conditions likely prevented the pilot from attempting to glide to the nearest airfield.

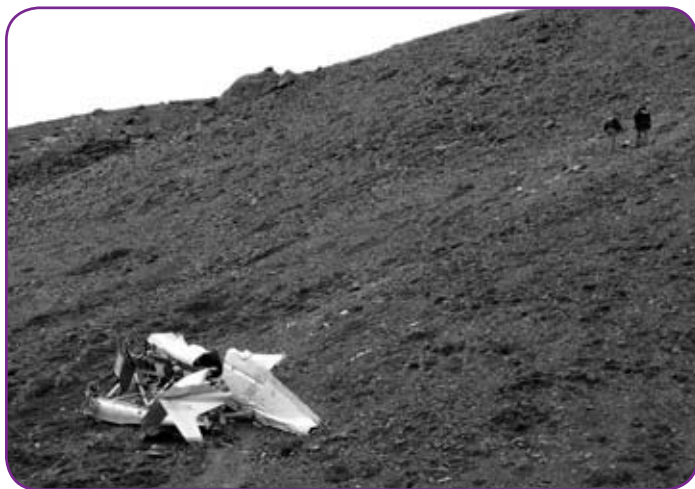
*Aerial view of accident site, with TSB investigators at the approximate impact point*

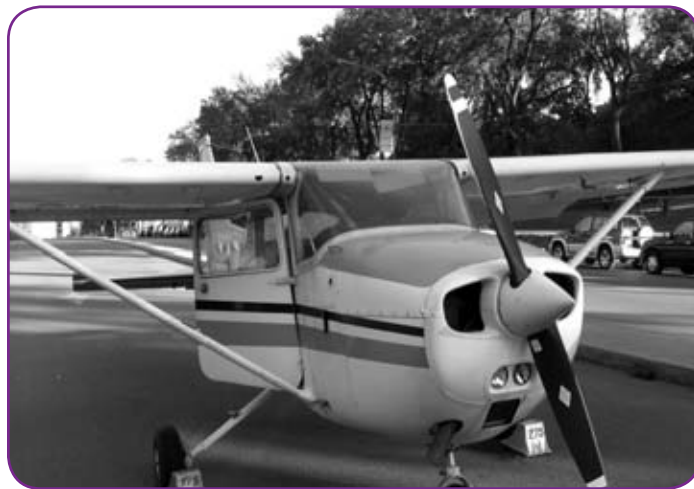
The pilot tried to restart it, but without success. The pilot transmitted a distress message and quickly reported the situation to the control tower. The aircraft was approximately 1 250 ft above ground level (AGL) at the time. The pilot landed the aircraft on the northbound side of Parc Avenue, in Montréal. On landing, the left wing tip struck a traffic light post before the aircraft came to rest. The aircraft was substantially damaged, but there were no injuries.

1. The aircraft was not on level ground when the draining was done before the flight. Consequently, the water in the fuel tank was lower than the drain valve and could not be removed with the pipette.
2. The water accumulated in the right fuel tank migrated to the gascolator bowl, saturating it, and causing the engine to stop.

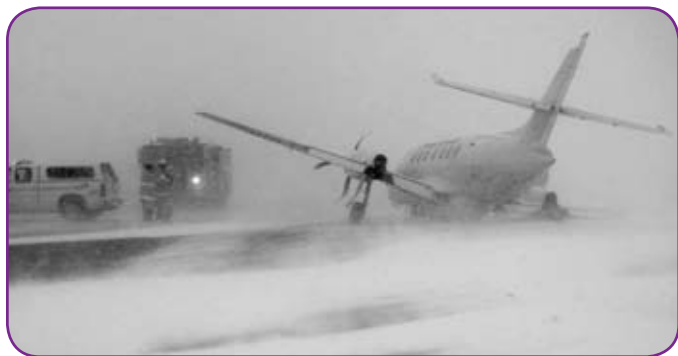
*This picture taken shortly after the occurrence illustrates the poor visibility*

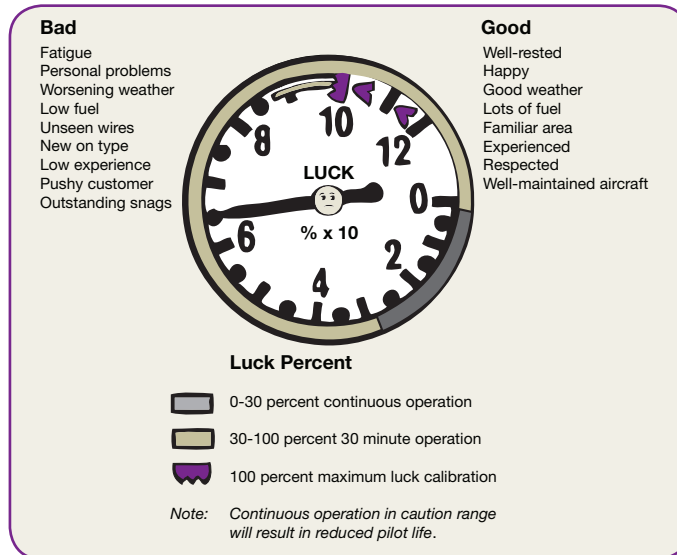
A luck meter: think about it! Because of the obvious connection between high-risk activities and resulting bad luck (cause and effect?), such an instrument would be without equal for keeping us safe. As good luck—not surprisingly—most often follows solid safety practices, the luck meter would indicate movement into the realm of chance, which is really a loss of control of one's destiny. The readout would let pilots know when they are on relatively safe ground, or rolling the dice.

Accordingly, I have listed some of the common causes of good and bad luck on the appropriate sides of the luck meter. There are many more, but you get the idea. The grey arc indicates a minimum level of risk that leaves little to chance. The idea is to start a flight with solid safety practices in place, and to minimize dependence on luck wherever possible.
