CNSC Staff Integrated Safety Assessment of Canadian Nuclear Power Plants for 2008

INFO-0790

Published by the Canadian Nuclear Safety Commission (CNSC), August 2009

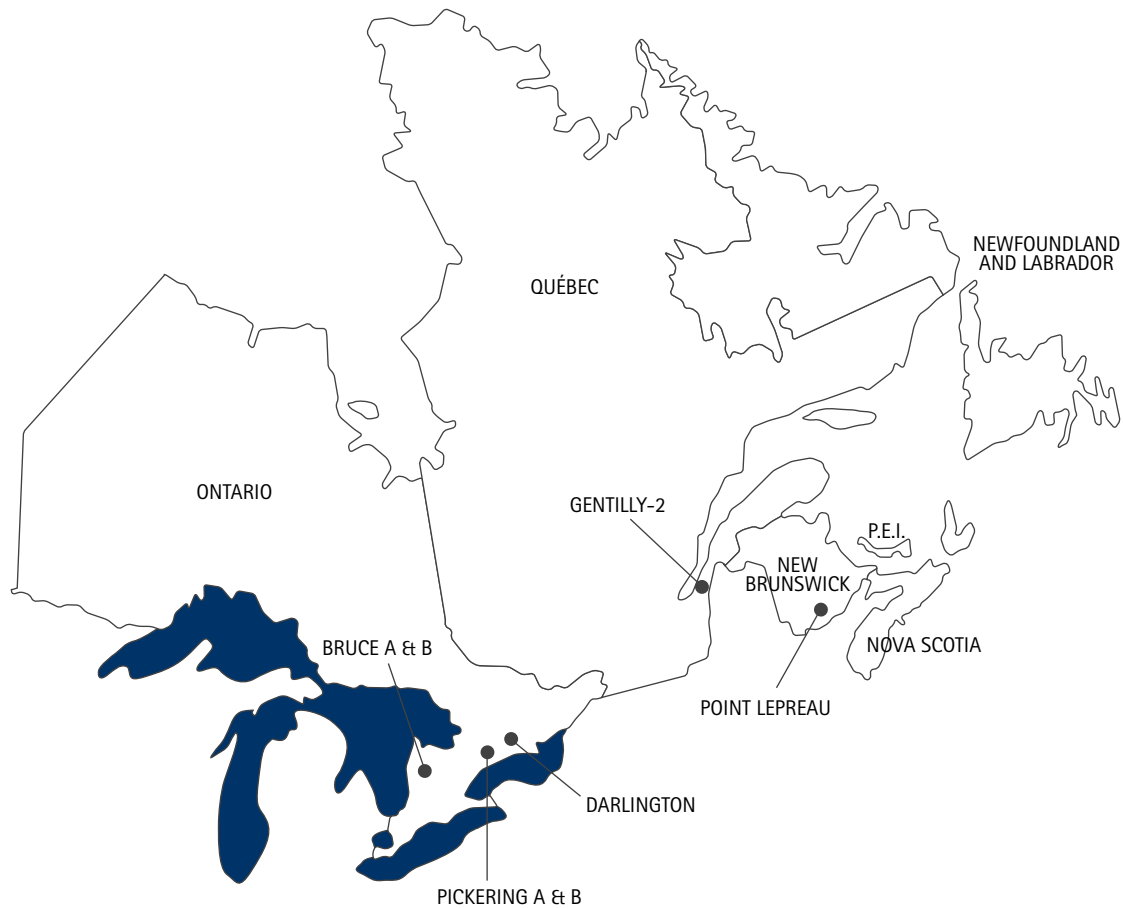
FIGURE 1: LOCATIONS AND PLANT DATA OF POWER REACTOR SITES IN CANADA

Plant Data							
Plant	Bruce		Darlington	Pickering		Gently-2	Point Lepreau
	A	B		A	B		
Licensee	Bruce Power	Bruce Power	Ontario Power Generation	Ontario Power Generation	Ontario Power Generation	Hydro-Québec	New Brunswick Power Nuclear
Reactor Units	4	4	4	2*	4	1	1
Gross Electrical Capacity/Reactor (MW)	904	915	935	542	540	675	680
Start-Up	1977	1984	1989	1971	1982	1983	1982
Licence Expiry	2009/10/31	2009/10/31	2013/02/28	2010/06/30	2013/06/30	2010/12/31	2011/06/30

* plus 2 units in safe storage

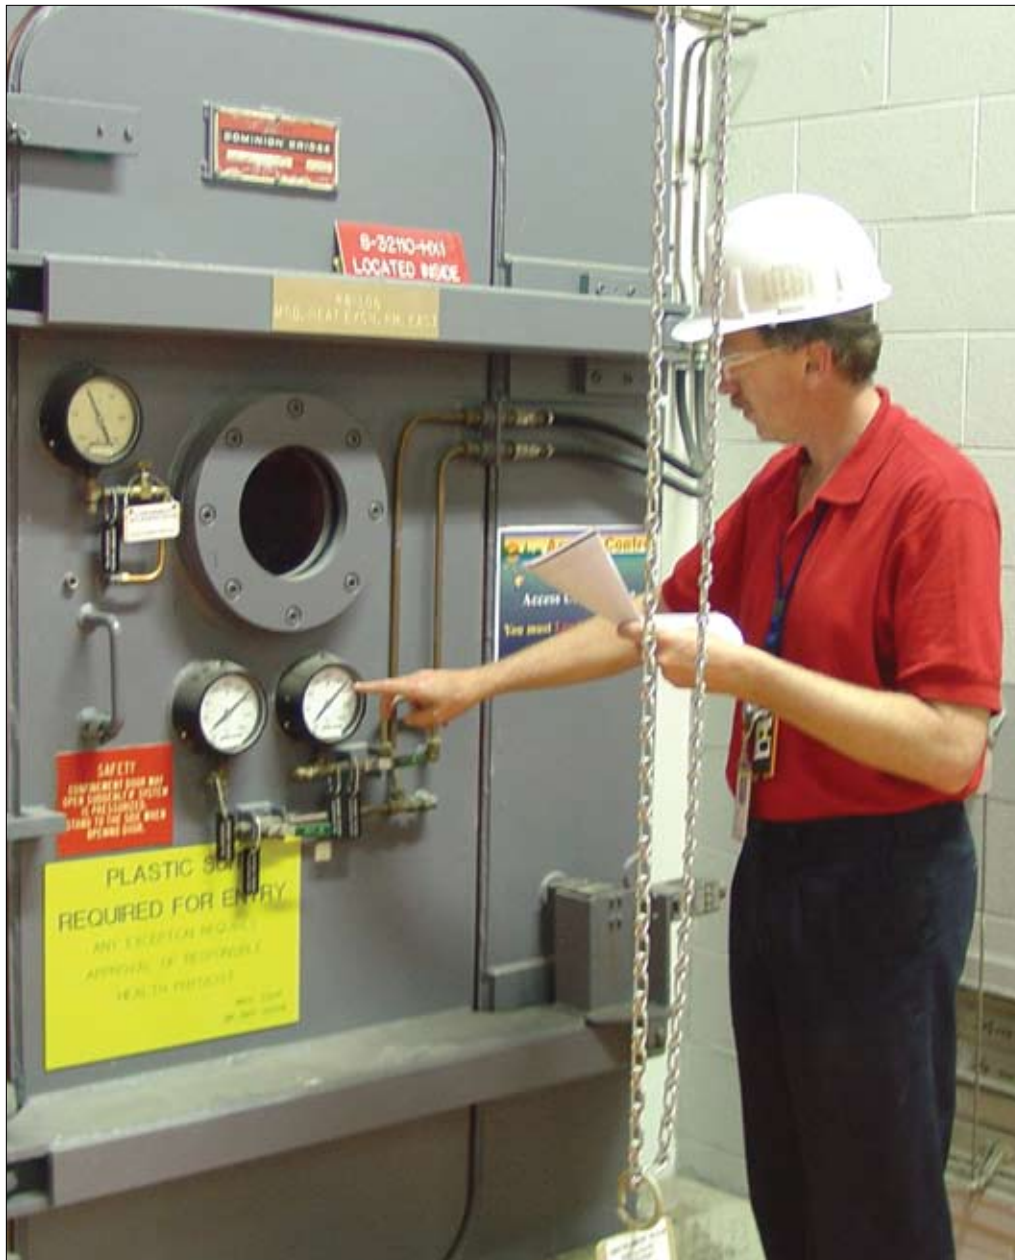
CHECKING THE CONFINEMENT DOOR TO ENSURE THE SEALS ARE INFLATED AND WITHOUT LEAKS.

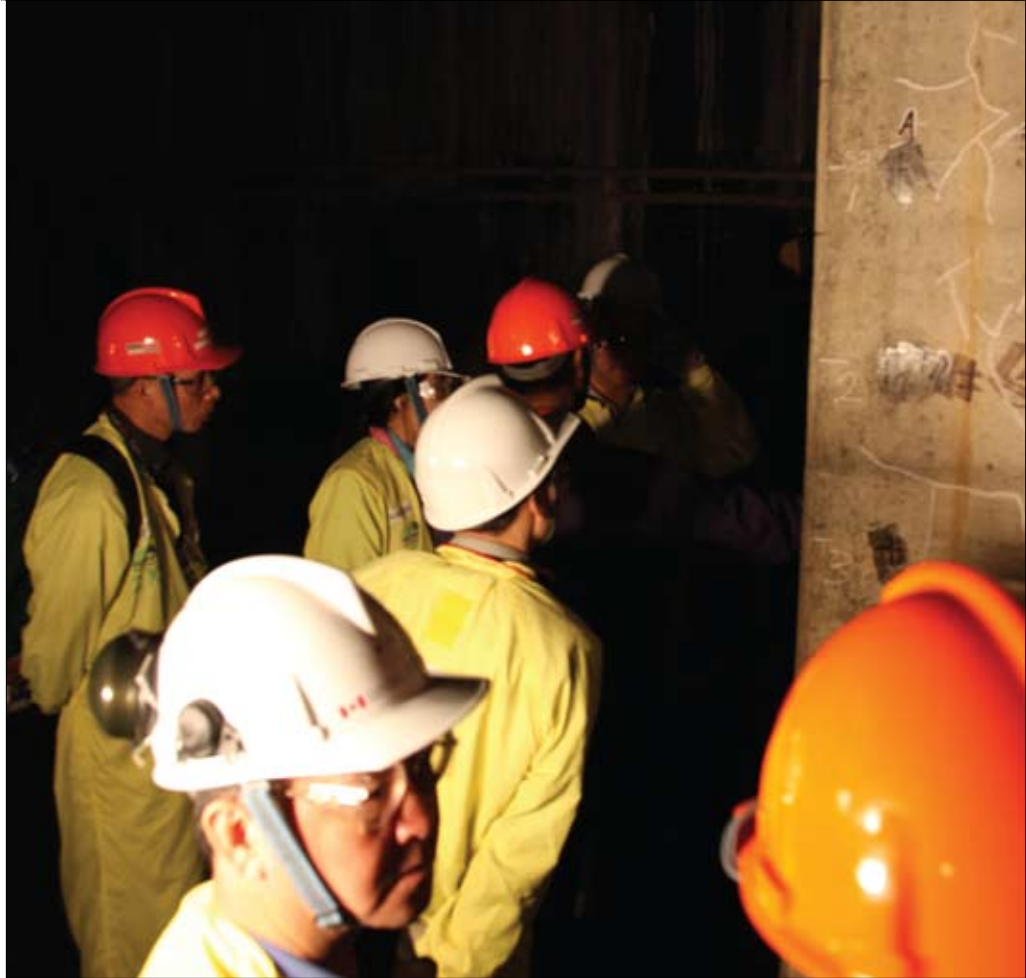
INSPECTORS MONITOR THE
STRUCTURAL INTEGRITY OF A
VACUUM BUILDING.

Bruce Power conducts periodic inspections at Bruce A and B, according to station Periodic Inspection Programs (PIPs) and CSA standards N285.4 "Periodic Inspection of CANDU Nuclear Power Plant Components" and N285.5 "Periodic Inspection of CANDU Nuclear Power Plant Containment Components". The inspection reports are submitted to CNSC staff on an ongoing basis, for review and acceptance.

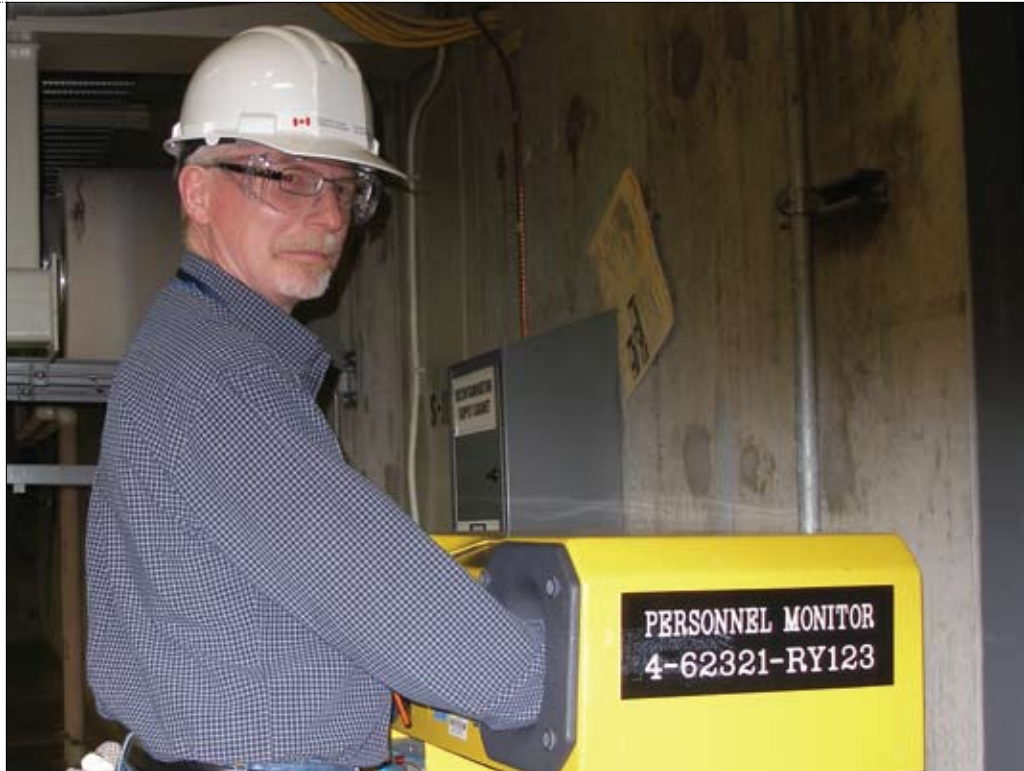
CNSC STAFF PASS THROUGH A HAND AND FOOT MONITOR TO ENSURE THEY HAVE NOT PICKED UP ANY RADIOACTIVE PARTICLES. THIS PREVENTS THE SPREAD OF CONTAMINATION BETWEEN ZONES.

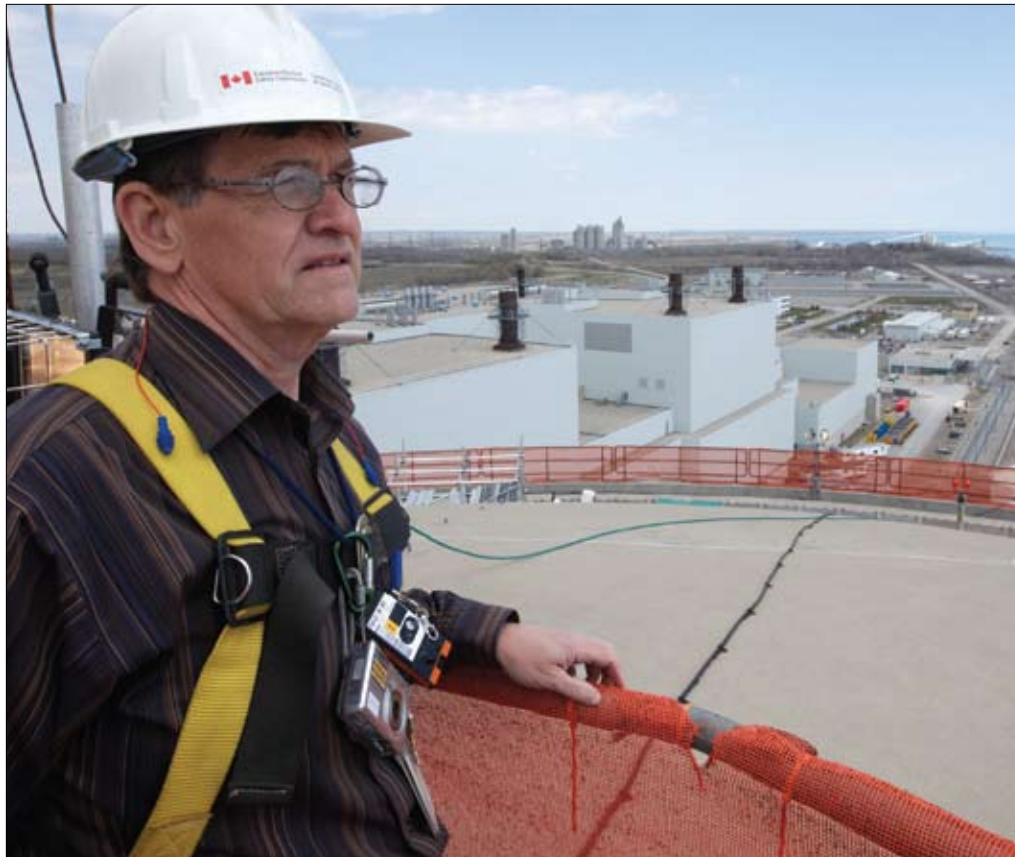
ONCE EVERY SIX YEARS, NUCLEAR GENERATING STATIONS ARE SHUT DOWN TO TEST THE CONTAINMENT IS LEAK TIGHT. THIS INSPECTOR IS ON THE ROOF OF THE VACUUM BUILDING AT DARLINGTON.

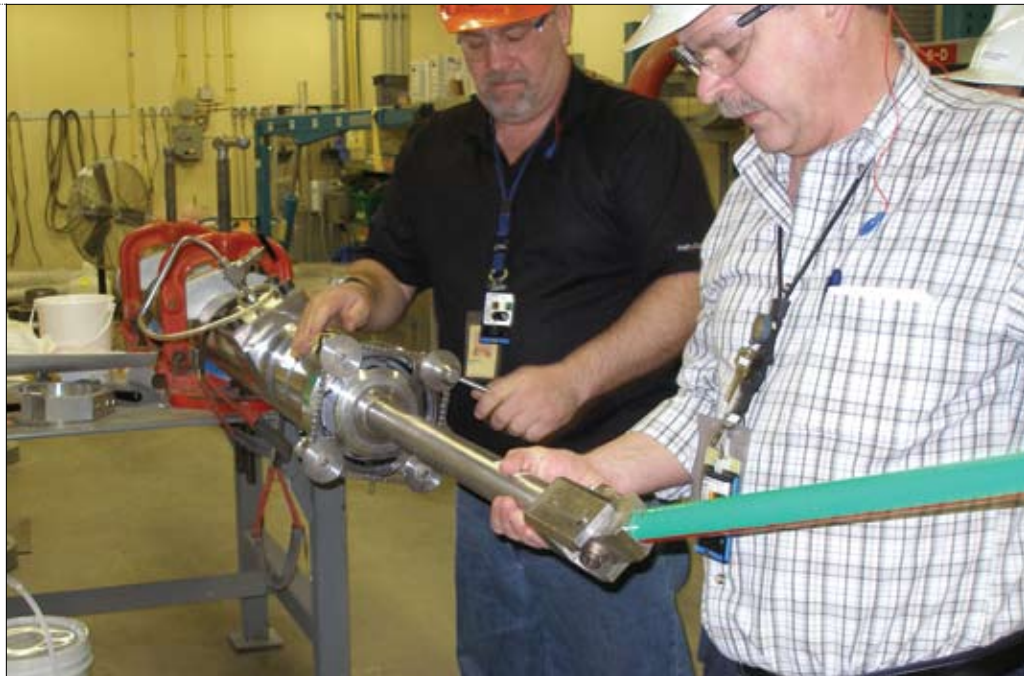
CNSC INSPECTORS CHECKING THE VENTED CLOSURE PLUG THAT WILL BE PUT INTO THE REACTOR DURING AN OUTAGE. THIS COMPONENT ALLOWS WORK DURING THE OUTAGE TO BE DONE FASTER.

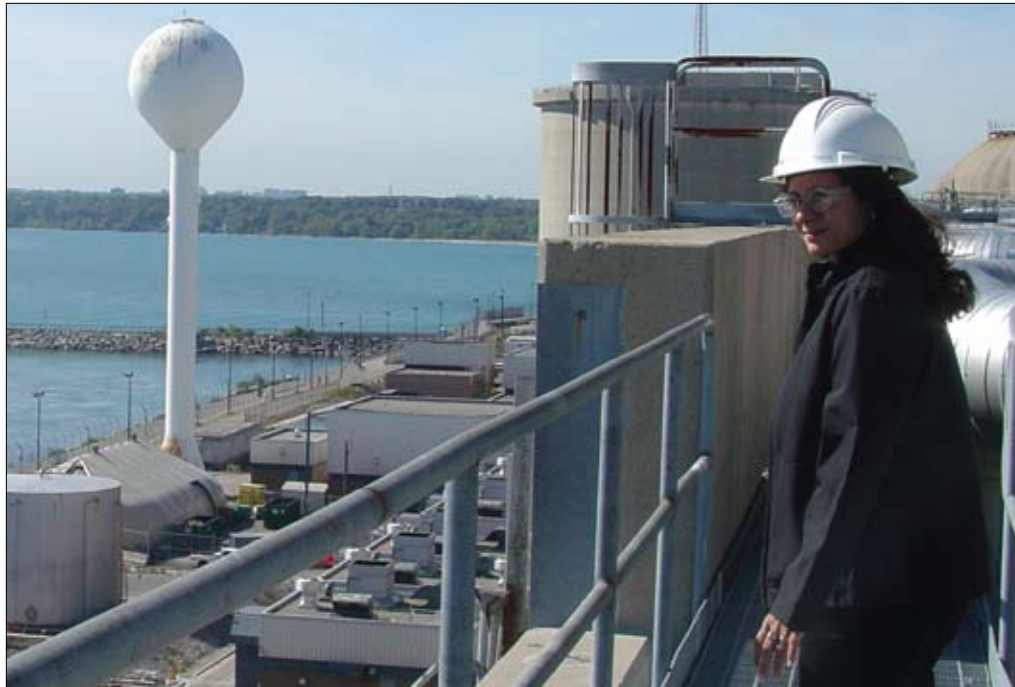
VERIFYING THE STATUS OF THE PRESSURE RELIEF DUCT AT PICKERING.

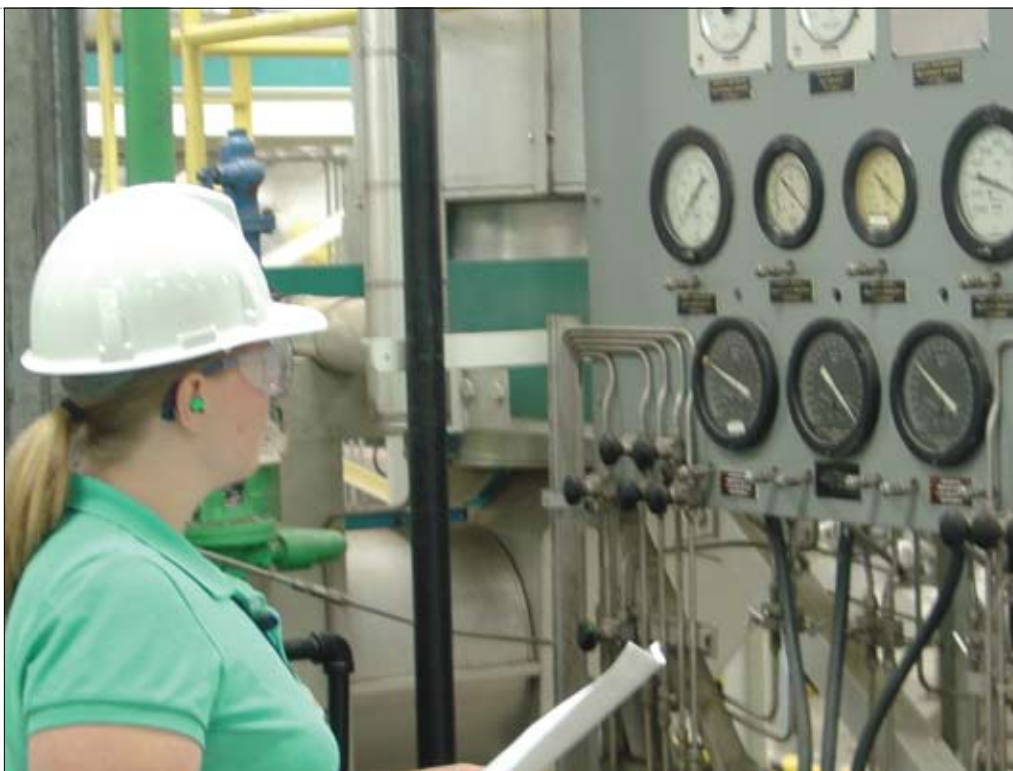
*CHECKING GAUGES TO ENSURE
ADEQUATE PRESSURE OF THE
BOILER FEED PUMP.*

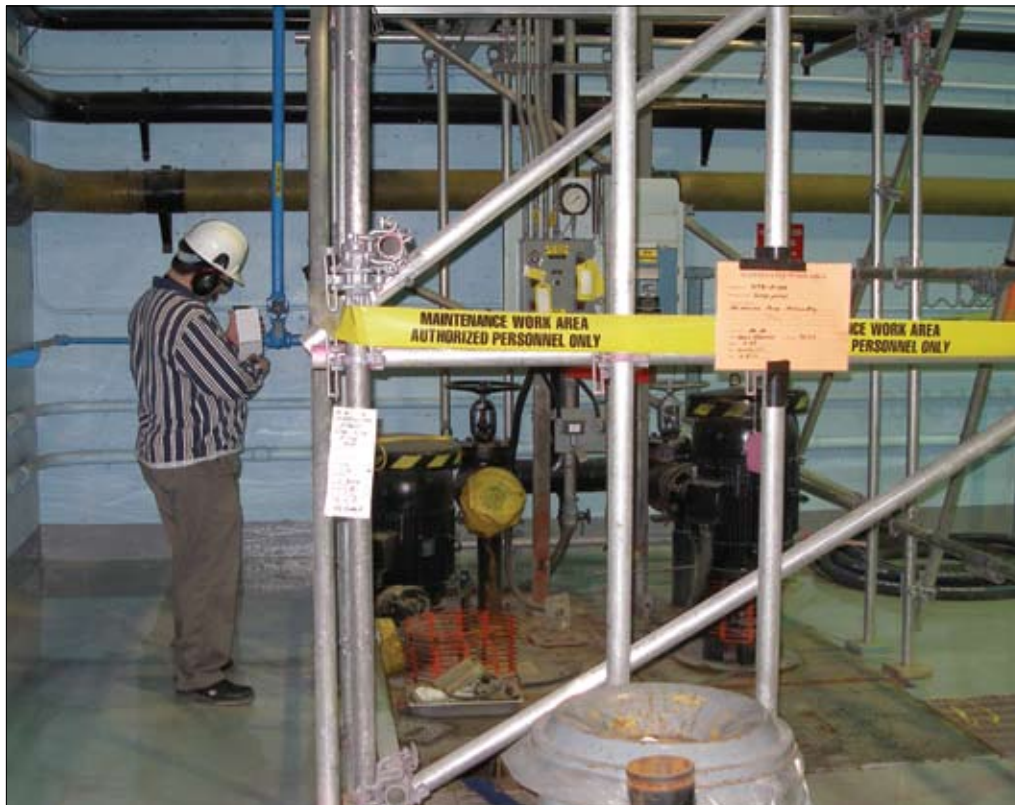
CHECKING TURBINE SUMP PUMP LEVELS TO ENSURE THEY ARE WORKING EFFECTIVELY.

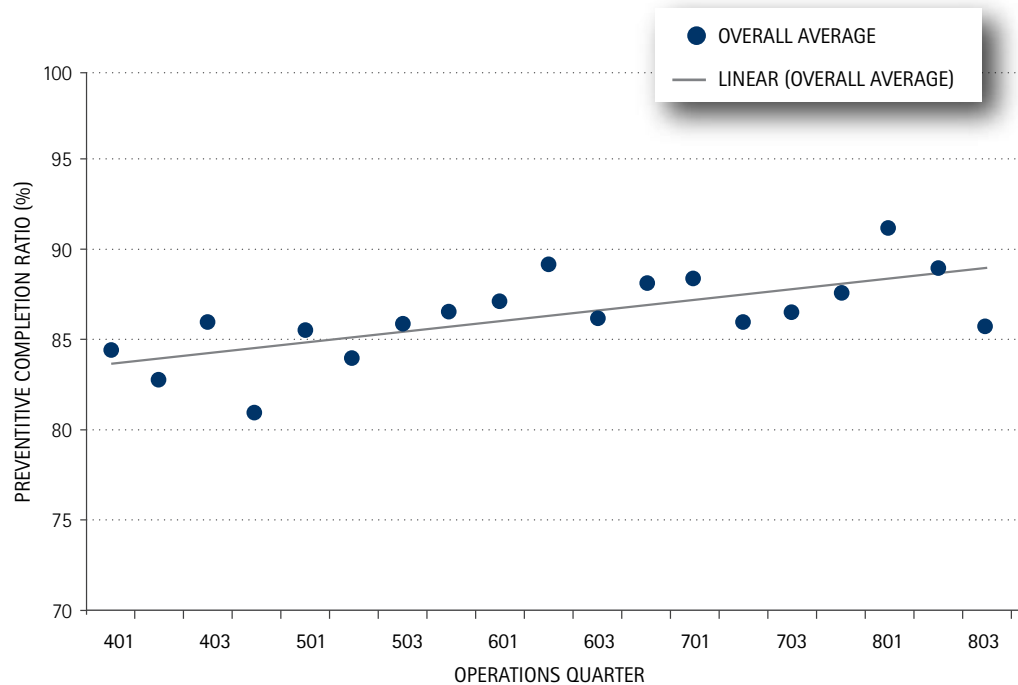
FIGURE 2: AVERAGE PMCR FOR ALL NPPS

The PMCR is a lagging indicator of PM program effectiveness. An optimal PM program will minimize—but not eliminate—corrective work, thus increasing the ratio. The historical data for PMCR is given in Figure 2 below. Since the first quarter of 2004 (set as 401 in this graph), the overall PMCR average data shows a general upward trend. Best industry practice sets a target of 90% or better for this indicator.

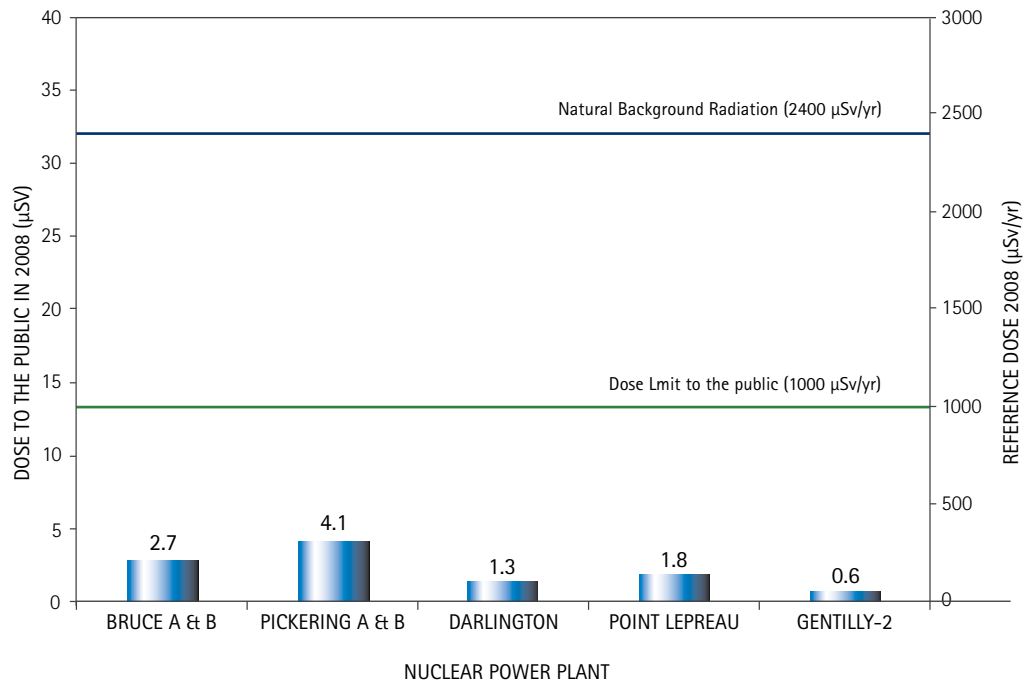
FIGURE 3: DOSE TO THE PUBLIC FROM CANADIAN NUCLEAR POWER PLANTS IN 2008

The dose to the public from each Canadian NPP in 2008 is provided in Figure 3. The figure shows that the doses to the public are well below the regulatory limit of 1000 $\mu\text{Sv}/\text{year}$.

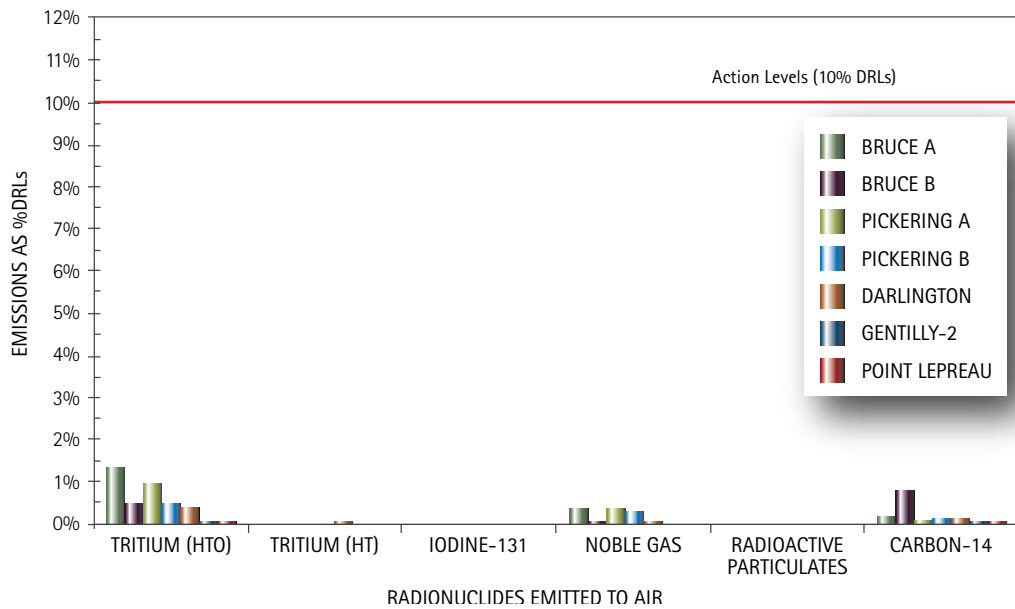
FIGURE 4: RADIONUCLIDES EMITTED TO AIR BY CANADIAN NPPS IN 2008

Airborne emissions and liquid releases are shown in Figures 4 and 5, respectively. Both airborne emission and liquid releases were lower than the DRLs in 2008, and always well below the Action Levels.

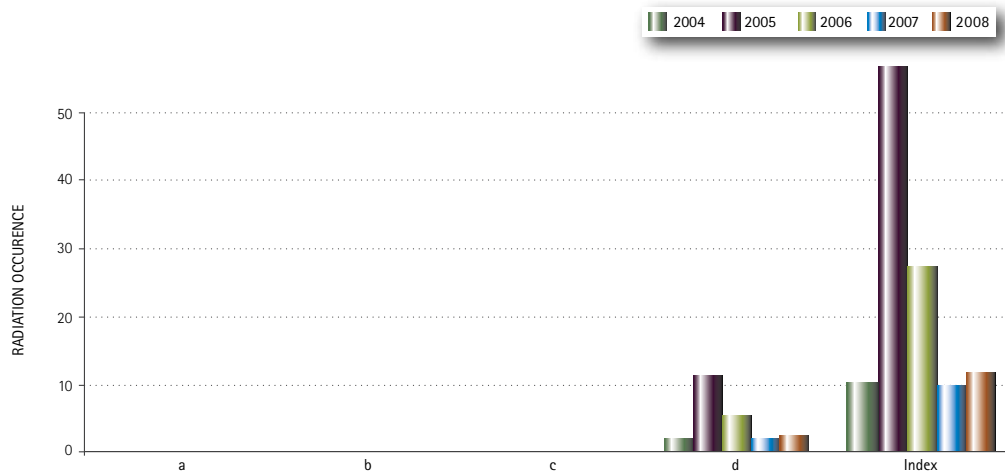
FIGURE 16: TREND DETAILS OF RADIATION OCCURENCE INDEX FOR INDUSTRY

The weight of each component in the formula indicates the relative safety significance of various types of occurrences. Table 16 and Figures 16 and 17 show the industry's Radiation Occurrence Index. In 2008, there were no doses in excess of specified limits (see the value of "d" in Table 16). Bruce A, Darlington, Pickering A, Gentilly-2 and Point Lepreau had no occurrences of any type. Bruce B and Pickering B each had a type "c" occurrence. Overall, the industry average for the index remained low, when compared with previous years.
