TP 185E
Issue 2/2009

AVIATION SAFETY LETTER

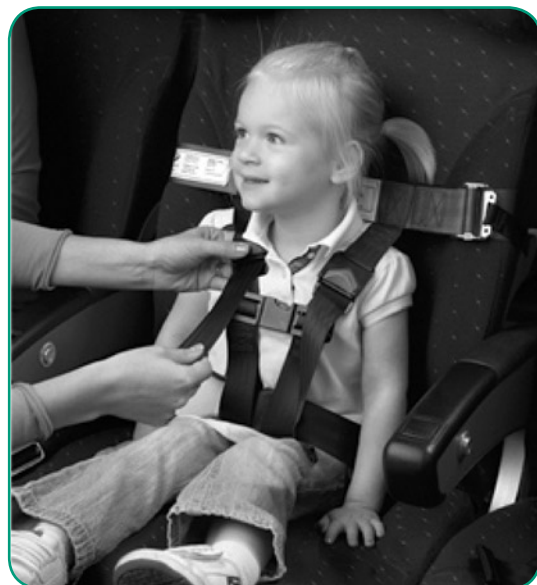
Child restraint systems are typically sold in the form of a car seat. However, Transport Canada recently accepted an alternative child restraint device called the Child Aviation Restraint System (CARES). Developed by AmSafe, CARES is a harness-type device that utilizes an aircraft passenger seat belt to secure a child's upper torso against the aircraft seatback.

one to four, weighing between 22 and 44 lbs and measuring 40 in. or less in height. The CARES device was examined by Transport Canada, and the test criteria was found to be acceptable for use on Canadian aircraft. This new restraint device weighs one pound, can be easily transported, and offers an alternative method of child restraint to passengers travelling with small children.

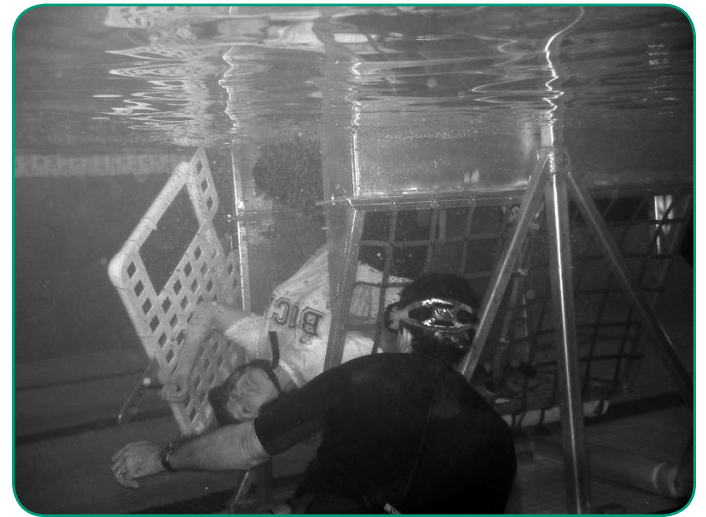
Typical underwater-egress training exercise, professionally supervised and done with portable equipment in local pools.
