Transport
Canada

TP 185E
Issue 3/2009

AVIATION SAFETY LETTER

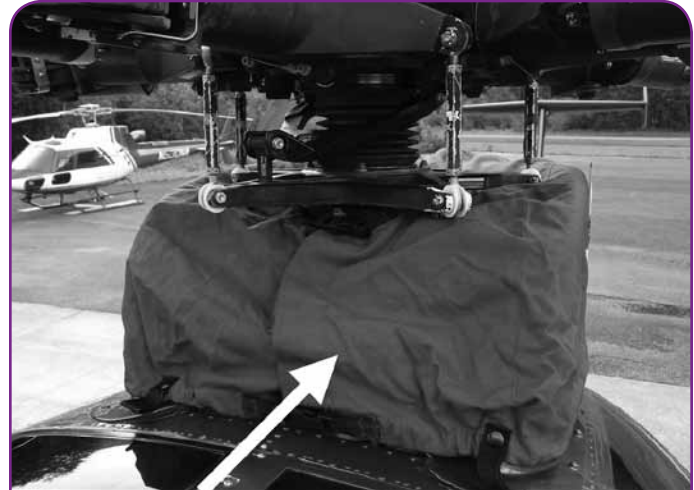
Doghouse cover

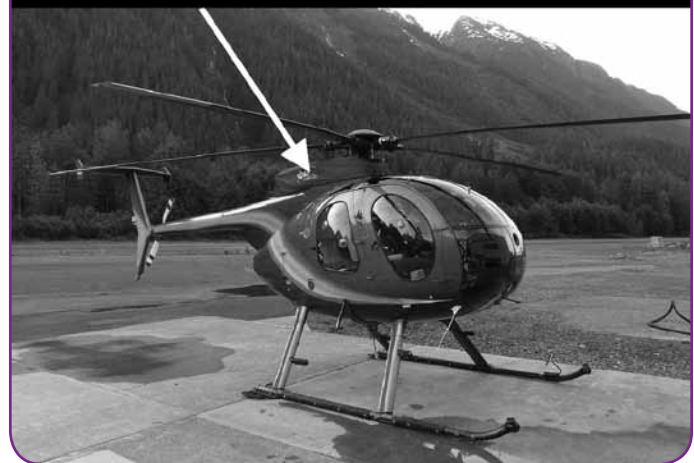
Photo 1: Doghouse cover

The cover did not have any straps or physical barriers that fall at or below human eye level. Once the pilot gets into the helicopter, there are no visual clues of the cover's installation. Before this occurrence, it was expected that the engine would not start with the cover installed, but we now know that as soon as the rotor started turning, the cover opened enough to let in sufficient air for the start.

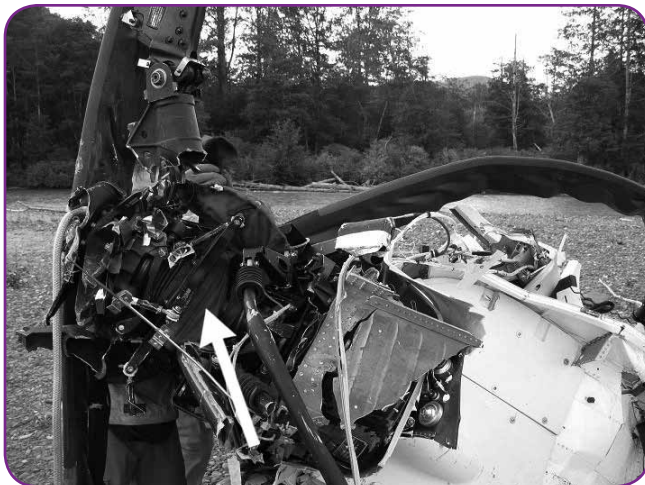
Photo 2: Doghouse cover wrapped between controls

It is clear that the removal of the cover was missed during flight preparation and that the cover damaged the main rotor controls while the rotor was turning. Also, rotor rpm was likely lost due to the binding effect that the cover had as it squeezed between the stationary and rotating components of the swashplate assembly. This rendered the helicopter uncontrollable after the takeoff, and it collided with terrain.

1. The doghouse cover was not removed before flight and it wrapped around the flight controls linkage, damaged the linkage, and rendered the helicopter uncontrollable.
2. The helicopter fell in an uncontrolled state, with reduced rotor rpm, until it collided with terrain.
3. Anomalies in the pilot's routine and the lack of physical barriers likely caused him to miss removing the cover before the flight.

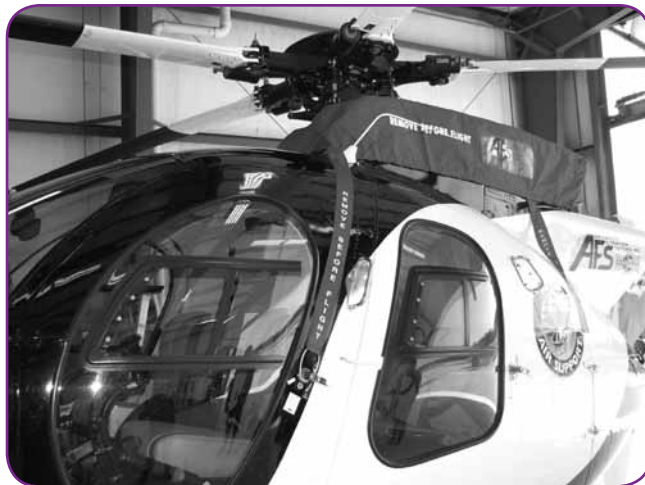
Photo 3: Modified doghouse cover

The manufacturer of the doghouse (Aerospace Filtration Systems Inc.) has taken safety action in modifying the cover (see Photo 3).

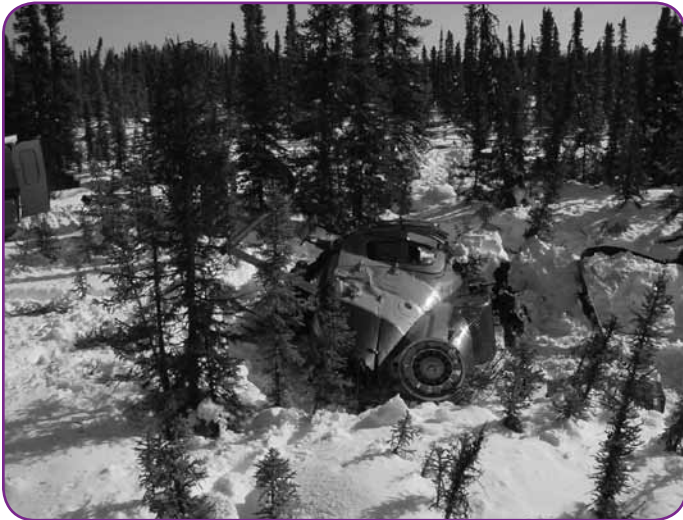
TSB Final Report A06W0041—Airframe Failure and Collision with Terrain

1. The attach fitting at the upper right attachment point of the tail boom failed in fatigue. The transfer of loads to the adjacent aft ring structure resulted in the cascading failure of the remaining three tail boom attach fittings and separation of the tail boom from the fuselage.
2. Aircraft control was lost following separation of the tail boom. Safe recovery following this type of structural failure was unlikely.
3. The 25-hr visual inspections allowed by the alternate method of compliance (AMOC) did not identify damage to the tail boom attachment fittings before structural failure.

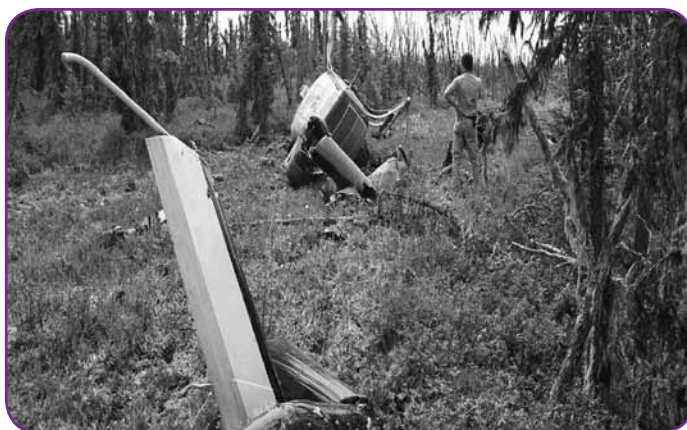
On July 4, 2006, the pilot of a Bell 206B helicopter was conducting water-bucketing operations in support of forest-fire suppression activities approximately 23 NM northeast of Wabasca, Alta. At approximately 16:00 Mountain Daylight Time (MDT), the helicopter contacted trees adjacent to a shoreline, broke up, and came to rest in an inverted position. The pilot, the sole occupant, was fatally injured.

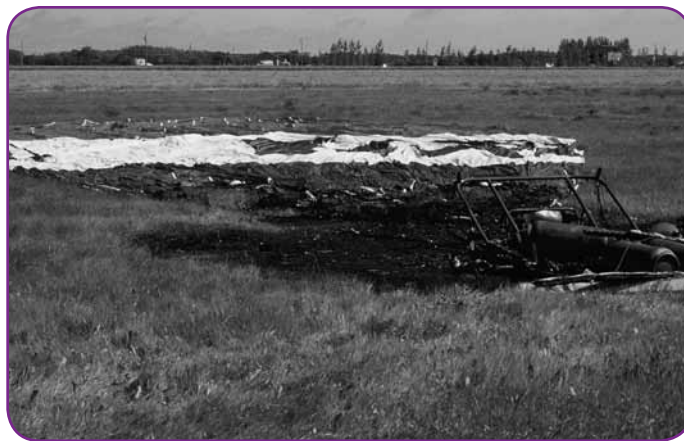
The flight had been extended beyond Winnipeg as the pilot searched for a suitable landing area in strong winds. The balloon touched down and skipped several times. The basket was dragged on its side for about 700 ft, and tipped over far enough for the burners to strike the ground as the balloon came to a stop. A propane fuel leak occurred and an intense uncontrolled fire ensued as the passengers were beginning to exit from under the partially-inverted basket. All occupants escaped; however, the pilot and two passengers suffered serious injuries in the intense fire. Four other passengers suffered minor injuries, some with burns. Two of the propane tanks and a fire extinguisher canister exploded, and the basket of the balloon was destroyed by fire. The accident occurred at about 09:08 Central Daylight Time (CDT).

2. The fuel system was not shut down as recommended in the balloon flight manual procedures for a hard landing, even though a hard landing was likely.
3. Because the balloon was not deflated quickly, the basket was dragged for some 700 ft and the integrity of the burner support structure was lost.
4. As the basket was dragged across the ground, the fuel-line fittings were pulled out at the burner manifolds and liquid propane was released in the vicinity of the pilot lights, resulting in the fire and subsequent explosion.
