# Views on Flight Safety

## Flight 27 Comment

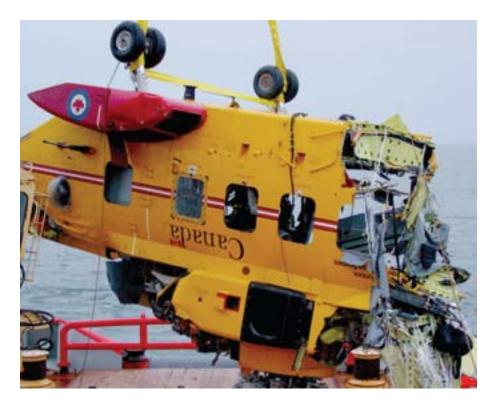
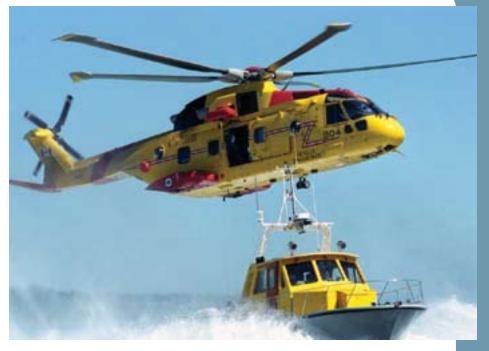
The CH149914 Cormorant helicopter crashed into the water on 13 July 2006 during an attempted goaround from an approach to a fishing vessel. The helicopter was equipped with a DRS Technologies Emergency Avionics System 3000 Flight Data Recorder and a Cockpit Voice Recorder System. Included in this system is the Beacon Airfoil Unit. In this occurrence the BAU was found still attached to the helicopter post accident and did not deploy. Fortunately all FDR and CVR data was successfully recovered by the National Research Council Centre for analysis by the Flight Safety investigators.

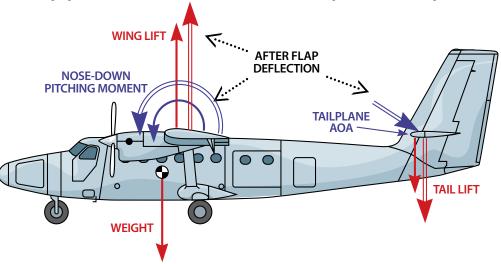
Tailplane counters the nose-down pitching moment caused by the center of gravity (CG) being forward of the center of pressure.

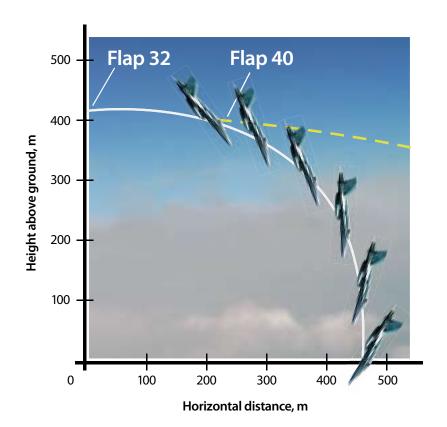
This diagram illustrates how severe nose-down pitch attitude and loss of control may become following tailplane stall.

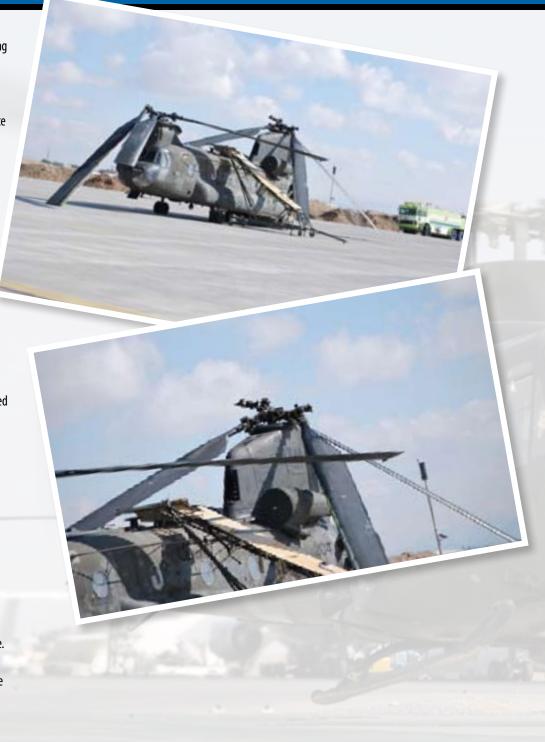
ircraft CH147204 was tasked on a training mission out of Kandahar airfield (KAF). No anomalies were noted by the crew during the flight. Later in the morning, while the aircraft was still on its mission, maintenance personnel found an aft rotor fixed droop stop on the ramp near where aircraft CH147204 was previously parked. The droop restraint system has no function while the aircraft is in flight and failure of the system does not impede safe flying operations. The droop restraint system supports the weight of the rotor blades on startup and shutdown to prevent them from striking the fuselage.

The maintenance personnel immediately checked all other aircraft on the ramp and determined that none of the helicopters were missing a fixed droop stop. Operations advised the occurrence crew of the situation and recalled the aircraft. Once safely in KAF, the aircraft was landed at a remote location away from personnel, buildings and other aircraft. Using a procedure borrowed from a coalition partner, a ladder/ramp was put in place to protect the fuselage from damage by the drooping blade. The crew set the parking brakes, secured the flight controls in place and exited the aircraft. The engines continued to run until the fuel supply was exhausted. After the engines stopped, the rotors began slowing down until they eventually impacted the ramp, causing damage to the rotor blade system and fuselage. There were no injuries. The investigation is focusing on aircraft pre-flight and maintenance procedures. •

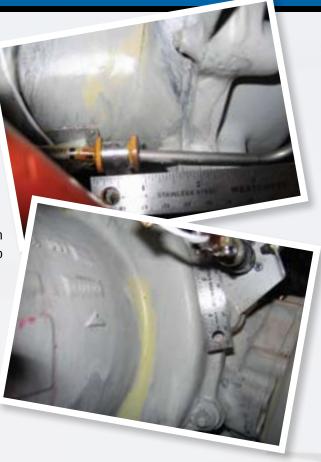
**TYPE: CH149 Cormorant (149910)**

he occurrence aircraft, CH149910, landed in Port au Choix, Newfoundland after having flown a three-hour training flight. A significant amount of oil was discovered on the starboard side of the aircraft in the vicinity of the number three engine. After discussion between the crew and maintenance personnel, the affected area was cleaned, the number three engine was replenished with oil, and a ground run was conducted. On the return flight, oil was again seen leaking along the starboard side from the vicinity of the number three engine, which led the crew to shutdown the number three engine in flight. The aircrew conducted a two-engine running landing, taxied in and shutdown. The aircraft was put in maintenance to change the number three engine. The engine change, ground run and maintenance test flight (MTF) proceeded as planned with no abnormalities. After the MTF, upon towing the aircraft in the hangar, oil was once again noticed on the starboard side. Initial inspection revealed considerable oil in the location of the connecting intermediate transmission casing forward of the number three engine bay, between the engine input shaft and the main gear box. Further inspection revealed a crack approximately 18.5 inches in length on the intermediate case of the number three mechanical drive assembly.

The preliminary investigation has revealed that the aircraft damage was contained to the number three main gear box power train system, specifically the intermediate case of the number three mechanical drive assembly connecting the

main gear box to the number three engine. The fracture in the intermediate transmission case outboard flange of the number three mechanical drive assembly spanned more than half of the circumference of the casing. The investigation also made a collateral safety observation concerning Search and Rescue technician dry suits. The investigation revealed stains on the dry suits due to contact with possible contaminants such as oil, grease and other debris that is present during the conduct of routine flying duties.

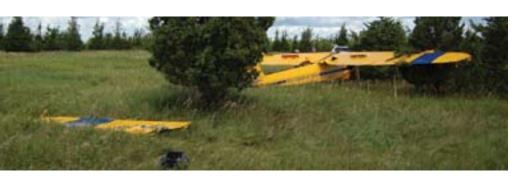
**LOCATION: Picton Airport, Ontario**

he accident occurred during the Air Cadet Glider Pilot course in Picton, Ontario. The flight involved a student glider pilot who was conducting a first solo flight on that course. The pilot stated that the air tow launch from runway 35 was normal in all aspects until the glider was approximately 1/2 nautical mile (NM) from the launch point and at 60 ft above ground level (AGL). At this point, the pilot heard a "ping" (sound) from the forward area of the fuselage and observed the tow rope separate and "shoot forward" from the glider. The pilot immediately established a glide speed of 50 miles per hour and carried out the emergency procedure for a tow rope break (premature release) below 200 ft AGL. The landing areas available from this altitude were extremely limited and the option of returning to the runway was not possible. The pilot levelled the wings in accordance with the emergency procedure and landed straight ahead in a field approximately 3/4 NM from the launch point. The glider impacted several trees and came to rest, upright, approximately 45 ft from the initial impact point. The pilot sustained minor injuries and the glider damage level was assessed as very serious.

The investigation determined that the tow rope release was uncommanded and therefore centered on the tow hook and release mechanism installed on the glider. Inspection of the release mechanism revealed that a small "ledge" existed in the tow hook securing slot in the release arm. The ledge was formed due to the reinforcing slug being mounted slightly higher than the bottom surface of the tow hook securing slot. Due to the presence of this ledge, it was possible to insert the tow hook into the release arm just far enough to rest on the ledge and to achieve a "false" hook-up. The hook-up person most likely conducted a cursory inspection of the release mechanism from a position forward of the release mechanism. This was not sufficient to detect the false hook-up condition, which could "pass" a cursory visual inspection if viewed from a forward angle and even pass the tactile "tug" check. It was determined that the false hook-up could hold sufficient strain to allow the glider to become airborne but would release, without command, once the glider was airborne and the geometry of the rope position altered. Examination of procedures revealed that there
