AVIATION OCCURRENCE REPORT

COLLISION WITH TERRAIN

**INTERLAKE INTERNATIONAL PILOT TRAINING CENTRE
DIAMOND AIRCRAFT INDUSTRIES INC.**

**DA-20-A1 KATANA
KINOSOTA, MANITOBA 3 NM NE
20 FEBRUARY 1998**

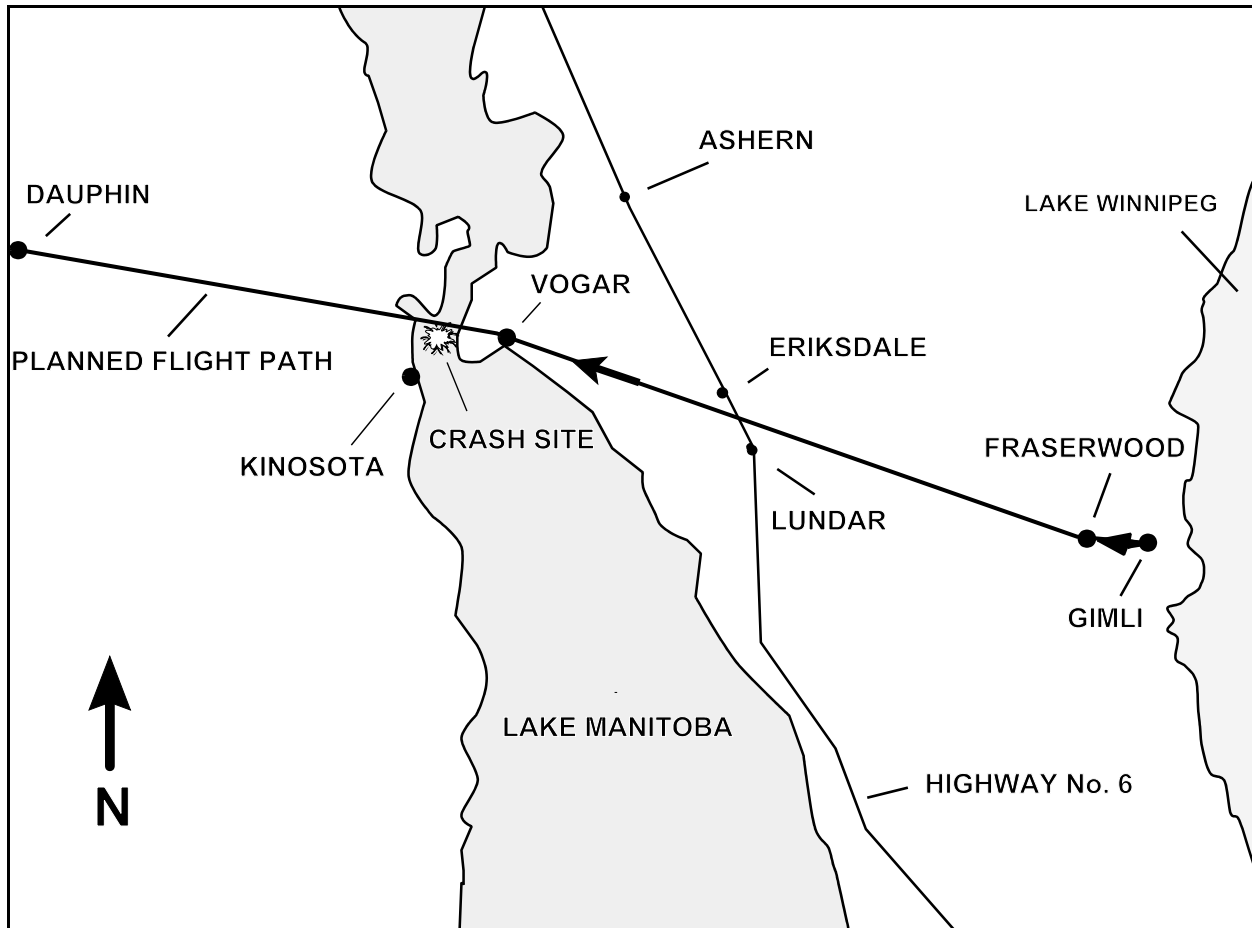
Distance along the planned route of flight from Gimli to the accident site: 69 nm

Distance along the planned route of flight from Gimli to Dauphin: 118 nm
