# CNSC Staff Integrated Safety Assessment of Canadian Nuclear Power Plants for 2009

INFO-0809

October 2010

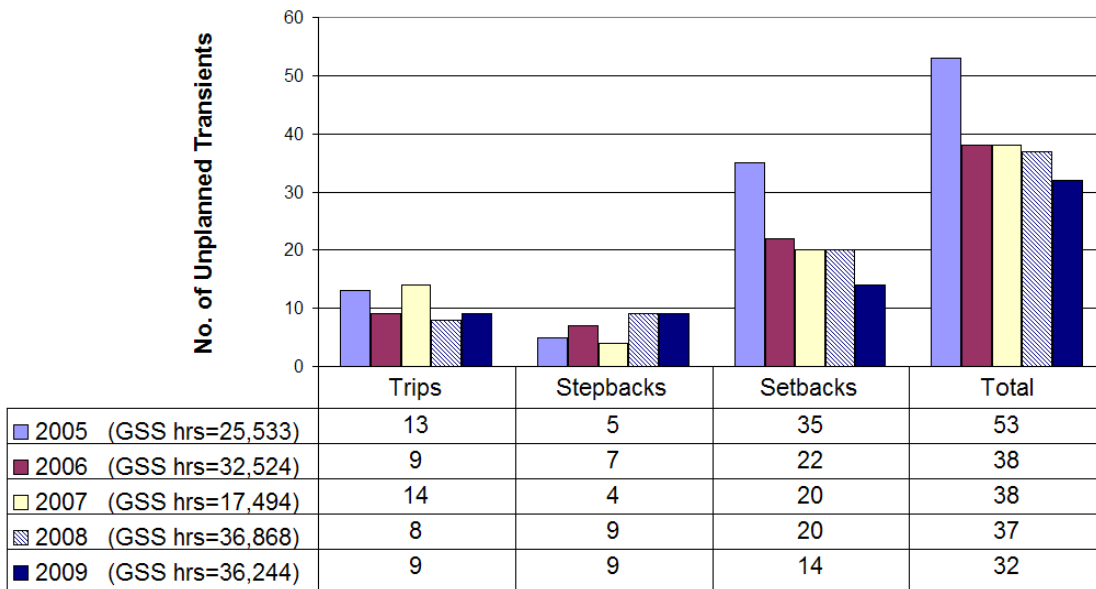
**Figure 2: Trend Details of Number of Unplanned Transients for Industry**

The “Number of Unplanned Transients” PI denotes the unplanned reactor power transients due to all sources, while the reactor was not in a guaranteed shutdown state (GSS). This PI, illustrated in Table 1 and Figures 2 and 3, shows the number of manual and automatic power reductions from actuation of the shutdown, stepback or setback system (note that Pickering A does not have a stepback system). Unexpected power reductions may indicate problems within the plant and place unnecessary strain on systems. Many of the unplanned transients in 2009 were setbacks, which typically pose little risk to plant operations.

Figures 2 and 3 show the trend of this PI since 2005. Industry-wide, the total number of transients in 2009 was lower than in previous years, although the number of trips and stepbacks remained approximately the same. In 2009, there was an industry average of 6,300 hours of non-GSS time between reactor trips and stepbacks (calculation based on 17 operating units). The international performance target is one reactor trip per 7,000 hours of operation, which puts Canadian NPPs slightly below the international target.

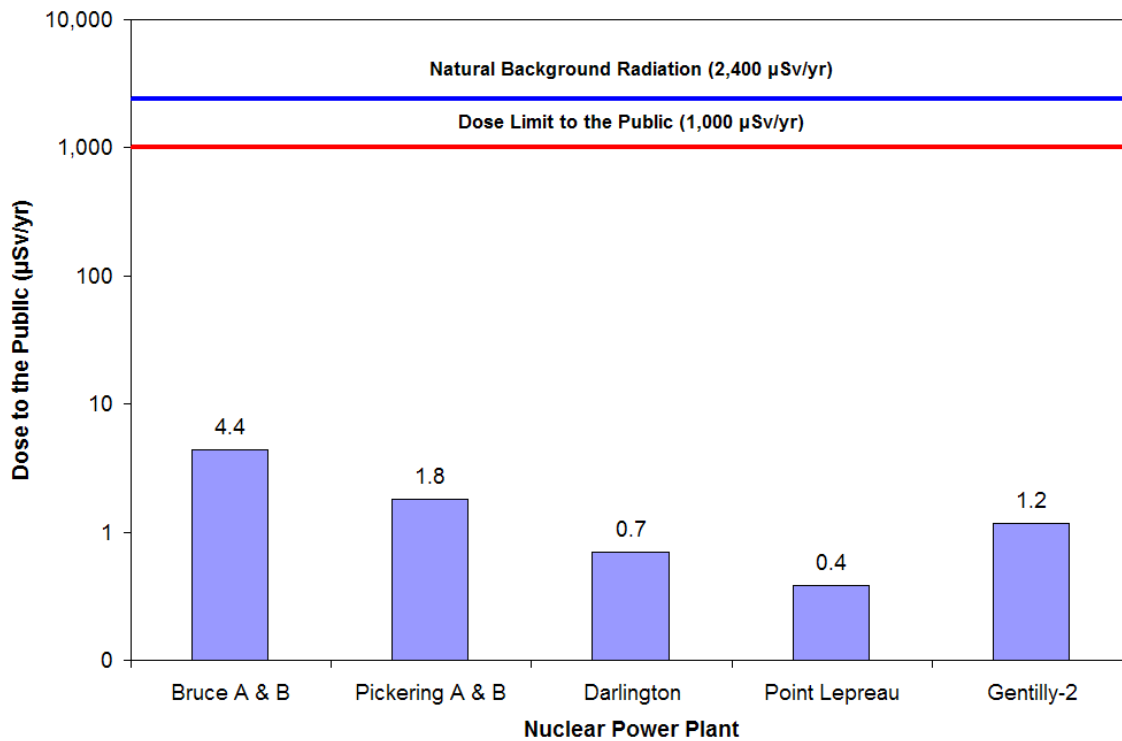
**Figure 11: Doses to the Public from Canadian NPPs in 2009**

The dose to the public from each Canadian NPP in 2009 is provided in Figure 11. The figure shows that the doses to the public are well below the regulatory public dose limit of 1,000 µSv/year.

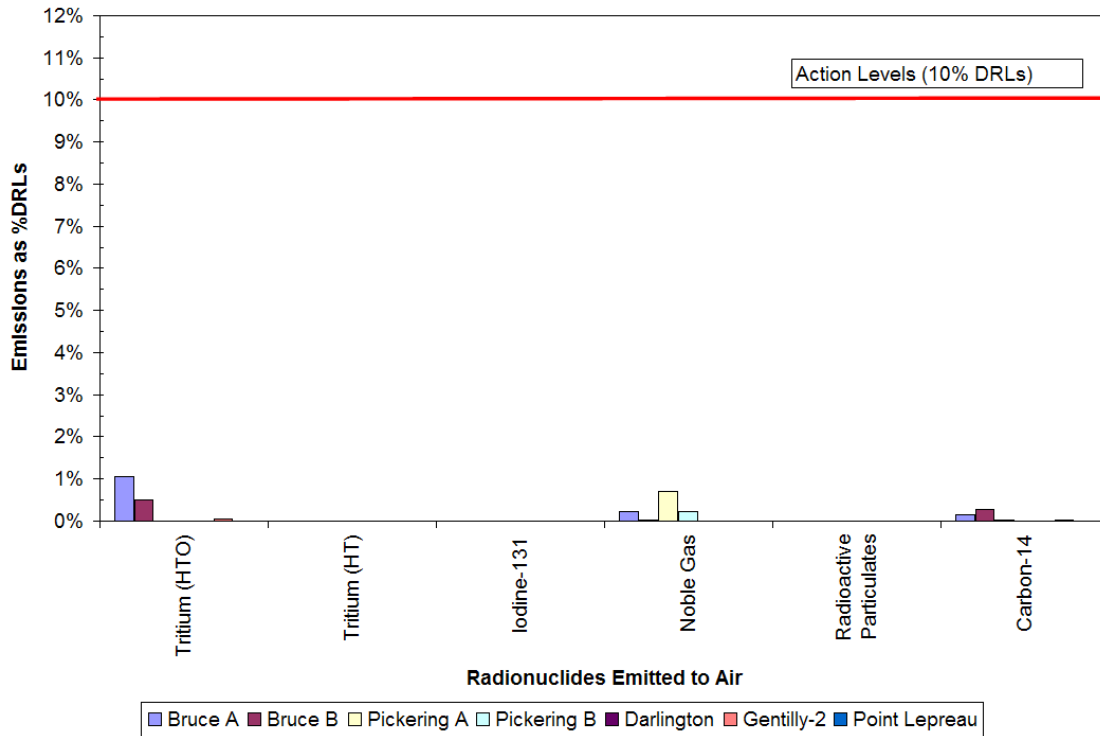
**Figure 12: Radionuclides Emitted to Air by Canadian NPPs in 2009**

Airborne emissions and liquid releases for 2009 are shown in Figures 12 and 13, respectively. Both airborne emission and liquid releases were lower than the DRLs in 2009, and were always well below the Action Levels.

To ensure that the public dose limit and release limits are not exceeded, the power reactor operating licence (PROL) restricts the amounts of radioactive material that may be released from the NPP. These effluent limits are derived from the public dose limit (1,000 µSv/year) and are referred to as Derived Release Limits (DRLs).

The licensees establish Action Levels which are set at 10% of the DRLs. If reached, these levels may indicate a loss of control of part of a licensee's environmental protection program, and triggers a requirement for specific action to be taken and reported to CNSC.
