RESEARCH REPORT

Flanking Sound Transmission in Wood Framed Construction

**FLANKING SOUND
TRANSMISSION
IN
WOOD FRAMED
CONSTRUCTION**

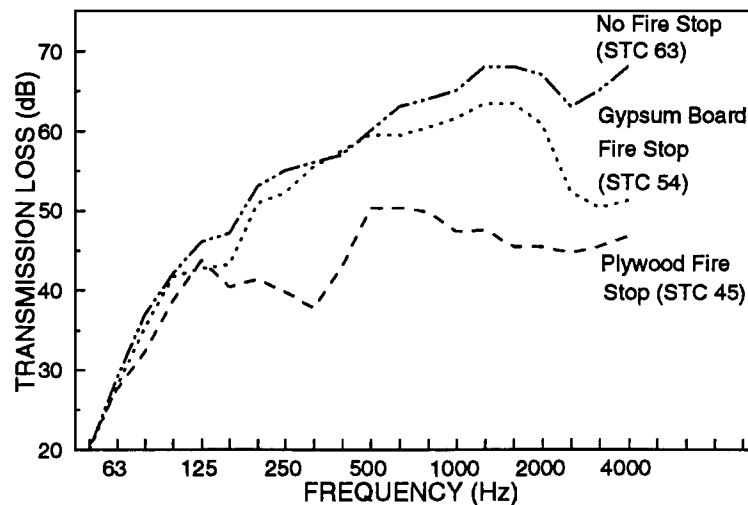
Figure 16: Comparison of the effect on airborne sound insulation (E336) due to plywood and gypsum board fire stops.

Figure 16 shows the effect on the measured sound transmission loss between rooms A and B for two fire stops made from a room surface continued across the party wall. From the figure it can be seen that continuing the gypsum board across the end of the party wall (i.e., gypsum board fire stop) gives greatly reduced sound insulation when compared to the Base Case (without fire stop). The reduced sound insulation starts at about 500 Hz and increases with frequency. Between about 2000 and 2500 Hz, the insulation is degraded more rapidly due to the onset of the coincidence dip.

The sound insulation of the party wall that had the plywood floor decking continued under it (i.e., plywood fire stop) exhibited greatly reduced insulation for all frequencies greater than 125 Hz when compared to either the gypsum board fire stop or the Base Case.

The reduction in sound insulation caused by continuing the gypsum board surface across the party wall (with the gypsum board fire stop) is considerably less than continuing the plywood floor decking across the party wall (with the plywood fire stop). It suggests that one or more of the factors are significantly different for the two cases. However, in both cases the continued surfaces are likely to provide an effective path for the flow of vibration energy because there are no physical breaks. If the continued surface in each case allows vibration energy to propagate with similar efficiency, then the difference in sound insulation performance must be due to their relative ability to accept and radiate acoustic energy.

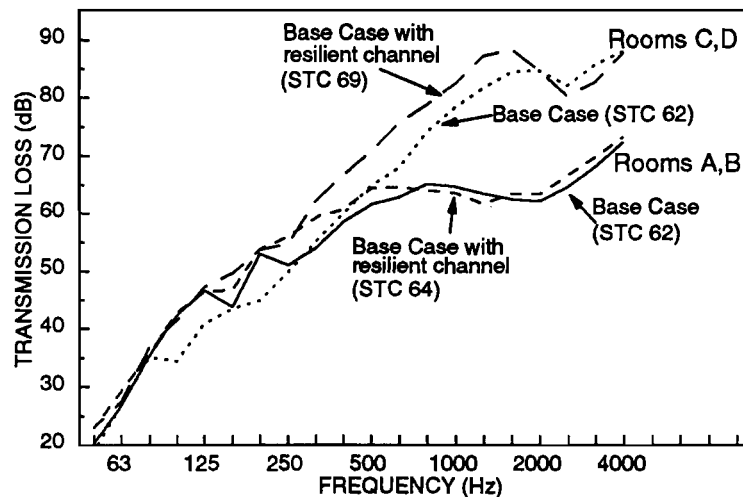
Figure A1 shows the transmission loss performance as measured using ASTM E336 for the room pairs CD and AB for Case I (Base Case) and Case II (Base Case with resilient channels).

Figure A1: Measured transmission loss (E336) for room pairs AB and CD, Base Case with and without resilient channels (RC).

From the figure it is evident that adding the resilient channels caused a greater increase in sound insulation between the lower two rooms (C and D) than between the upper two rooms (A and B). Since both walls are of nominally identical construction, the improvement should be identical for the upper and lower rooms (provided that there are no flanking paths). Later inspection revealed that the 39x240 mm joists on either side of the upper double stud party wall had warped such that the bottom of the joists (which were not adequately strapped) bridged the 25 mm air gap. This strong physical connection between the upper two rooms created a flanking path that caused the floor to be the dominant radiator when compared to the very little energy transmitted by the superior party wall. Consequently, increasing the performance of the wall, by adding the resilient channels, had little effect on the net sound insulation.

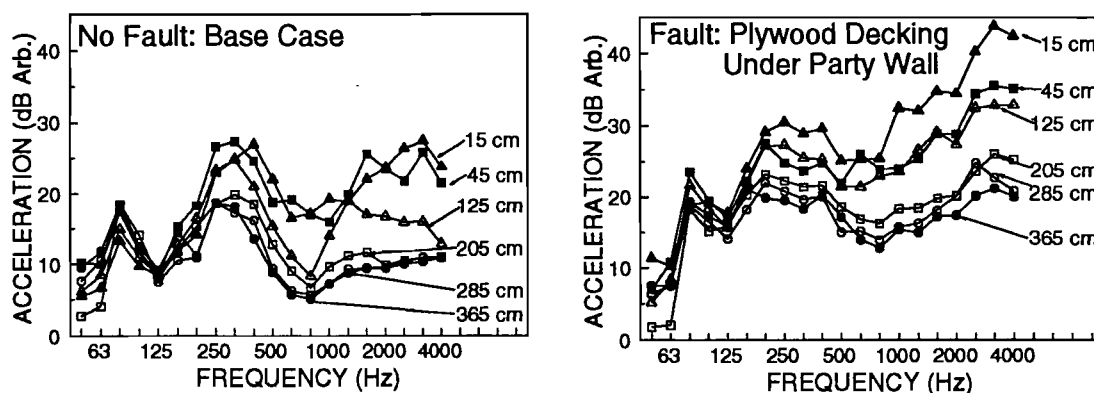
Figure 6: Average floor acceleration Room B, source Room A, with and without the fault. Data are an average of six points along parallel lines located at various distances from the party wall.

Surface Velocity: Figure 6 shows the average measured acceleration of the floor along lines parallel to the party partition both with and without the fault. There were six measurement positions along each line. The figure reveals that the fault has caused a significant increase in vibration levels in the receiving room, especially for points near the party wall. This clearly indicates the fault has increased mechanical coupling and that it involves the floor and/or its support assembly near the party wall. This method can suggest possible propagation paths, but does not directly measure the sound insulation for each path. Using surface velocities, it is theoretically possible compute the sound power radiated by a surface and hence the transmission loss as long as the surface's radiation efficiency is known. ISO 140-4 suggests that for frequencies greater than the partition's critical frequency the radiation efficiency can be taken to be unity. However, this may not be very helpful especially when the critical frequency occurs near the upper end of the frequency bands of interest as is the case for gypsum board walls and other lightweight constructions.

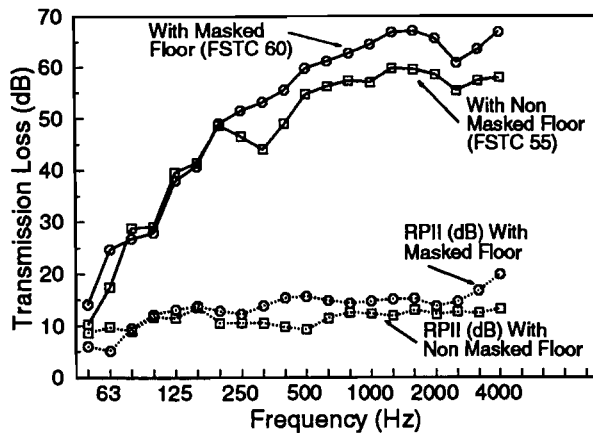
Figure 3: Party wall transmission loss obtained from the acoustic intensity with and without the floor masked.

transmission loss (TL) of the party wall shown in Figure 1 using the intensity technique when the floor is the dominant radiator, (i.e., under extreme flanking caused by the construction fault, Figure 2). Figure 3 shows the party wall transmission loss as computed from the measured intensity with and without the floor masked. The masking consisted of 1/2 inch thick gypsum board over 5/8 inch thick plywood separated from the measurement surface by 2 inch thick fiberglass batt insulation. A resilient air-tight joint between masking and measurement surfaces proved to be critical. The joint was made by using closed cell neoprene pipe lagging placed over the edge of the masking panels butting the measurement surface. The measurement surface was 4.54 m wide and 2.40 m high. Ninety-five points were used to sample the surface; using 10 columns over the width and 11 rows over the height. The probe was located at 6 cm from the measurement surface. The integration time was at least 60 seconds for each measurement point and the receiving room had at least 25 m² of 50 mm thick rigid fiberglass absorbing material. The results indicate that the P-P intensity probe is incapable of determining the normal radiated intensity of the measurement surface when there is an adjacent non masked radiating surface coupled at right angles. This has a significant impact on the usefulness of the method under extreme flanking conditions. Under these conditions, masking should be considered. In all subsequent intensity test data presented here, flanking surfaces were masked.
