Transport
Canada

TP 185E
Issue 2/2011

AVIATION SAFETY LETTER

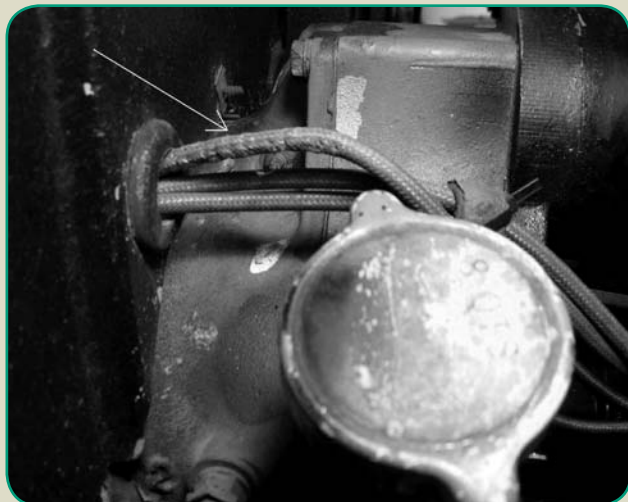
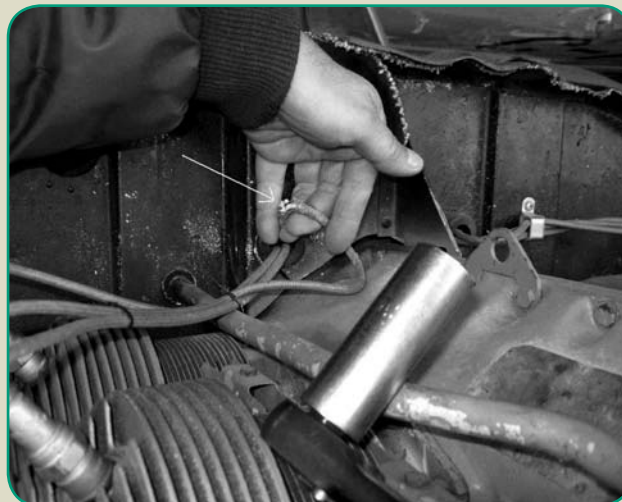
Mr. Paul Harrington of Cottam, Ontario, thought this would be of interest to ASL readers. Just after maintenance on a Cessna 172, he pushed the aircraft out to run it up, and he suddenly had a large drop on the right magneto. He decided to check the spark plugs and ignition wires, so he pushed the aircraft back in the hangar, took the cowls off, and found number 5 magneto wire with the top chewed in half, and other wires with teeth marks. In 36 years of working on aircraft, Mr. Harrington said this was the first time he had ever seen this happening. So, he wanted to share this with pilots and, aircraft maintenance engineers (AME): if you get a magneto drop, you may want to double-check the condition of the ignition wires! He replaced the right magneto harness; for some reason, the mice didn't touch the left one. Be careful out there!

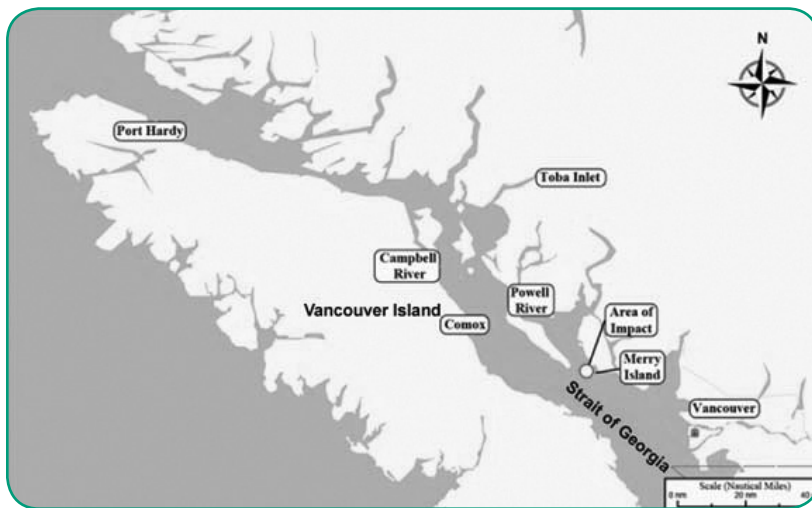
Area map with relevant weather information locations available to the pilot

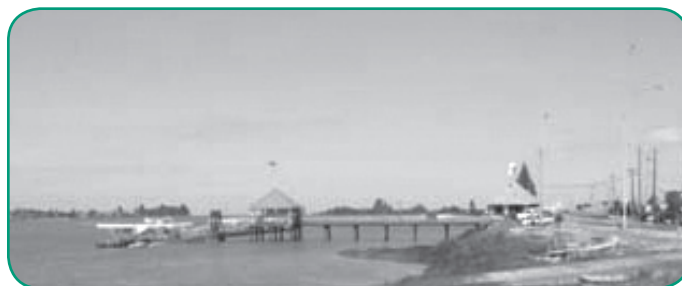
Photo 2. Same location as Photo 1 taken on clear day

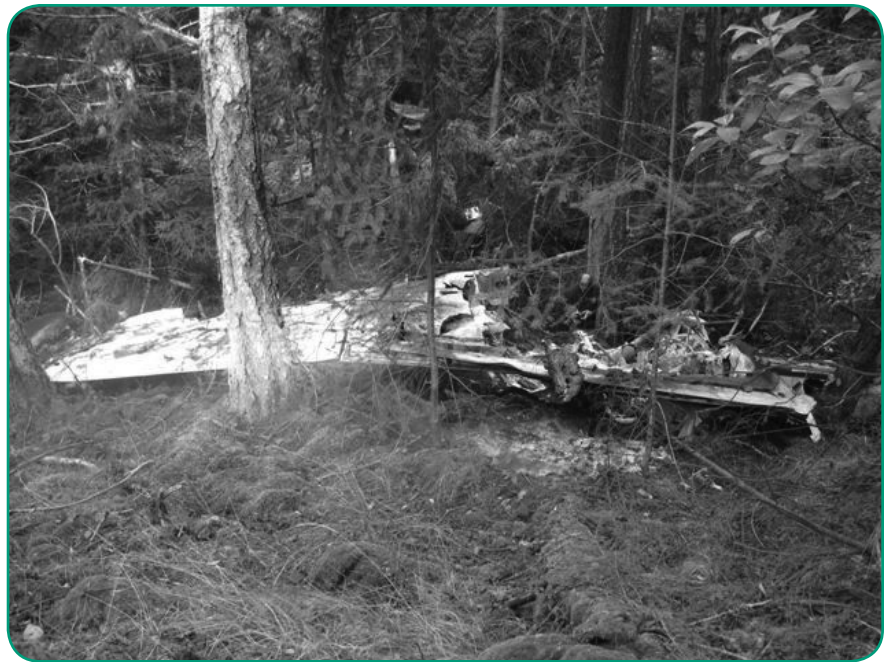
Wreckage of the Grumman Goose being examined by an accident investigator from the Transportation Safety Board of Canada.

Damage to the aircraft and to the trees at the accident site indicated the aircraft's speed and attitude immediately before impact. The long, straight, rising angle of the swath cut through the trees and the extreme damage to those trees and to the aircraft indicate that the aircraft was flying at relatively high speed and climbing rapidly before collision with terrain. Extreme damage to all the propeller blades indicates that high engine power was being developed. This combination indicates that the pilot reacted to sighting terrain seconds before impact and pulled the aircraft up into a rapid climb. However, the pull-up was initiated too late to out-climb the rising terrain that lay ahead.

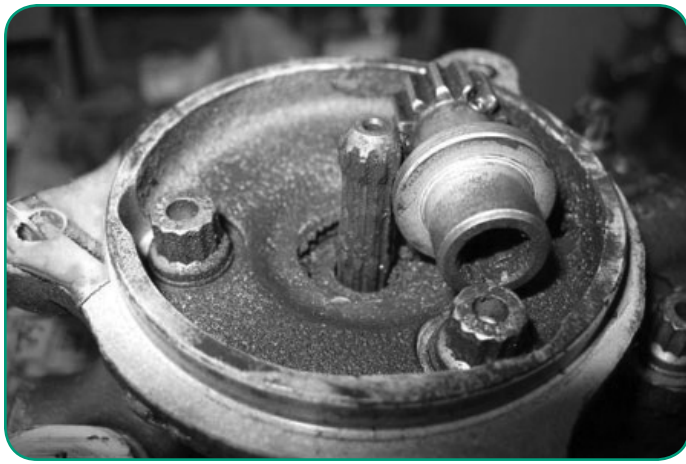
Left engine drive splines and coupling

It was concluded that mechanical failure of the left-hand engine fuel pump drive splines resulted in the loss of power from that engine. The bang, the shuddering, and the yaw to the right that was experienced may have been caused by the left-hand engine fuel pump drive splines disengaging momentarily and then re-engaging. This disengagement would have caused the engine to flameout, and the re-engagement would have caused a relight with a corresponding bang. This would have been accompanied by a surge of power which could have caused the aircraft to yaw to the right.

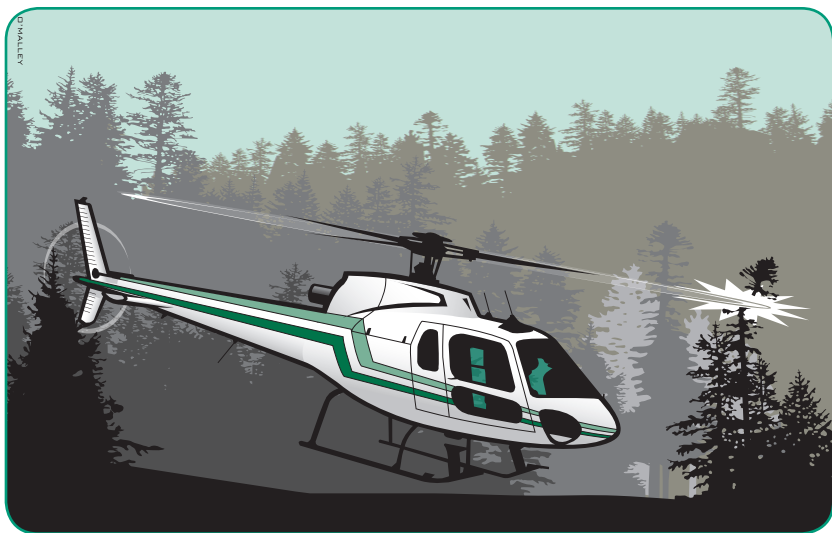
Artist's impression of rotor strike

— On August 31, 2010, an **Aérospatiale AS350 BA helicopter** was dropping off two surveyors in the Namur Lake area, Alta. The landing site was in a confined area. The initial touchdown was successful; however, the pilot repositioned the helicopter a short distance to facilitate an easier exit for the surveyors. During this manoeuvring, the main rotor blades contacted a sapling 2 in. in diameter, which resulted in major damage to all three blades. *TSB File A10W0143.*

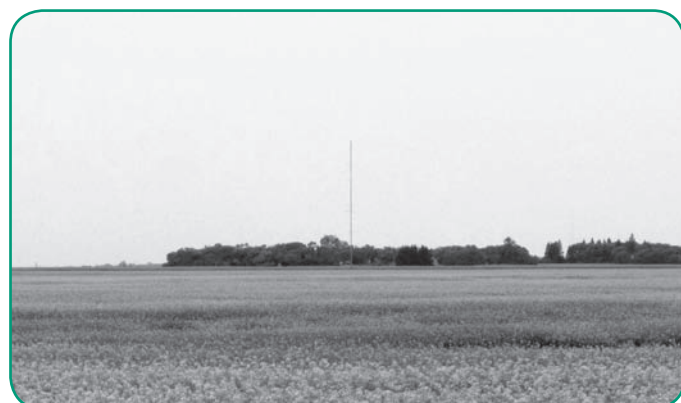
Both the mast and guy wires of a MET tower may be quite difficult to see, depending on the ambient lighting conditions and direction of approach. The photo below illustrates this potential problem well.

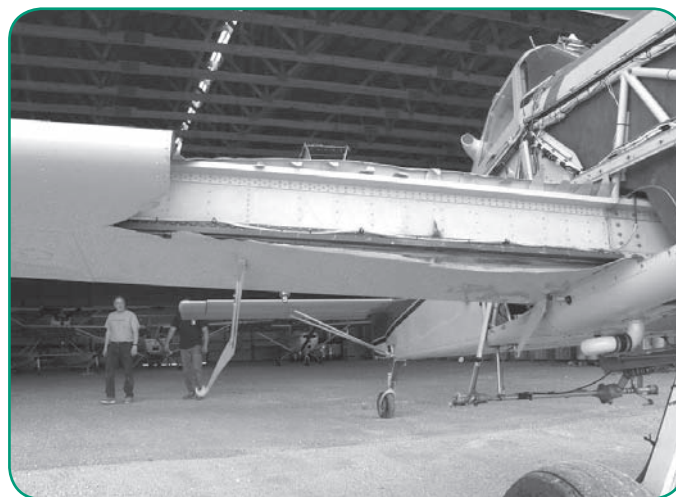
The photo of the damage to the leading edge clearly shows how fortunate this pilot was in terms of where the aircraft struck the pole. Had the aircraft hit the pole further out on the leading edge, aircraft control may have been lost. According to the operator, the structural integrity of the Air Tractor wing next to the fuselage is believed to have allowed the aircraft to remain airworthy and retain controllability. The top of the pole was damaged and a galvanized guy wire $\frac{3}{8}$ in. thick was severed. The Transportation Safety Board of Canada issued a Class 5 report (A10C0101) on this occurrence.

On June 29, 2010, an Air Tractor 502B was engaged in aerial application near Portage la Prairie, Man., when it collided with an unmarked metal wind power test pole approximately 56 m high. The pilot elected to perform a precautionary landing in a nearby field. Inspection of the aircraft revealed damage to the propeller, right landing gear, flap and wing leading edge, approximately 1.2 m from the fuselage.
