1016-22-1 (DFS 3-4)  
27 July 2006

# DFS 2005 Annual Report on Flight Safety

Directorate of Flight Safety

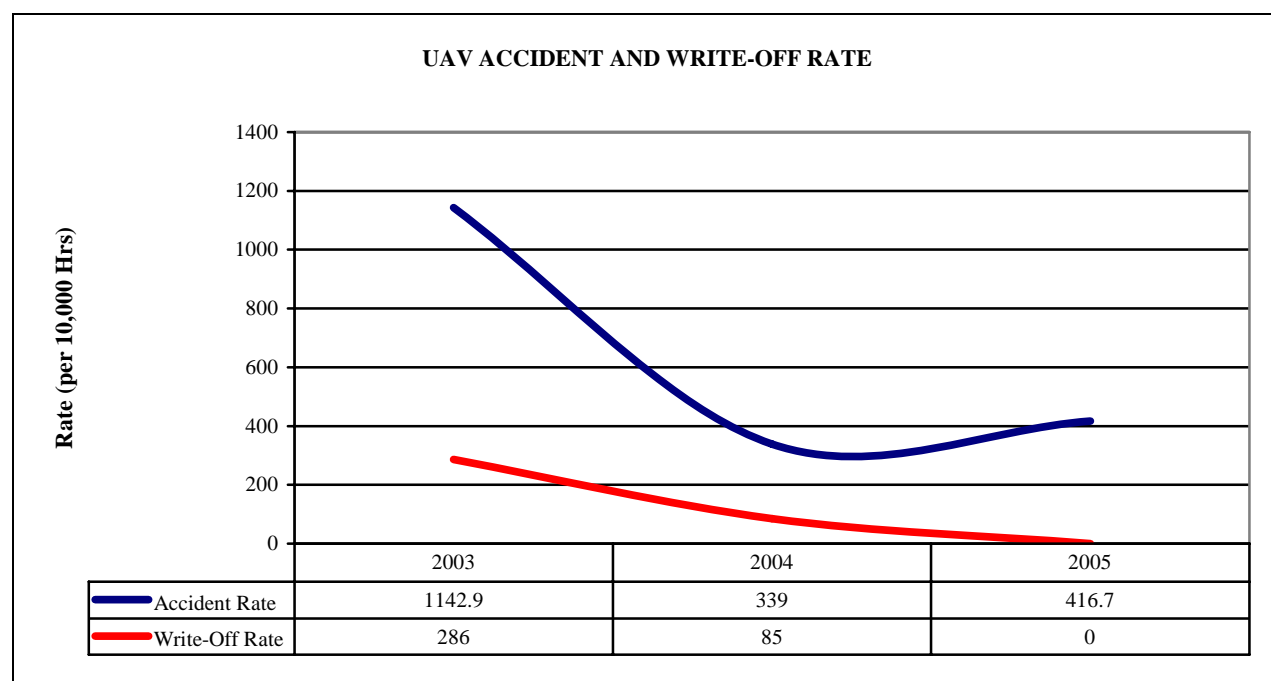
**Graph 01 – UAV Accident Rate and Write-off Rate**

The write-off rate for UAVs dropped to a record low, with no aircraft being lost in 2005. There were two accidents in 2005. Two Sperwer were damaged (one Cat 'C' and one Cat 'D') Despite this, the accident rate increased from 339 to which resulted in an accident rate of 416 per 10,000 hours flown. Although this rate is dramatically higher than that of manned aircraft, one must consider that the program is in the initial stage of operational employment, and that the aircraft operate at a much higher risk level. Aircraft accreditation took place in 2004, and higher rates in 2005 were the result of testing/training prior to operational deployment. Over the short lifespan of the UAV operations in the CF/DND, significant improvements were noted in 2005. UAV statistics are not included in subsequent section and statistics.

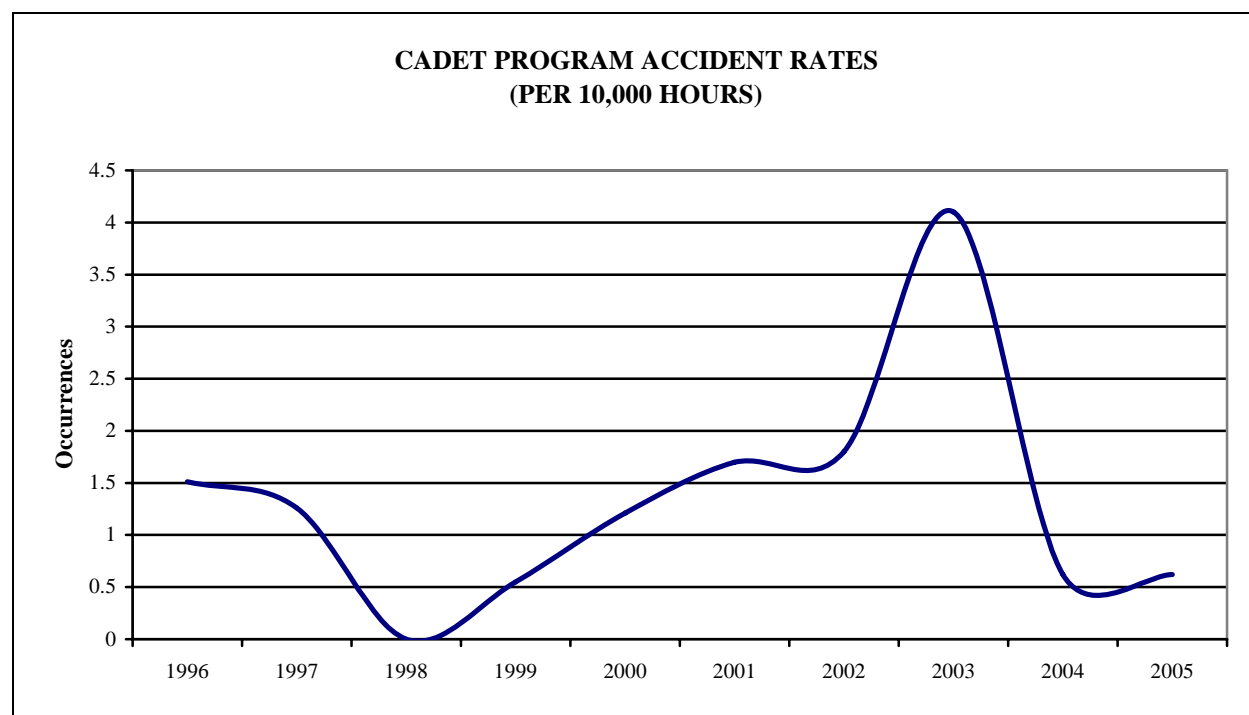
**Graph 02 – Cadet Program Accident Rates**

DESCRIPTION	1996	1997	1998	1999	2000	2001	2002	2003	2004	2005
Hours Flown	13221	15908	17498	18049	16590	17634	16662	17068	16033	16149
Glider Incidents	32	41	32	53	98	81	81	65	69	53
Glider Accidents	2	1	0	1	1	1	1	7	1	1
Tow Aircraft Incidents	20	34	19	33	39	33	33	41	32	32
Tow Aircraft Accidents	0	1	0	0	1	2	2	0	0	0

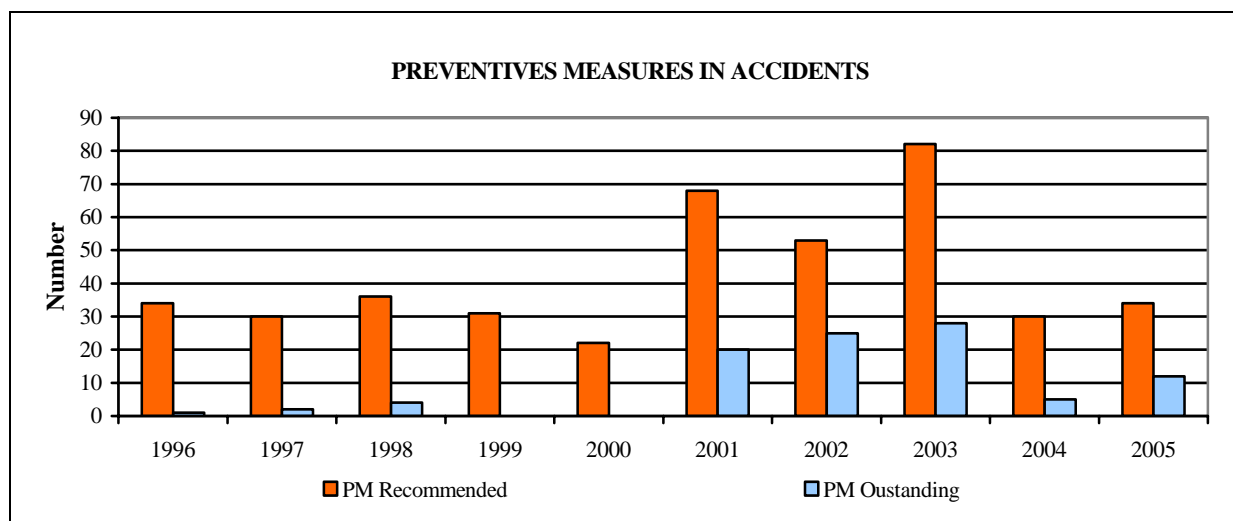
**Graph 03: Preventives Measures in Accidents**

A significant amount of work has been done in closing accident investigations and implementing the preventives measures identified by these investigations over the last five years. The peak in 2002-2003 is attributable to the increased workload from a particularly bad year in 2001, where a high accident rate was experienced. Complex investigations, such as the one conducted on the CH146 accident in Goose Bay in 2002, resulted in multiple safety measures, which led to unusually high numbers for 2003. The increasing trend in 2005 reflects current investigations, and is not unusual, as a six month period is typically allotted to implement preventives measures. In summary, the situation with respect to outstanding recommendations is assessed as good.

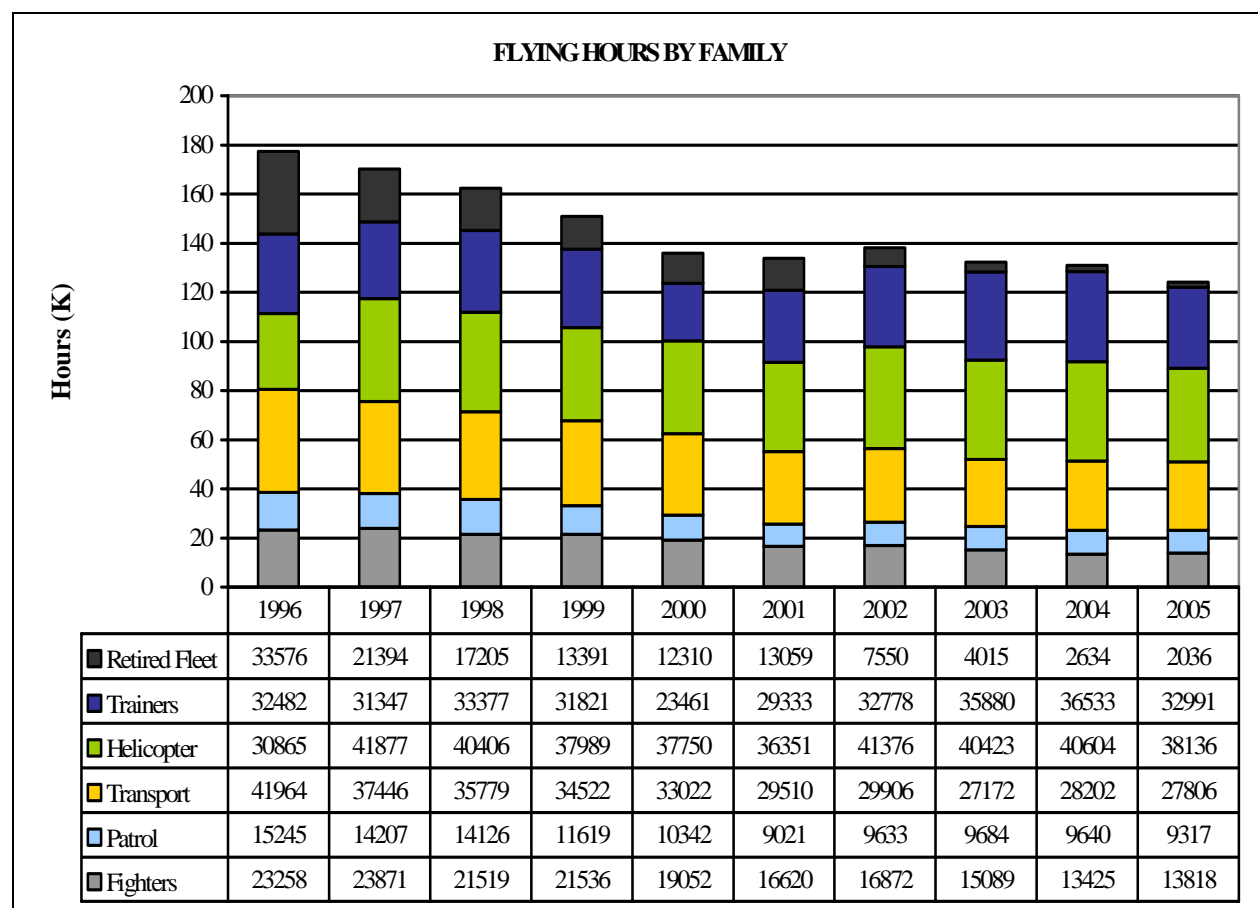
**Graph 04: Flying Hours by Family**

Although flying hours have been steadily decreasing over the last ten years, they have remained

fairly constant since 2001. It is significant to note that Trainer and Helicopter hours have remained fairly stable over the years, with Fighter, Patrol, and Transport fleets taking the majority of the cuts.

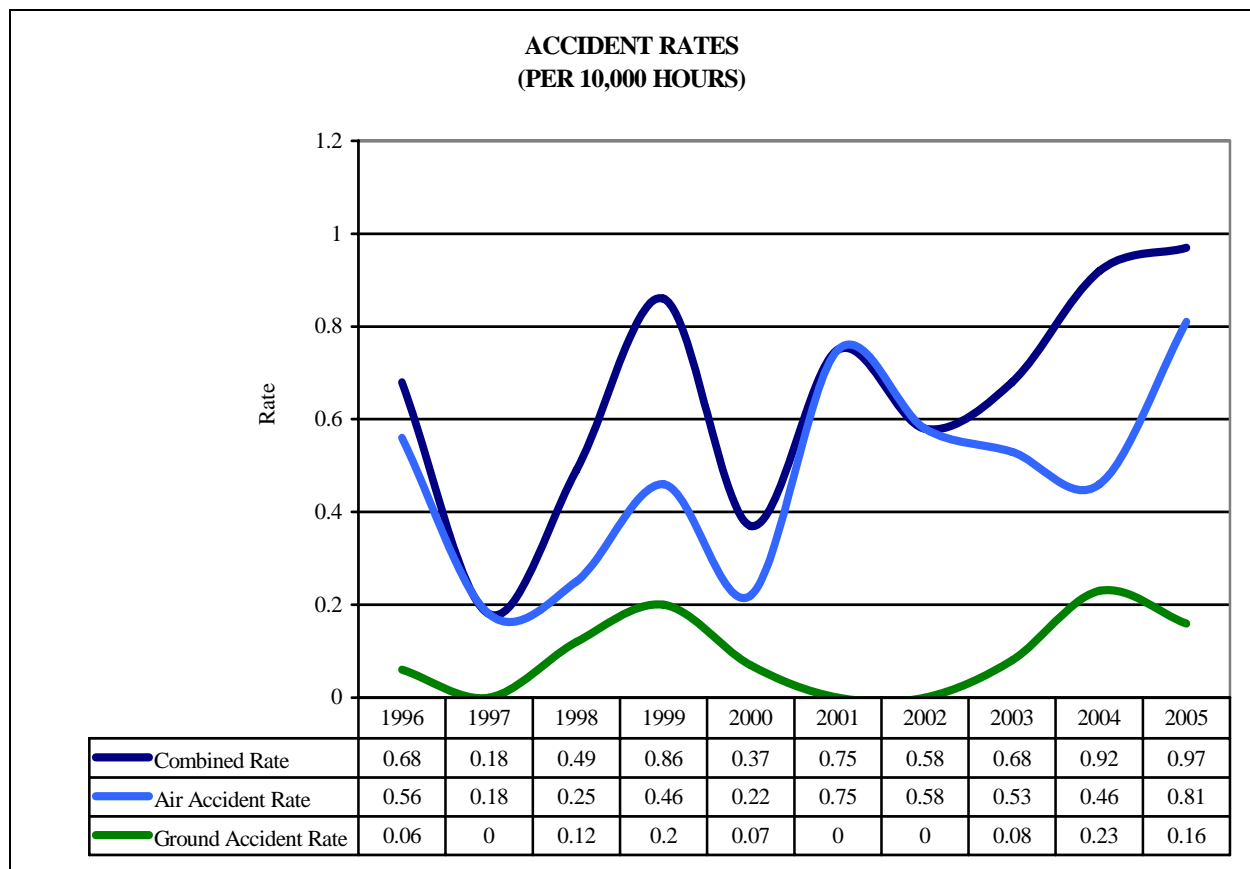
Graph 05: Accident Rates

The air accident rate for 2005 was 0.81 per 10,000 flying hours, which is a 76% increase from the previous year of 0.46. The rate excludes cadets and UAV's occurrences. In addition, this rate is well above the 10-year average of 0.45. However, of the 10 accidents, four were attributable to a series of CH146 engine related incidents in which the engines had to be returned to third line facilities for maintenance due to the terms of the CH146 maintenance contract. According to current flight safety policies, these occurrences are automatically classified as C Cat accidents because a major component had to be shipped to a third line facility. DFS is drafting revisions to this policy to ensure that anomalies such as this do not skew the statistics. In addition, the actual level of damage in each of these accidents is being reviewed to ensure that each occurrence was in fact an accident. This occurrence rate may change as a result of this analysis. A further four were the result of serious SAR Tech / Flight Engineer injuries. While this is of concern, no significant trends were drawn from an analysis of these accidents. UAV and Cadet accidents were not included in these statistics.

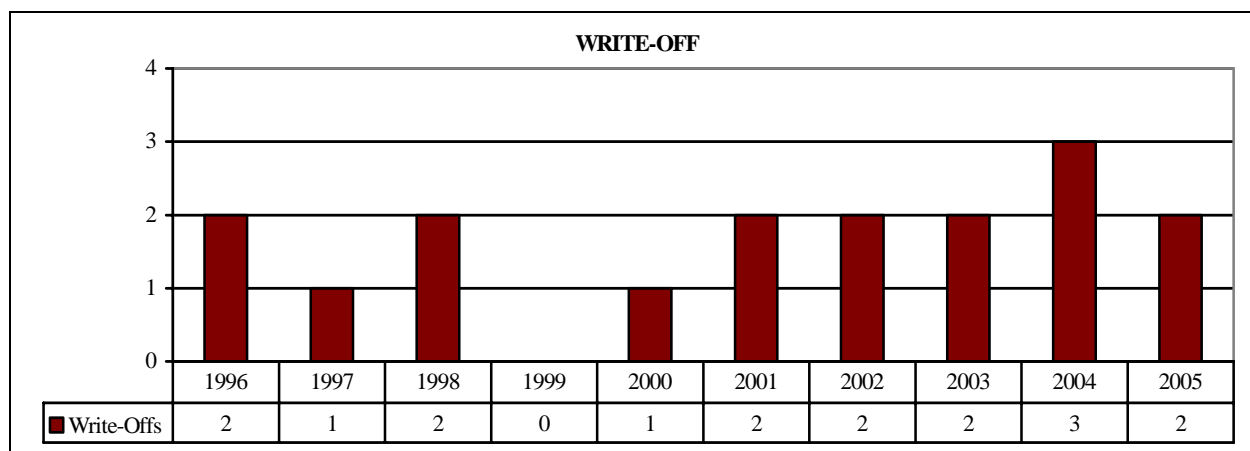
Graph 06: Write-Off

The number of aircraft destroyed in 2005 was two. Both were a result of accidents in August 2005: a CF188 in Bagotville, and a CT114 in Thunder Bay. There were no aircraft losses in any of the other fleets. While the objective is to reduce this number to zero, the 2005 statistics reveal that there is no significant deviation from the current norm (as shown in Graph 4).

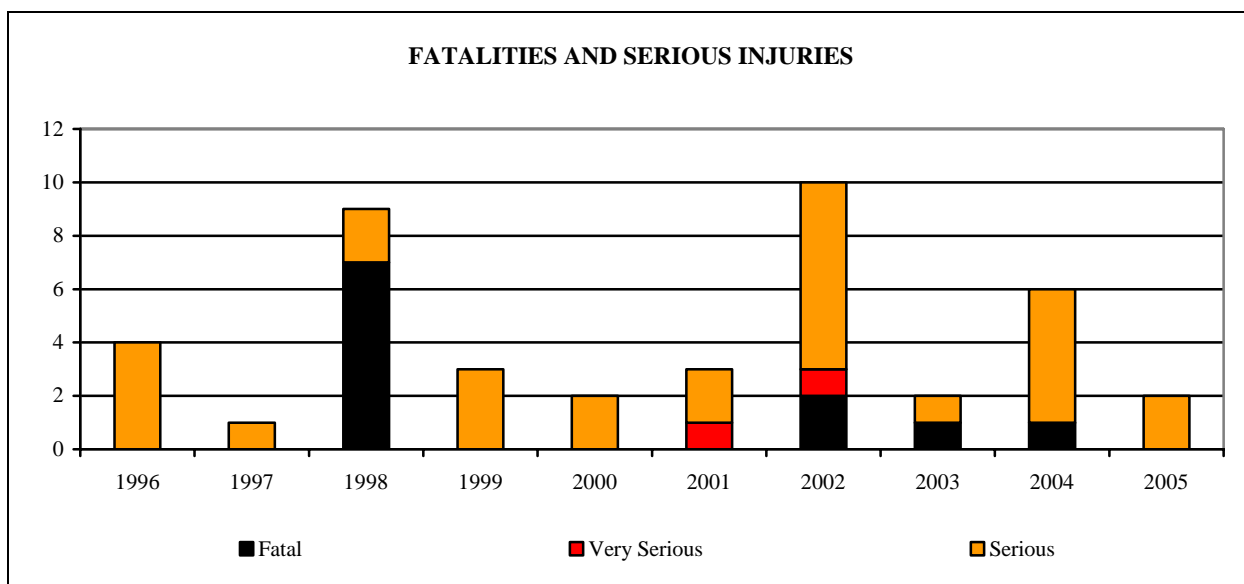
Graph 07: Fatalities and Serious Injuries

With the low write-off rate, came an accompanying low number of injuries in 2005. Despite these promising statistics, two serious injuries were reported. This is still a major concern although it is a slight decrease from the previous year. The injuries were experienced by SAR tech.

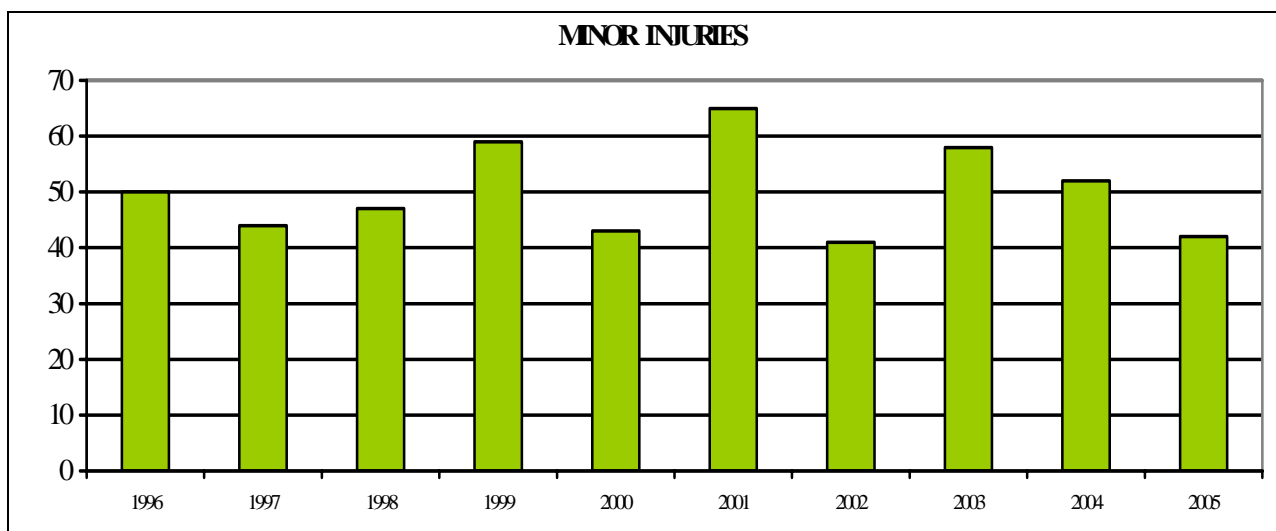
Graph 08: Minor Injuries

The number of minor injuries in 2005 represents a 10-year low of 42 (Graph 8). These types of injuries were predominantly experienced by ground/support personnel.

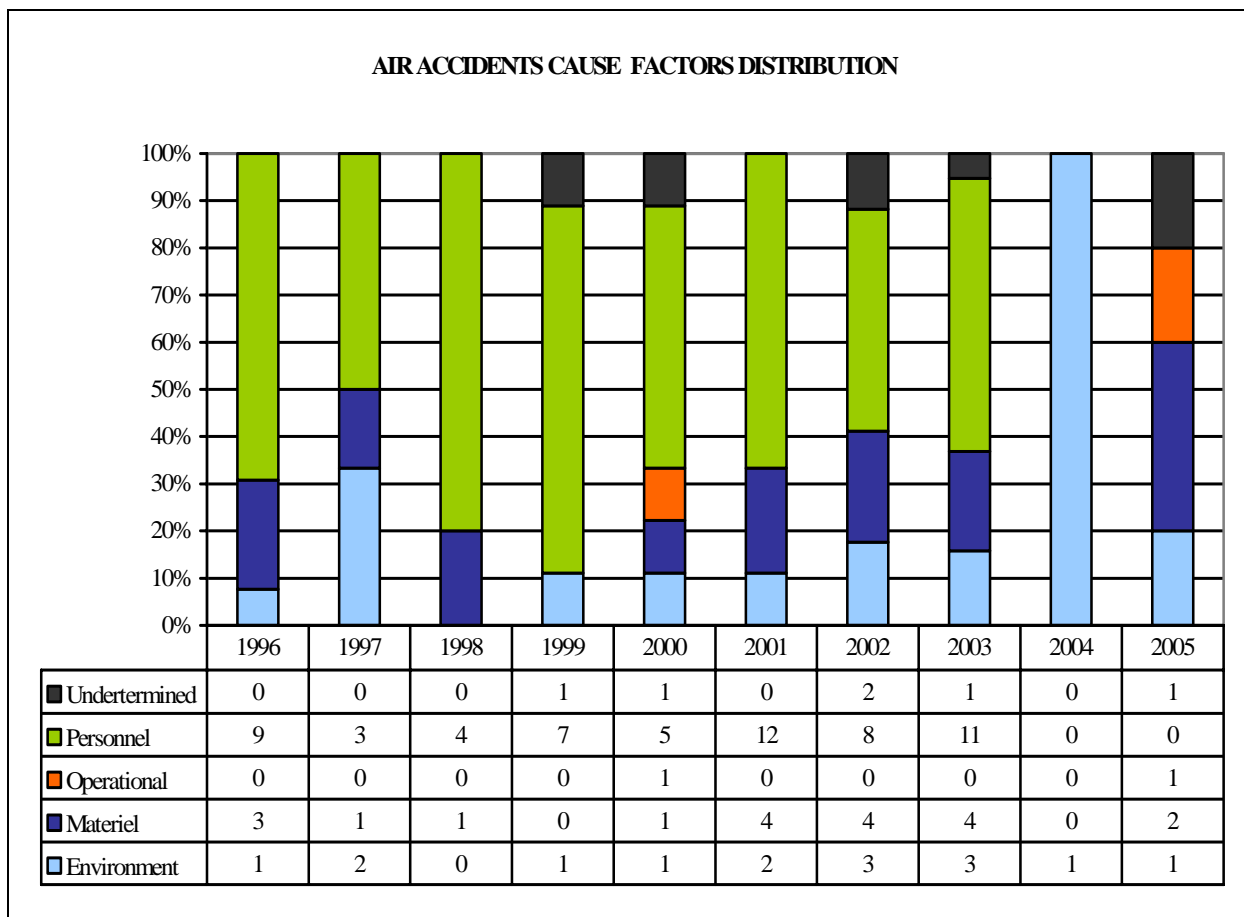
**Graph 16: Air Accidents Cause Factors Distribution**

Graph 16 provides cause factors information for completed investigation. It should be noted that cause factors identification for the year 2004 and 2005 are not fully completed since several investigation are still ongoing for those years.
