National Défense
Defence nationale

1016-22-1 (DFS 3-4)
22 August 2007

2006

Annual Report on Flight Safety

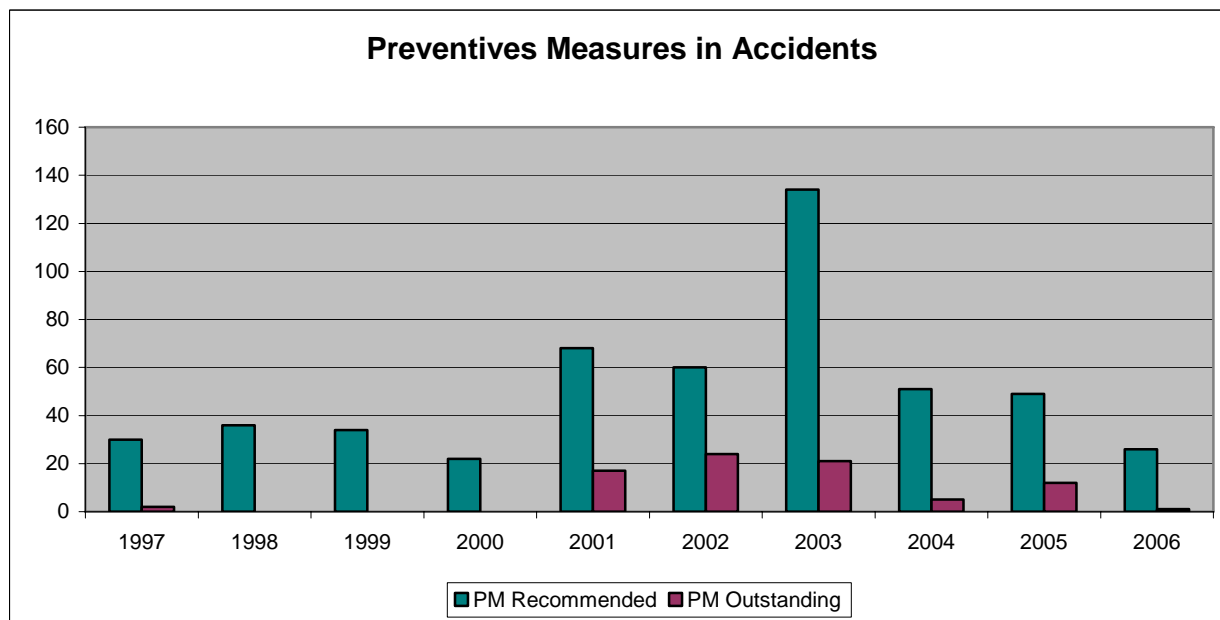
With the exception of 2 PMs in 1997, all PMs up to 2000 have been actioned. Overall, the number of outstanding PMs continues to decrease.

Graph 8 - Preventive Measures in Accidents

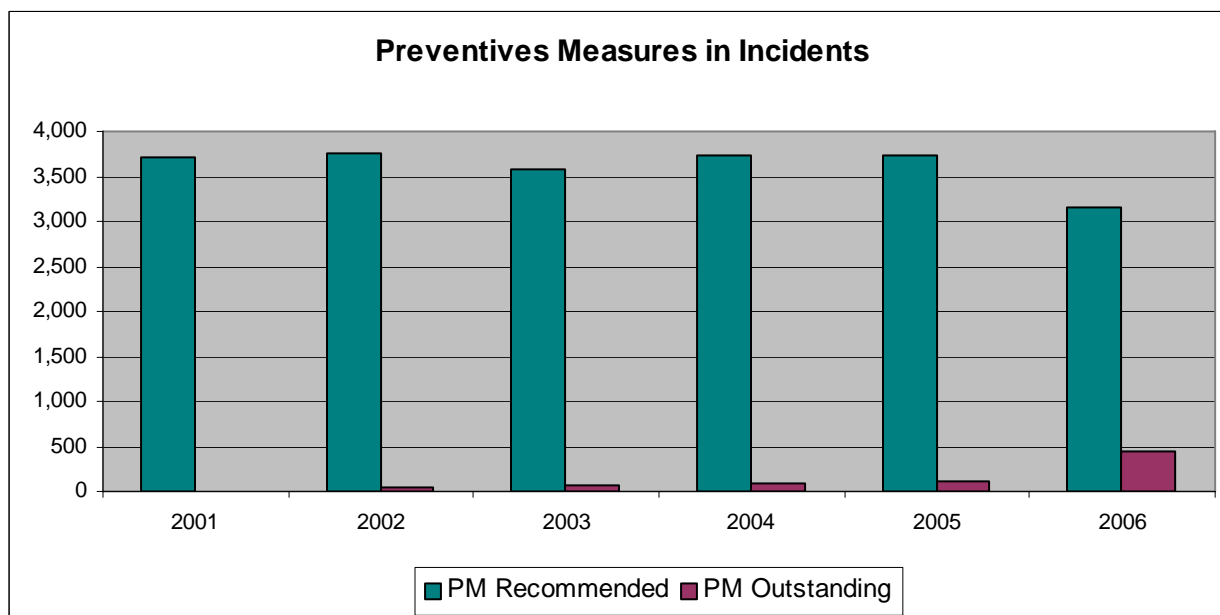
Despite the high number of PMs for incidents, the majority are actioned in a timely fashion. The charts indicate that PMs are often actioned within a year, and typically no longer than 5 years.

Graph 9 - Preventive Measures in Incidents
