Flight Comment

ISSUE 3, 2011

Issue 3, 2011

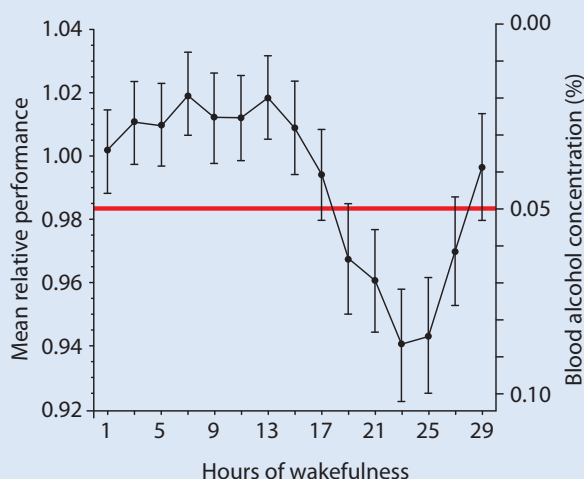
Figure 2. Cognitive performance over hours without sleep relative to blood alcohol concentration⁶. Performance demonstrated in this graph is influenced both by lack of sleep and the circadian rhythm. There is a circadian influenced improvement after the 25th hour of no sleep corresponding to the morning after a missed night of sleep. It is important to note that without sleep this recovery does not return to the person's usual performance level.

There are also performance consequences of fatigue for sustained wakefulness (see Figure 2). The performance of a person who wakes at 0700 hours and stays awake for 17 hours until midnight will be as impaired as that of someone with a blood-alcohol concentration (BAC) of 0.05%. (BAC 0.05% is the legal driving limit in many countries; nine of the 13 provinces and territories impose administrative licence

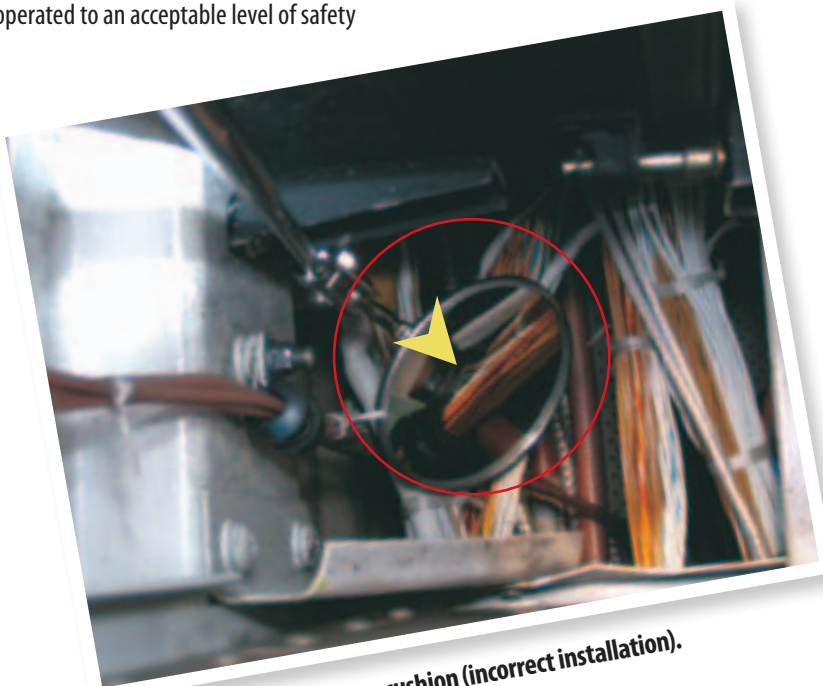
Figure 1. Wire outside clamp cushion (incorrect installation).

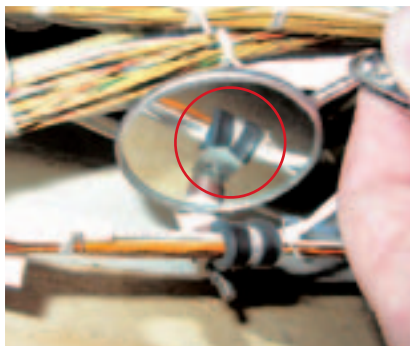
Figure 6. Bottom of cushion clamp not secured (looks good from the front).

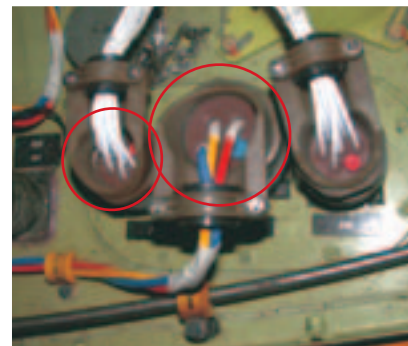
Figure 8. Environmental seal compromised (wires pulled too tight).

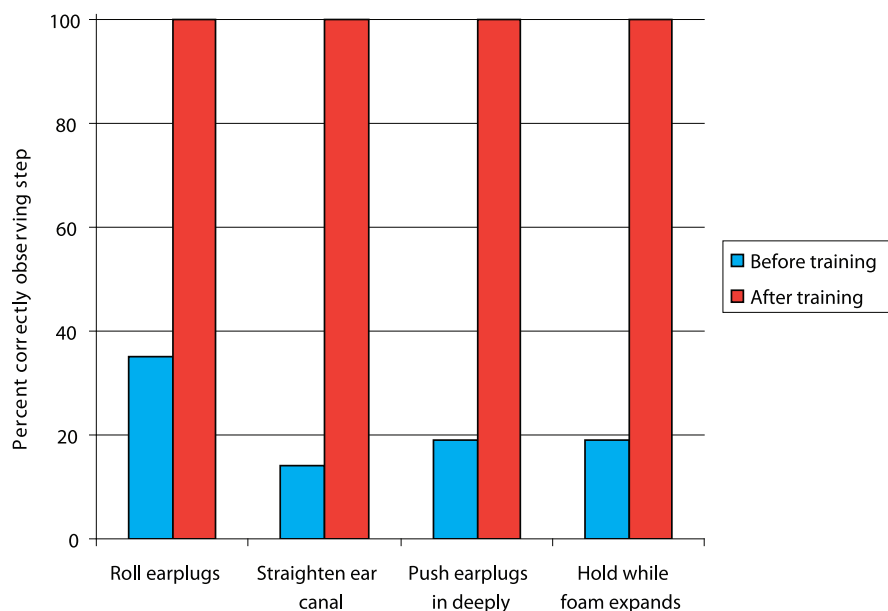
Figure 1. This graph shows the percentage of participants who correctly followed the steps to insert foam earplugs properly, in accordance with the manufacturer's instructions. At the beginning of the study, few people knew how to insert their earplugs correctly.

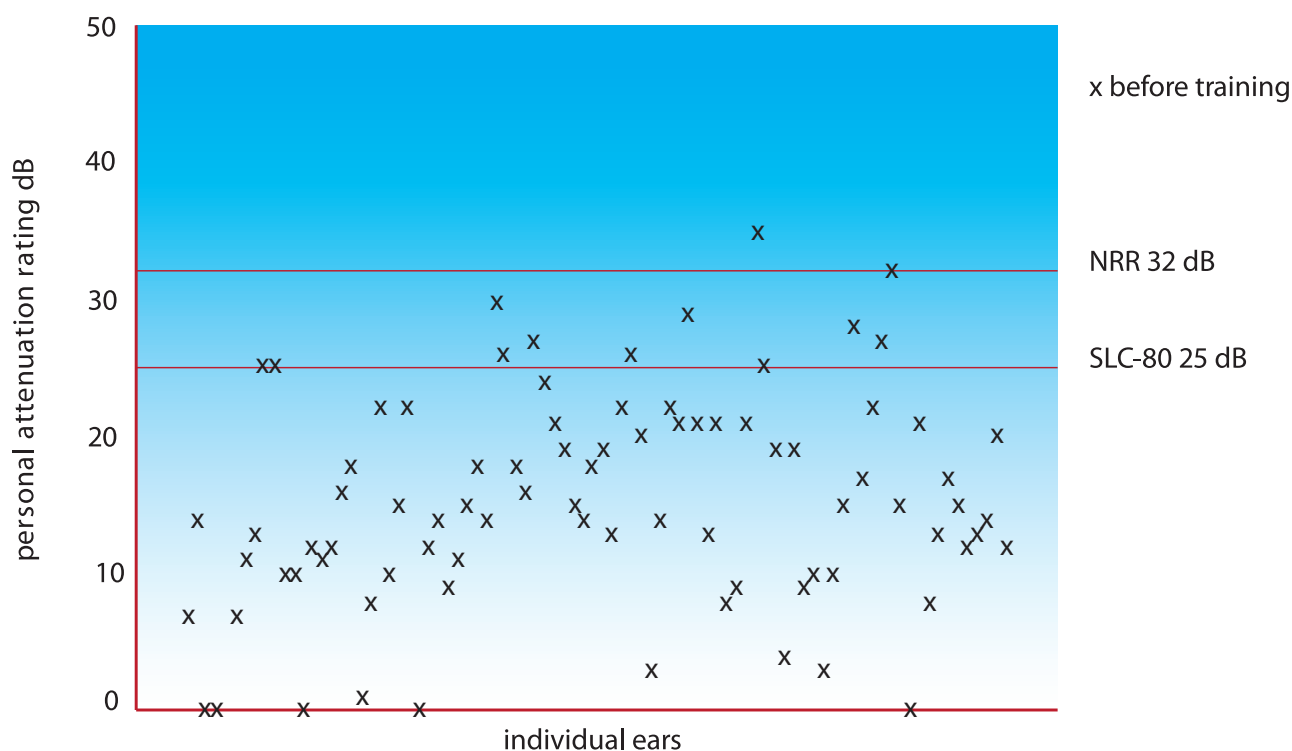
Figure 2. Each 'x' indicates how much noise was being blocked out by the earplugs inserted during this study. Note: earplugs inserted correctly should be able to provide a level of protection of 25–32 dB (indicated by the two horizontal lines across the middle of the graph). At the start of the study, very few people achieve a satisfactory level of hearing protection, with many getting little or no protection from their earplugs.

The average level of noise protection afforded by the earplugs at the beginning of the study was only 15 dB, with 12% receiving a level of protection less than 10 dB. Of significant concern is that 7% received little or no protection at all. Remember, these earplugs are supposed to provide 25-32 dB of protection.

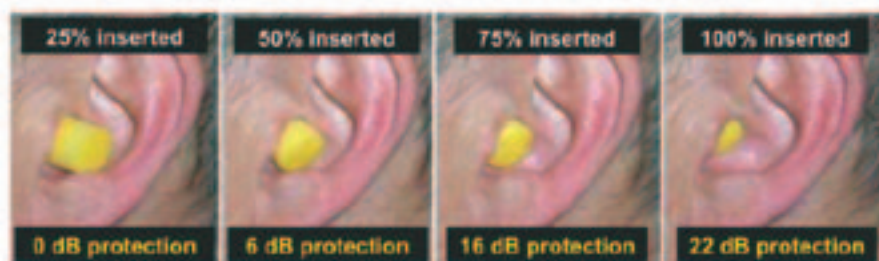
Figure 1. Hearing protection (noise reduction) achieved with different degrees of earplug insertion².

Proper insertion of earplugs is critical. If they are not inserted correctly, then they are ineffective. Consider the following example of an earplug that should provide 22 decibels (dB) of protection (in other words, the earplug should be able to reduce the sound energy that reaches your ear by 22 dB). In order for that earplug to work properly, it must be fully inserted into the ear canal², such that only the top of the earplug is visible to an outside observer. As shown in Figure 1, the protection provided by the earplug drops off considerably when the earplug is not fully inserted into the ear canal². Note the left-most picture in Figure 1: an individual who only inserts 25% or less of

the earplugs into their ear canals may technically be “wearing earplugs”, but the earplugs in this circumstance are providing no hearing protection whatsoever.

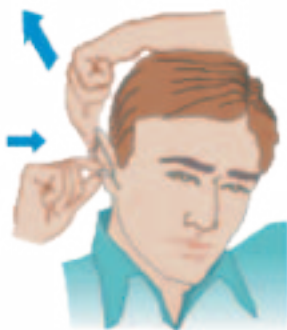
2. Pull the top of your ear up and back with your opposite hand to straighten out your ear canal. The rolled-up earplug should slide right in.

Figure 2. Steps required to ensure proper insertion of foam earplugs⁷ (Note that for step #3, counting inside your head may be more socially acceptable).

The steps that must be followed to ensure that foam earplugs are inserted properly is shown in Figure 2. In addition to the figure, the National Institute of Occupational Safety and Health (NIOSH) website (<http://www.cdc.gov/niosh/mining/topics/hearingloss/earplug.htm>) also has a link to an instructional video. As well, NIOSH has a website link that allows individuals to very quickly and easily check the effectiveness of their hearing protection (<http://www.cdc.gov/niosh/mining/topics/hearingloss/quickfitweb.htm>); all that is required is internet access and a computer with speakers.

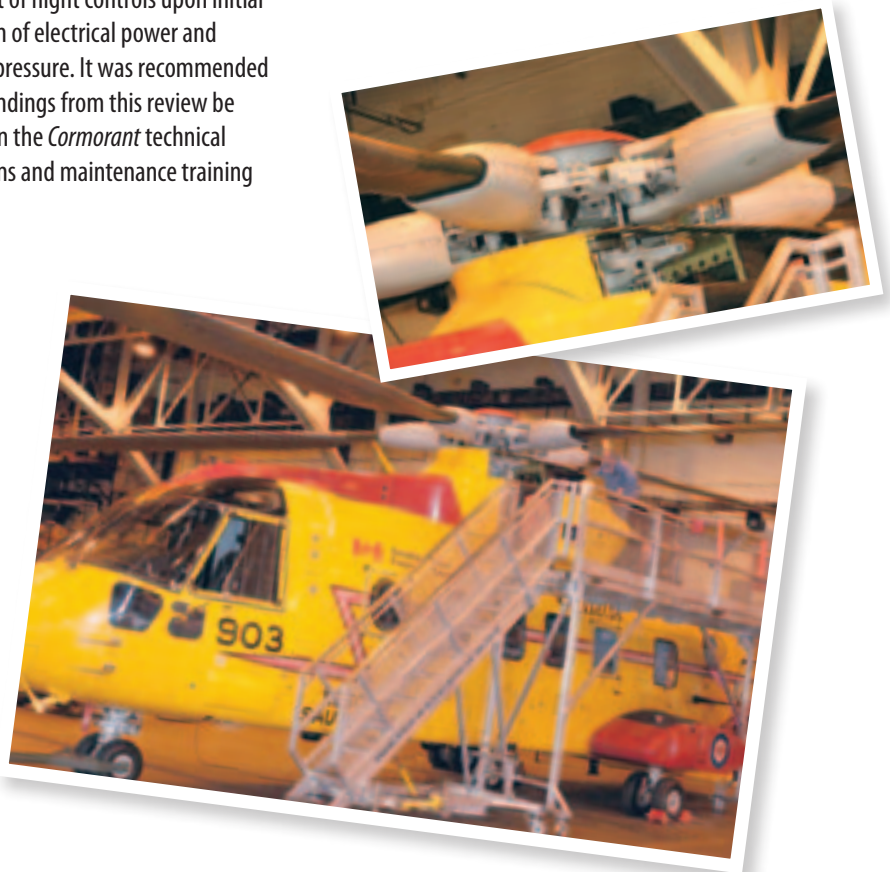
The investigation also found inconsistencies with the approved maintenance procedures for the swashplate friction adjustment check. It was recommended that a detailed review and re-write of the Swash Plate Friction Adjustment procedure be carried out to ensure it matches the second line procedure. ♦

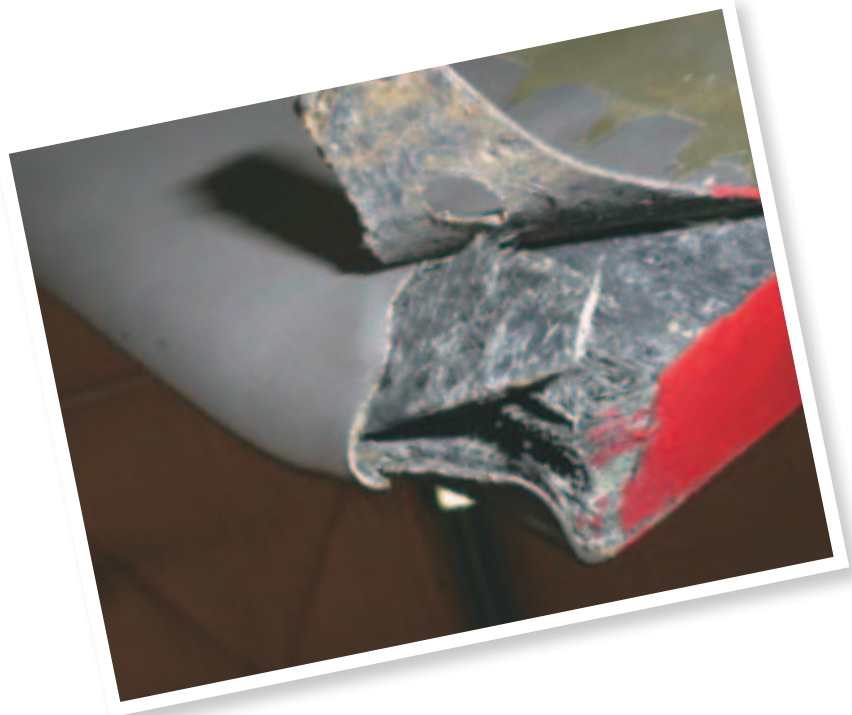
TYPE: CH146425 *Griffon*

The field investigation revealed a seven foot long, four inch deep groove in the crushed rock. Post mission inspections revealed signs of a stinger strike and damage to one tail rotor blade. Evidence and testimony revealed that the final approach was fast, steep and flown in an aggressive manner for the given ambient conditions.

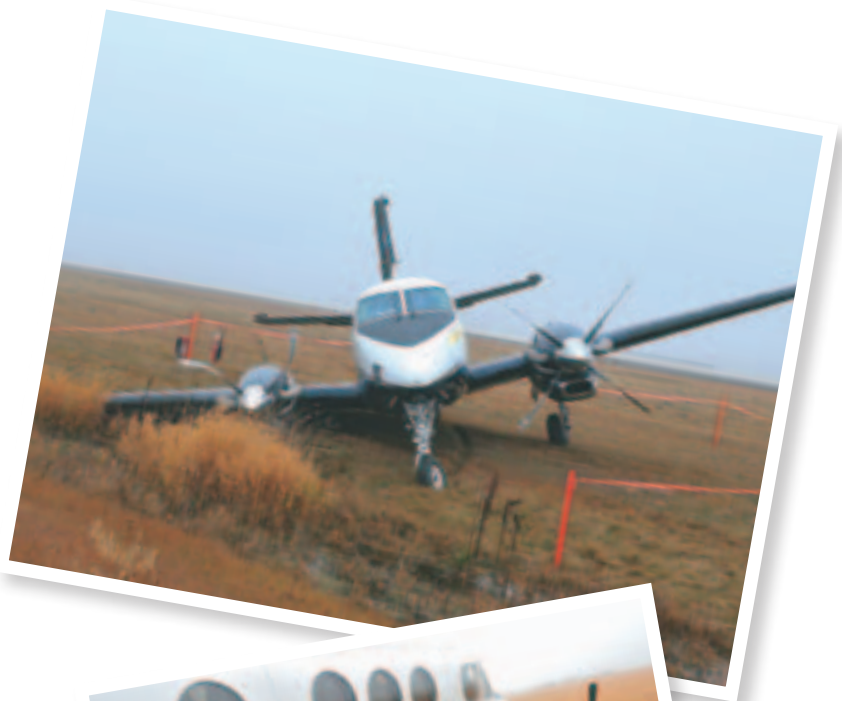
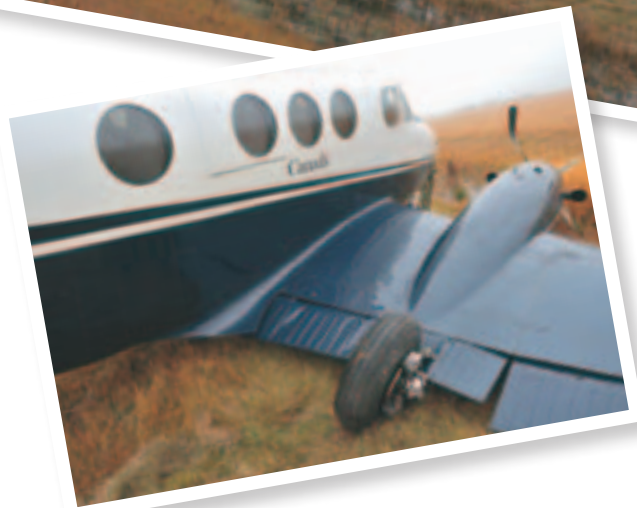
TYPE: CT145 *King Air* (C-FMFR)

A CT145 *King Air* operated by 3 CFFTS departed the hard surface of runway 13R at Portage la Prairie as the aircraft was completing a full stop landing. The aircraft was crewed by a Qualified Flight Instructor (QFI) in the right seat and a student pilot in the left seat, under training as part of the Multi-engine Pilot Course. Immediately after touchdown, the right wing began to sink due to failure of the right main landing gear. Attempts to maintain runway centreline proved futile as the aircraft drifted right, departing the hard surface of the runway approximately 600 meters after touching down. The aircraft came to a full stop at the crest of a drainage ditch, 78 meters right of runway 13R centreline. Both pilots were able to safely egress with no injuries. The aircraft sustained "C" category damage.

The investigation revealed that the right main landing gear lower drag brace arm bolt failed due to fatigue prior to achieving the design criteria of six years or 8,000 landings.

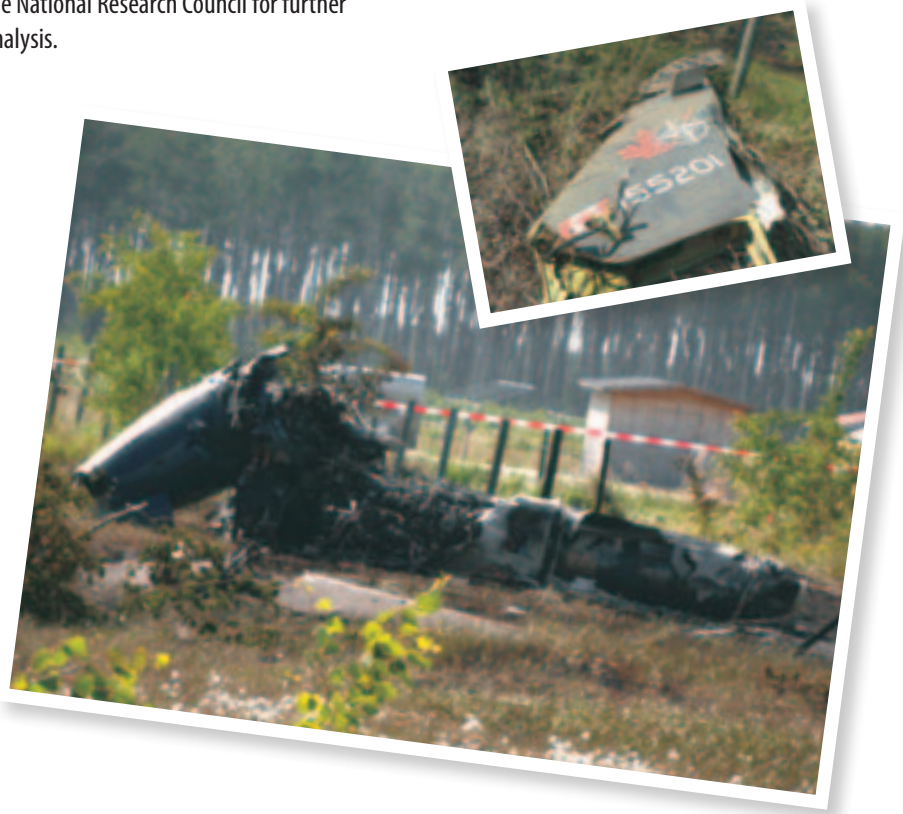
TYPE: CT155 *Hawk* (155201)

The post-crash field investigation revealed a missing Low Pressure Turbine (LPT) blade from Module 8 in the engine, which is similar to LPT blade failures in four previous CF *Hawk* aircraft occurrences. The engine and other aircraft components have been sent to the Quality Engineering Test Establishment and the National Research Council for further analysis.
